## Montgomery Associates, Resource Solutions Construction Site Inspection Report/Erosion Control Checklist

| <b>Construction Site (Project) Name:</b> Lake Koshkonong Dredging and Shoreline Restoration Project | <b>Project ID #:</b> 1453-001 |
| <b>Date of Inspection (mm/dd/yyyy):</b> 02/18/2013<br><b>Start Time:</b> 10:45 am <b>End Time:</b> 11:45 am | <b>Type of Inspection:</b> <input checked="" type="checkbox"/> <b>Weekly</b> <input type="checkbox"/> <b>Precipitation Event</b><br><input type="checkbox"/> <b>Other (specify):</b> |

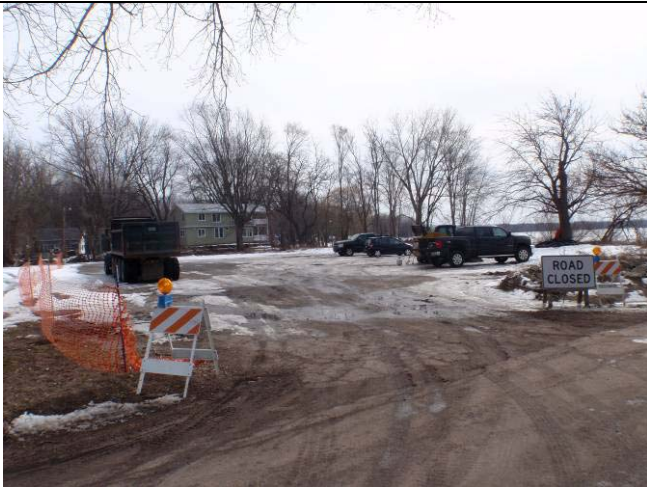
**Description of Observation:** The construction fencing has been placed and a Road Closed sign is at the entrance. All vehicles and equipment are utilizing the staging area and it appears to be in good condition.

At the entrance of the staging area, looking east.

- Follow-up Required    **Action Items: None**

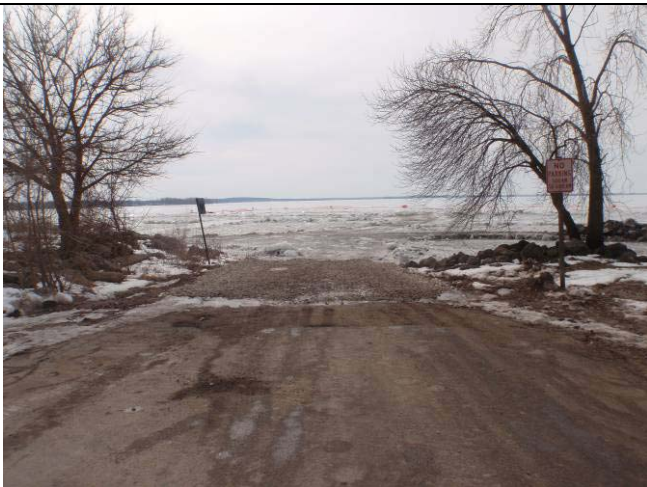
| BMP Inspected | Acceptable | Follow-up Required | N/A | Comments / Observation Number |
|---|---|---|---|---|
| Tracking Pad | X | | | The tracking pad has been placed over geotextile and appears to be functioning appropriately. See Observation #2. |

**Description of Observation:** The tracking pad has been placed and appears to be functioning appropriately.

At the tracking pad, looking south.

- Follow-up Required    **Action Items: None**

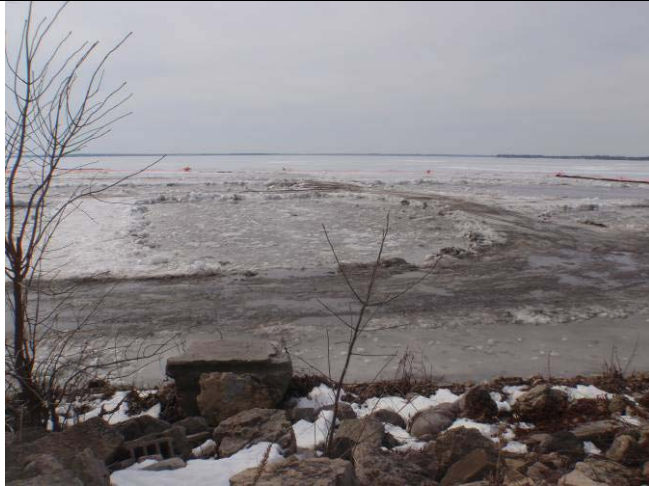
**Description of Observation:** The silt curtain has been placed but is covered by snow and frozen in place. The traffic control measures have been placed around the dredge area. Ice roads to access the dredge site have been built, and some dredge material is stockpiled. The ice roads are also acting as perimeter control as silt socks are no longer practical. There is continuity between the ice road and the silt curtain for a full perimeter. Dredging is on hold until ice road repairs are complete. A small amount of dredge material has been stock piled.

At the staging area, looking south onto the center of the dredge area.

- Follow-up Required    **Action Items: None**

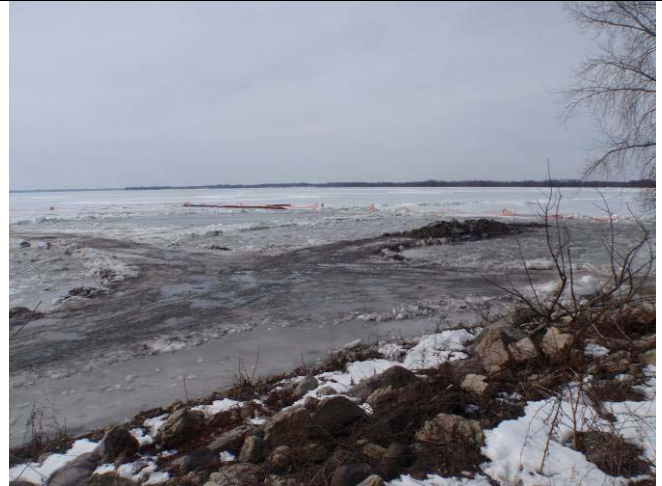
At the staging area, looking west onto the western side of the dredge area.

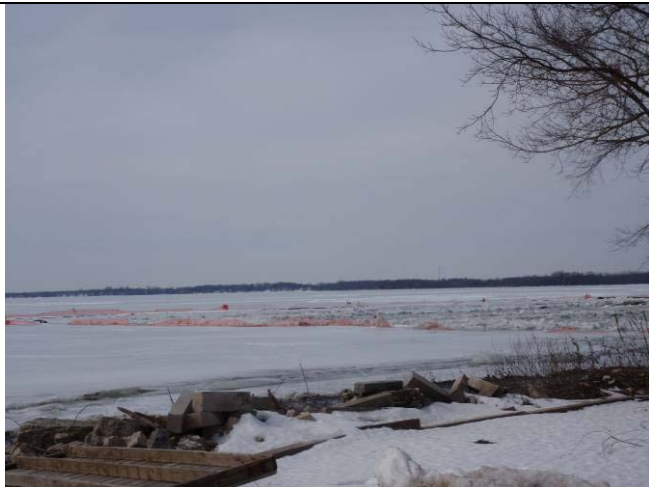
At Lamp Road, looking SW onto the eastern side of the dredge area.

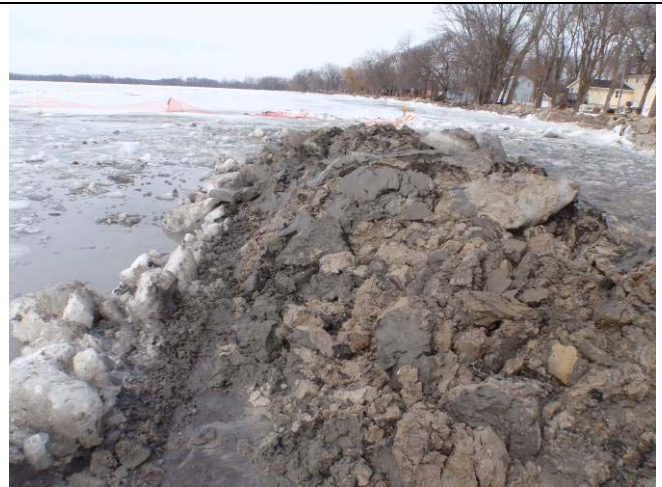
Close-up of the dredge spoils pile.

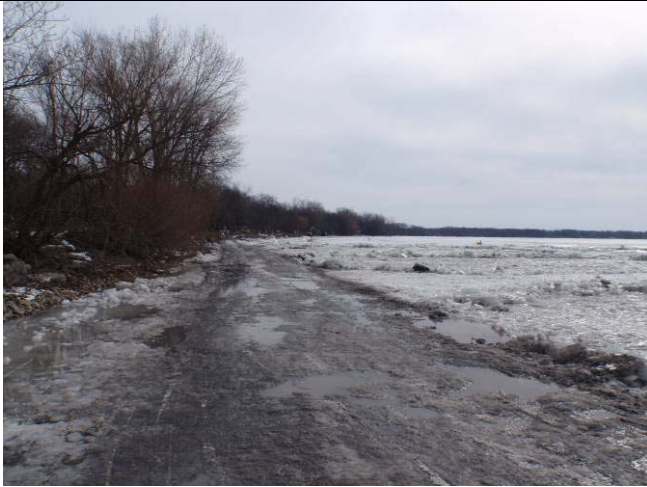
**Description of Observation:** The crew has completed the ice road and were actively using it for construction. Currently, repairs are being performed as the water level has risen, and ice heaves and cracks have formed.

At the boat launch, looking SW.

- Follow-up Required    **Action Items: None**

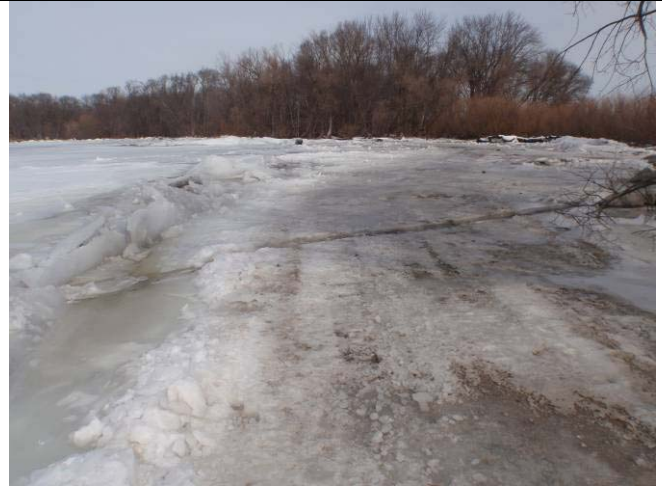
Just north of the berm, looking north.

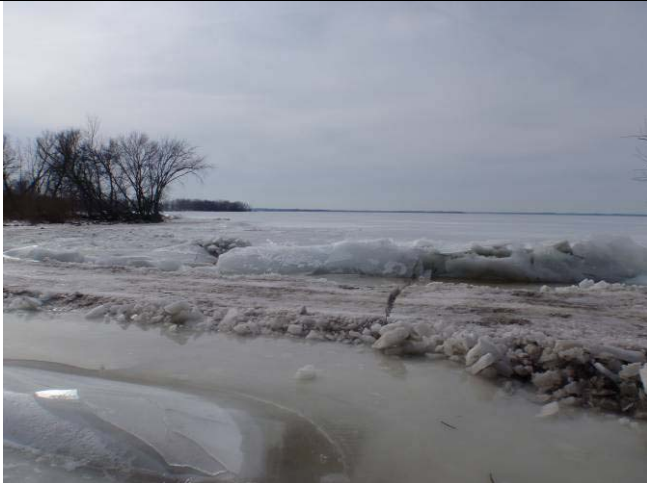
Along the Twin Island Gun Club property, looking south.

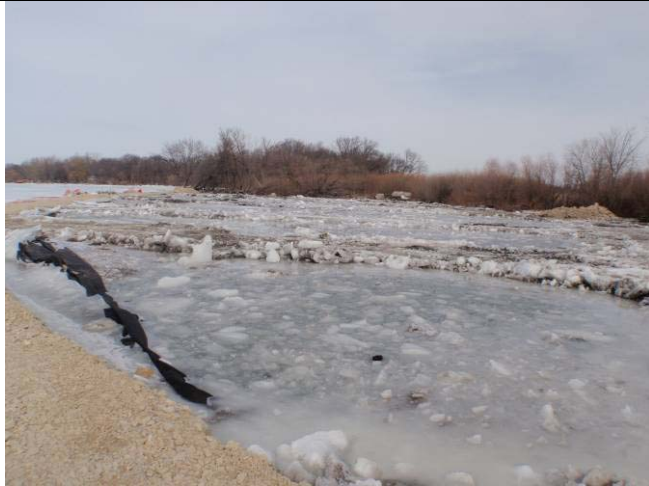
**Description of Observation:** The silt curtain has been placed but is covered by snow and frozen in place. The traffic control measures have been placed around the dredge placement area. The berm is constructed over geotextile, and the geotextile is also separating the riprap from the breaker run. The berm is about 95% complete with some basic tie in work remaining. There are small stockpiles of stone that will be used to complete the berm construction.

At the south end of the berm looking north onto the dredge placement area.

- Follow-up Required    **Action Items: None**

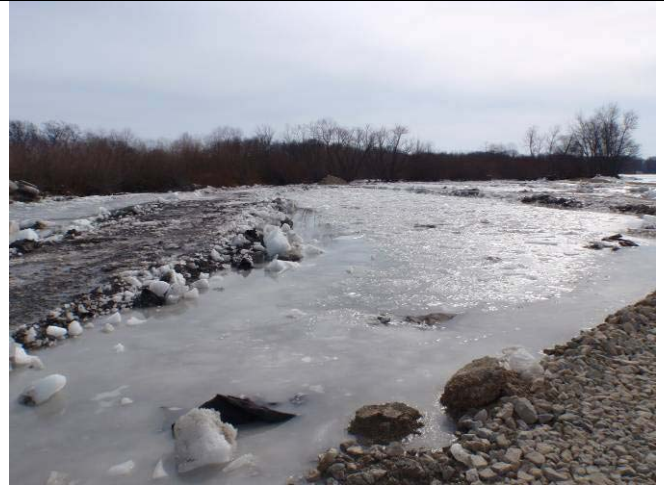
At the north end of the berm looking south onto the dredge placement area.

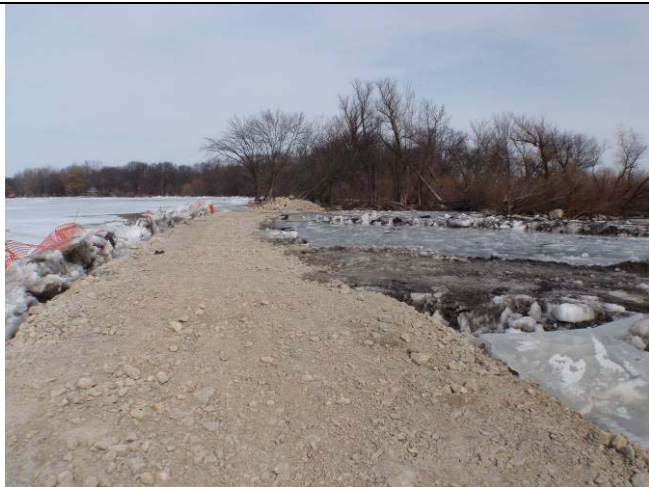
At the center the berm looking north.

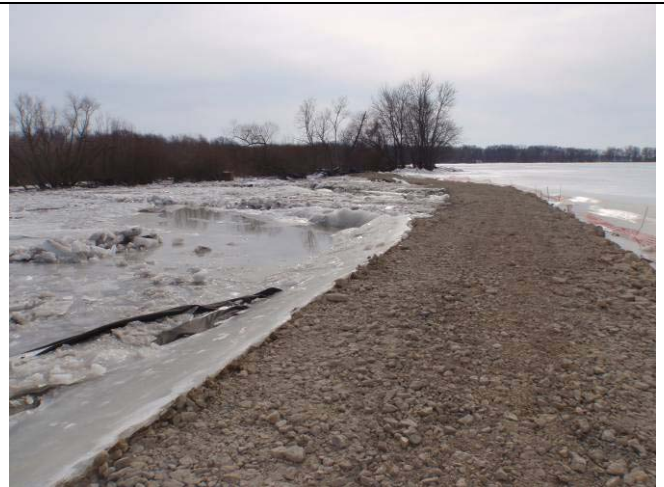
At center of the berm looking south.

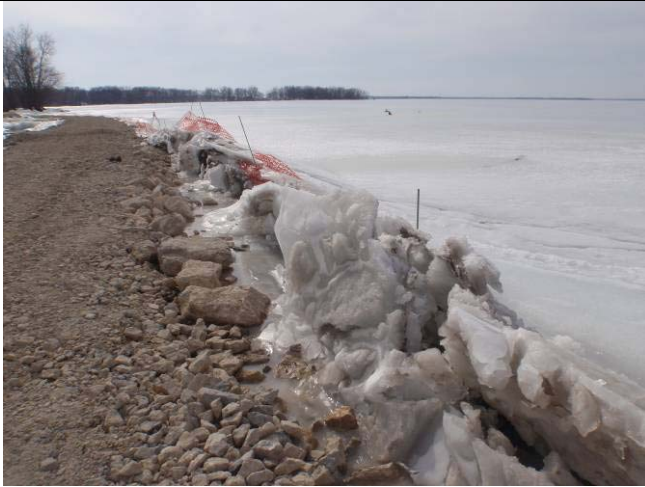
At the north end the berm looking SW at the ice heaves.

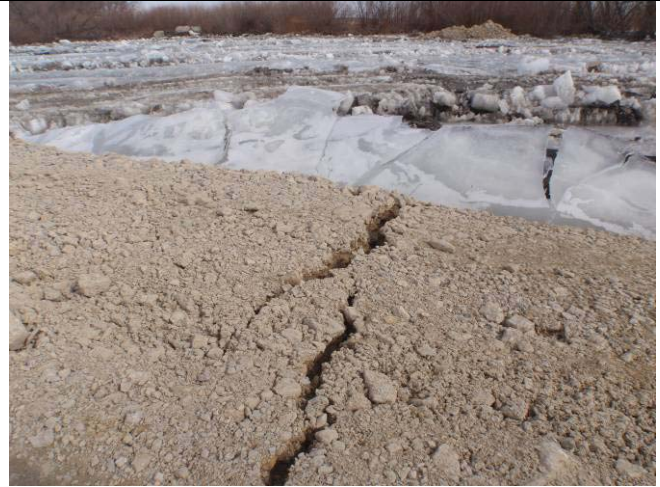
At the south end the berm looking at a crack caused by the ice heaves.
