## Montgomery Associates, Resource Solutions Construction Site Inspection Report/Erosion Control Checklist

<b>Name of Permittee:</b> Rock-Koshkonong Lake District (RKLD)	
<b>Construction Site (Project) Name:</b> Lake Koshkonong Dredging and Shoreline Restoration Project	<b>Project ID #:</b> 1453-001
<b>Site Location:</b> Boat Launch at end of North Shore Road, Town of Sumner	<b>County:</b> Jefferson
<b>Contractor:</b> Badgerland Excavating	<b>Site Contact Person:</b> Kevin Hahn: 608-333-5607 or Tim Van Bommel: 608-354-5442
<b>Name of Individual Performing Inspection:</b> Danielle Lee (MARS): 608-839-4422	
<b>Date of Inspection (mm/dd/yyyy):</b> 02/19/2013 <b>Start Time:</b> 2:40 pm <b>End Time:</b> 3:30 pm	<b>Type of Inspection:</b> <input type="checkbox"/> Weekly <input checked="" type="checkbox"/> Precipitation Event <input type="checkbox"/> Other (specify):
<b>Weather Conditions:</b> Overcast, 12°F.	<b>Rainfall Since Last Inspection (if applicable):</b> 0.50 inches of rainfall since the last inspection on 02/18/2013 (NOWData - NOAA Online Weather Data for Fort Atkinson)

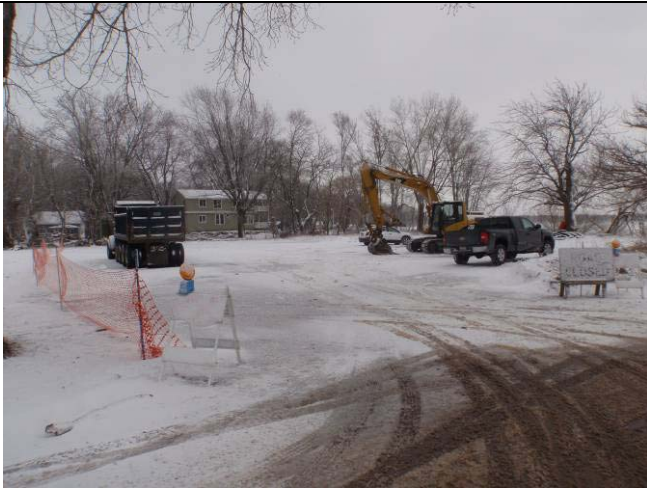
Observation #1: Staging Area

**Description of Observation:** The construction fencing has been placed and a Road Closed sign is at the entrance. All vehicles and equipment are utilizing the staging area and it appears to be in good condition.

At the entrance of the staging area, looking east.

- Follow-up Required    **Action Items: None**

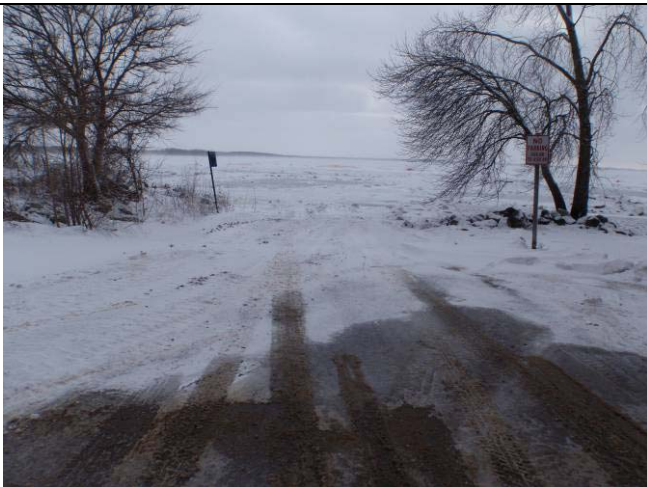
Observation #2: Tracking Pad

**Description of Observation:** The tracking pad has been placed and appears to be functioning appropriately.

At the tracking pad, looking south.

- Follow-up Required    **Action Items: None**

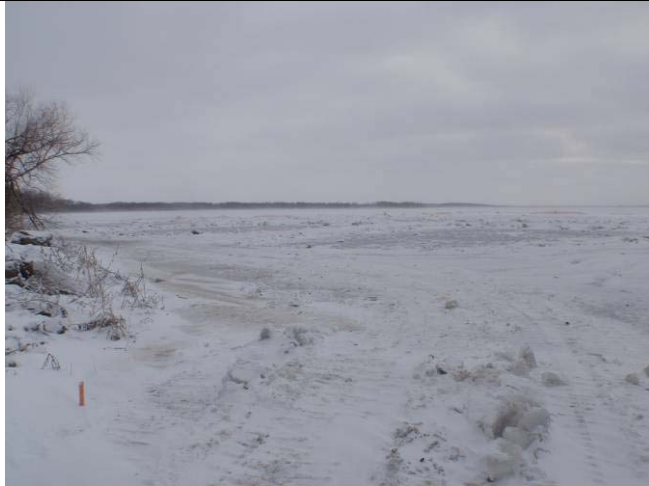
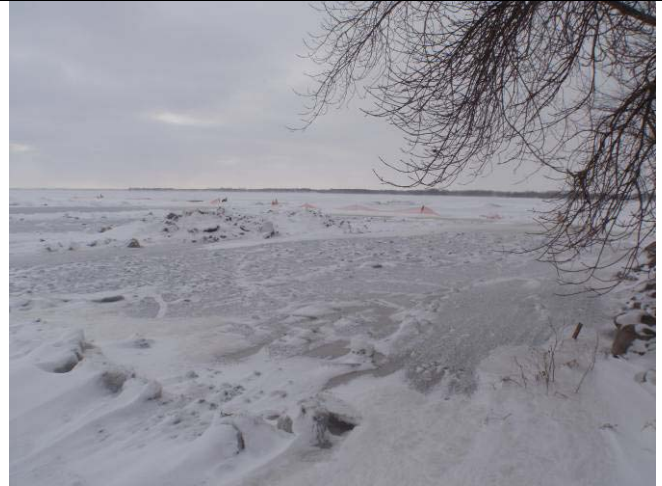
Observation #3: Dredge Area

**Description of Observation:** The silt curtain has been placed but is covered by snow and frozen in place. The traffic control measures have been placed around the dredge area. Ice roads to access the dredge site have been built, and some dredge material is stockpiled. The ice roads are also acting as perimeter control as silt socks are no longer practical. There is continuity between the ice road and the silt curtain for a full perimeter. Dredging is on hold until ice road repairs are complete. A small amount of dredge material has been stock piled.

At the boat launch, looking SE onto the eastern side of the dredge area.

At the boat launch, looking SW onto the western side of the dredge area.

- Follow-up Required    **Action Items: None**

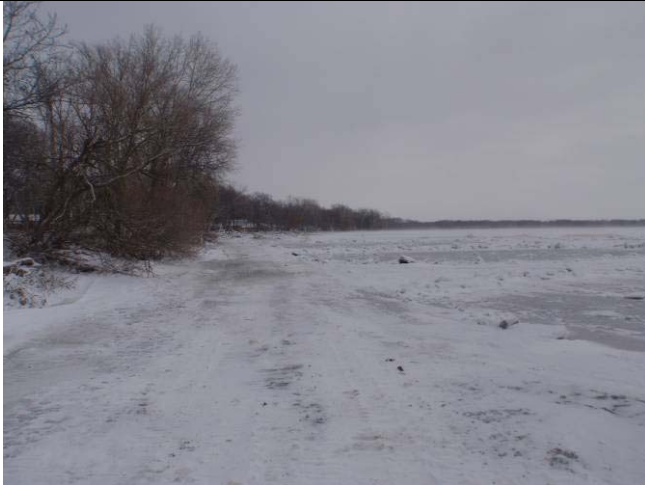
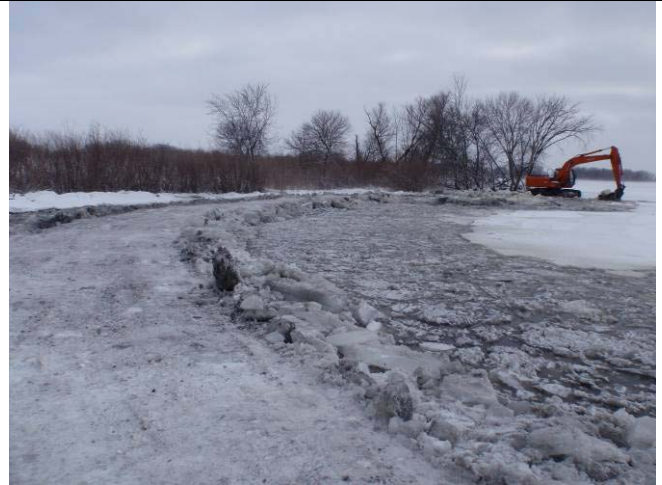
Observation #4: Haul Route

**Description of Observation:** The crew has completed the ice road and were actively using it for construction. Currently, repairs are being performed as the water level has risen, and ice heaves and cracks have formed.

At the boat launch, looking SW.

Looking south toward the north end of the berm.

- Follow-up Required    **Action Items: None**

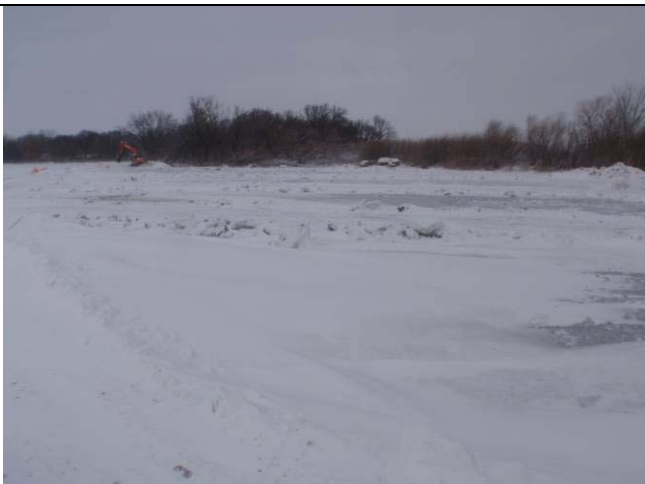
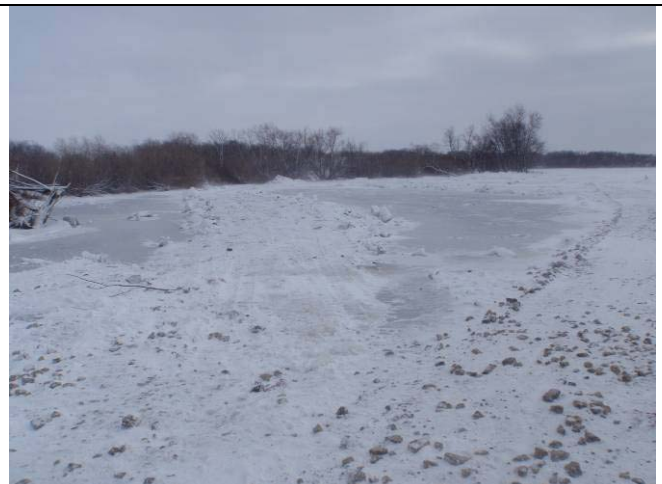
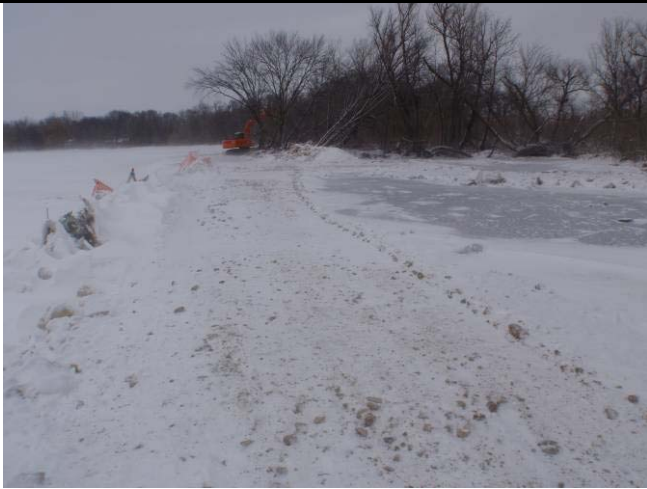
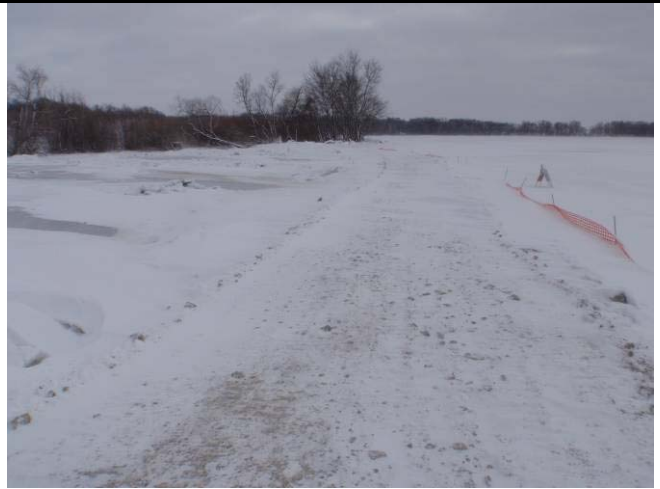
Observation #5: Dredge Placement

**Description of Observation:** The silt curtain has been placed but is covered by snow and frozen in place. The traffic control measures have been placed around the dredge placement area. The berm is constructed over geotextile, and the geotextile is also separating the riprap from the breaker run. The berm is about 95% complete with some basic tie in work remaining. There are small stockpiles of stone that will be used to complete the berm construction.

At the south end of the berm looking north onto the dredge placement area.

At the north end of the berm looking south onto the dredge placement area.

At the center the berm looking north.

At center of the berm looking south.

Kevin (Badgerland) said that the places where the breaker run has cracked/moved appear to be where work stopped for the day, and possibly some moisture got in and caused the heave. He will be pounding those areas back into place. The settling plates will be constructed today or tomorrow, and placed shortly after. Dredge work is due to beginning tomorrow.

- Follow-up Required    **Action Items: None**
