## Montgomery Associates, Resource Solutions Construction Site Inspection Report/Erosion Control Checklist

<b>Name of Permittee:</b> Rock-Koshkonong Lake District (RKLD)	
<b>Construction Site (Project) Name:</b> Lake Koshkonong Dredging and Shoreline Restoration Project	<b>Project ID #:</b> 1453-001
<b>Site Location:</b> Boat Launch at end of North Shore Road, Town of Sumner	<b>County:</b> Jefferson
<b>Contractor:</b> Badgerland Excavating	<b>Site Contact Person:</b> Kevin Hahn: 608-333-5607 or Tim Van Bommel: 608-354-5442
<b>Name of Individual Performing Inspection:</b> Danielle Lee (MARS): 608-839-4422	
<b>Date of Inspection (mm/dd/yyyy):</b> 02/26/2013 <b>Start Time:</b> 3:00 pm <b>End Time:</b> 3:50 pm	<b>Type of Inspection:</b> <input checked="" type="checkbox"/> <b>Weekly</b> <input type="checkbox"/> <b>Precipitation Event</b> <input type="checkbox"/> <b>Other (specify):</b>
<b>Weather Conditions:</b> Snowing, 28°F.	<b>Rainfall Since Last Inspection (if applicable):</b> 0.38 inches of precipitation (a portion as snow) since the last inspection on 02/19/2013 (NOWData - NOAA Online Weather Data for Fort Atkinson)

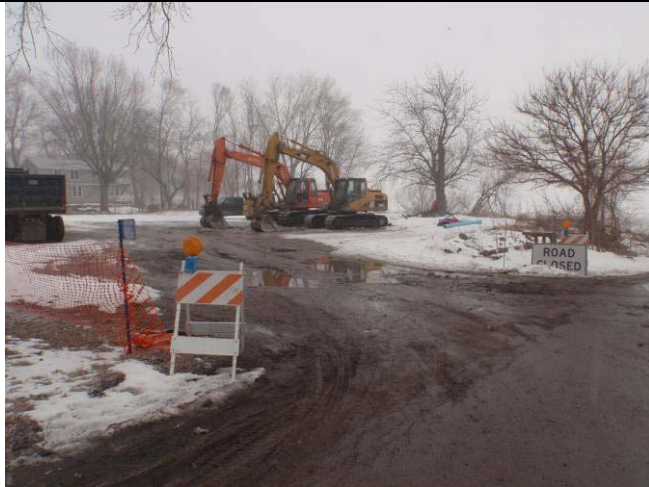
Observation #1: Staging Area

**Description of Observation:** The construction fencing has been placed and a Road Closed sign is at the entrance. All vehicles and equipment are utilizing the staging area and it appears to be in good condition.

At the entrance of the staging area, looking east.

- Follow-up Required    **Action Items: None**

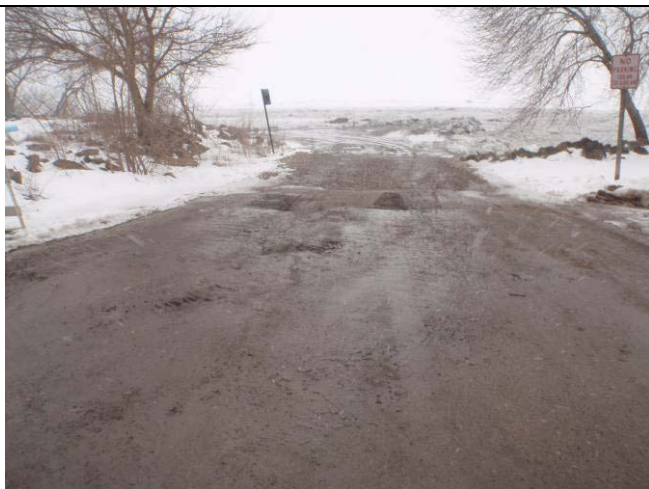
Observation #2: Tracking Pad

**Description of Observation:** The tracking pad has been placed and appears to be functioning appropriately.

At the tracking pad, looking south.

- Follow-up Required    **Action Items: None**

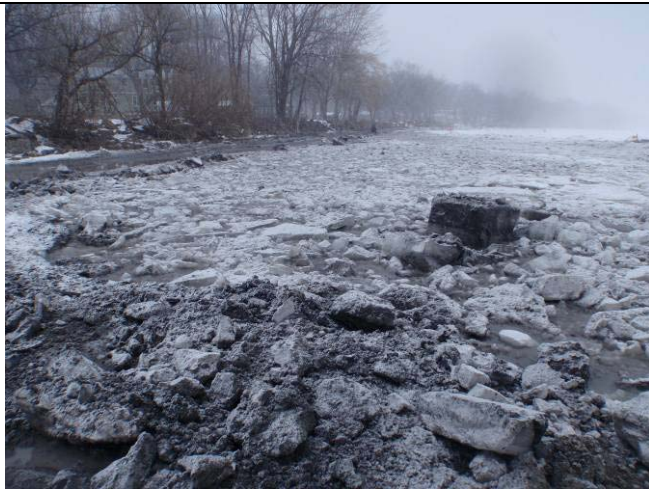
Observation #3: Dredge Area

**Description of Observation:** The silt curtain has been placed but is covered by snow and frozen in place. The traffic control measures have been placed. Dredging operations are nearly complete. The ice roads are also acting as perimeter control as silt socks are no longer practical. There is continuity between the ice road and the silt curtain for a full perimeter.

At an ice road just out from the boat launch, looking east onto the eastern side of the dredge area.

- Follow-up Required    **Action Items: None**

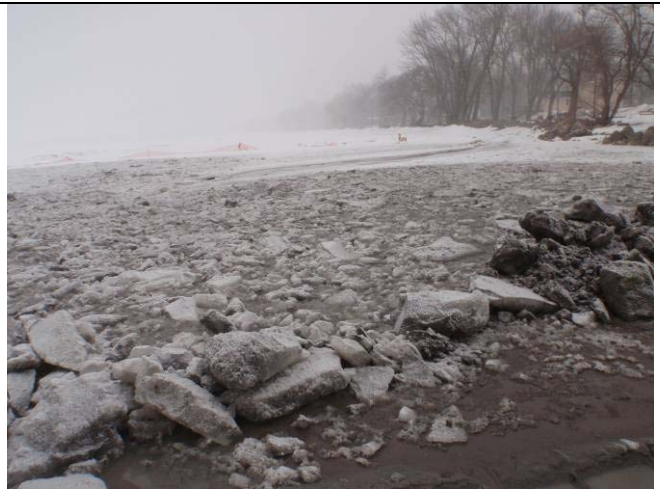
At an ice road just out from the boat launch, looking west onto the western side of the dredge area.

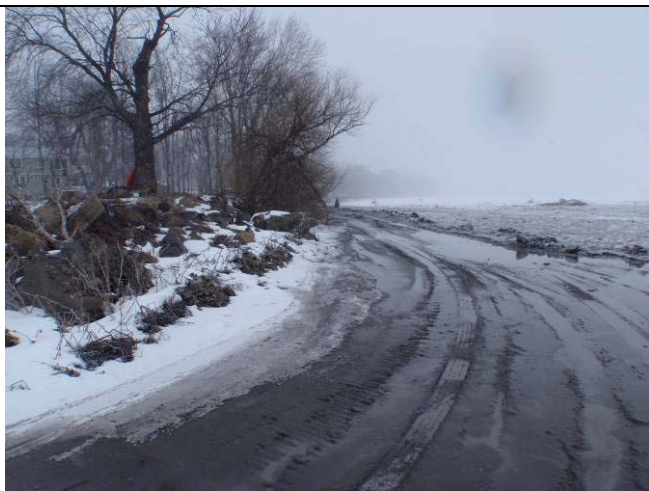
Observation #4: Haul Route

**Description of Observation:** The ice road has been actively used for construction.

At the boat launch, looking SW.

- Follow-up Required    **Action Items: None**

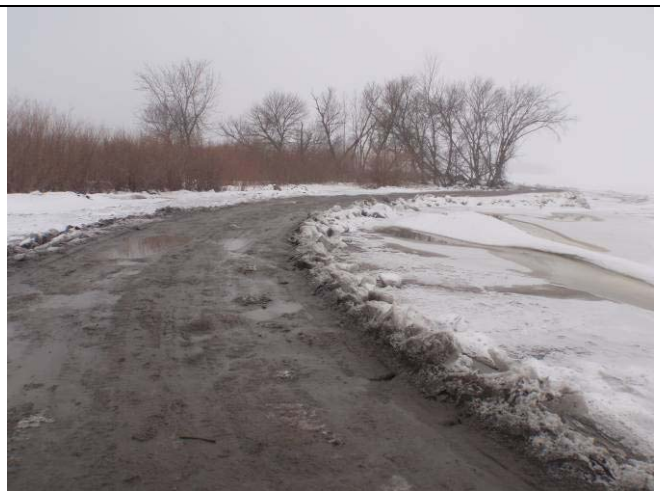
Looking south toward the north end of the berm.

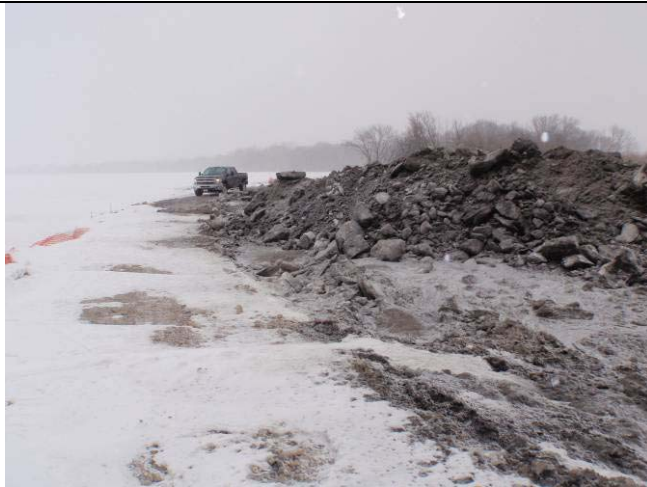
Observation #5: Dredge Placement

**Description of Observation:** The berm is about 95% complete with some basic tie in work remaining. The majority of the dredge material has been placed and grading work remains. The silt curtain has been placed but is covered by snow and frozen in place. The traffic control measures have been placed around the dredge placement area. The berm is constructed over geotextile, and the geotextile is also separating the riprap from the breaker run. There are small stockpiles of stone that will be used to complete the berm construction.

At the south end of the berm looking north onto the dredge placement area.

- Follow-up Required    **Action Items: None**

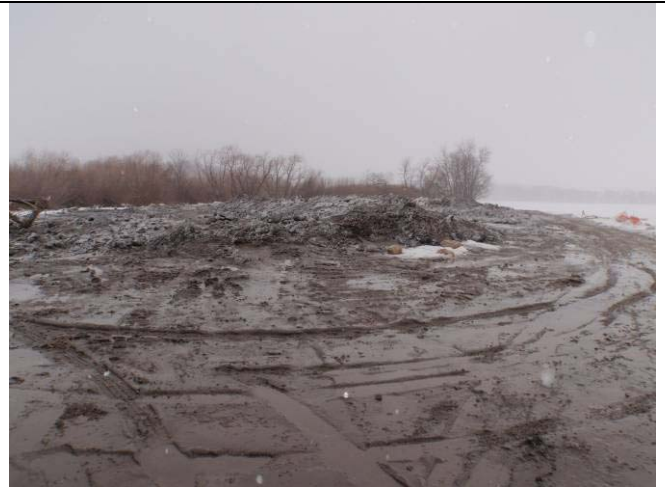
At the north end of the berm looking south onto the dredge placement area.

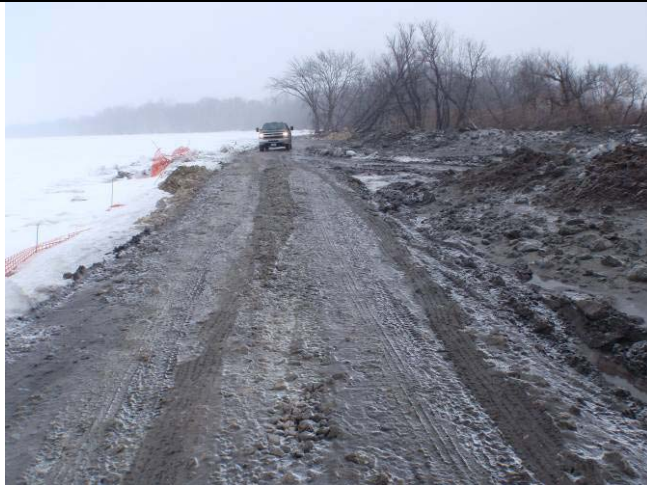
At the center the berm looking north.

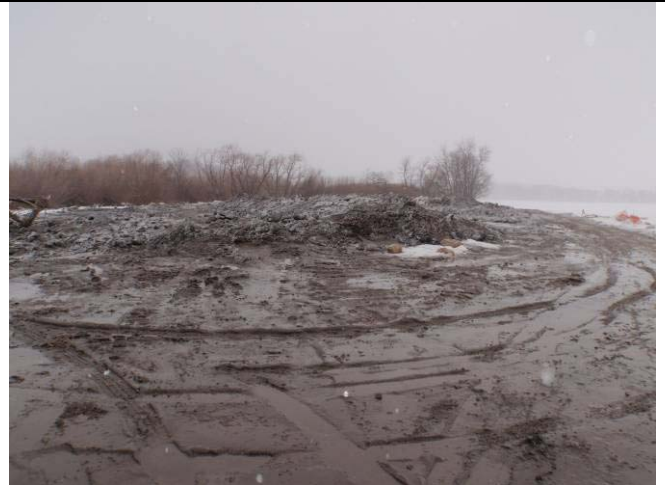
At center of the berm looking south.
