Montgomery Associates, Resource Solutions Construction Site Inspection Report/Erosion Control Checklist

Name of Permittee: Rock-Koshkonong Lake District (RKLD)	
Construction Site (Project) Name: Lake Koshkonong Dredging and Shoreline Restoration Project	Project ID #: 1453-001
Site Location: Boat Launch at end of North Shore Road, Town of Sumner	County: Jefferson
Contractor: Badgerland Excavating	Site Contact Person: Kevin Hahn: 608-333-5607 or Tim Van Bommel: 608-354-5442
Name of Individual Performing Inspection: Danielle Lee (MARS): 608-839-4422	
Date of Inspection (mm/dd/yyyy): 03/11/2013 Start Time: 2:45 pm End Time: 3:45 pm	Type of Inspection: <input checked="" type="checkbox"/> Weekly <input type="checkbox"/> Precipitation Event <input type="checkbox"/> Other (specify):
Weather Conditions: Light snow, 30°F.	Rainfall Since Last Inspection (if applicable): 1.5 inches of precipitation (a portion as snow) since the last inspection on 03/04/2013 (NOWData - NOAA Online Weather Data for Fort Atkinson)

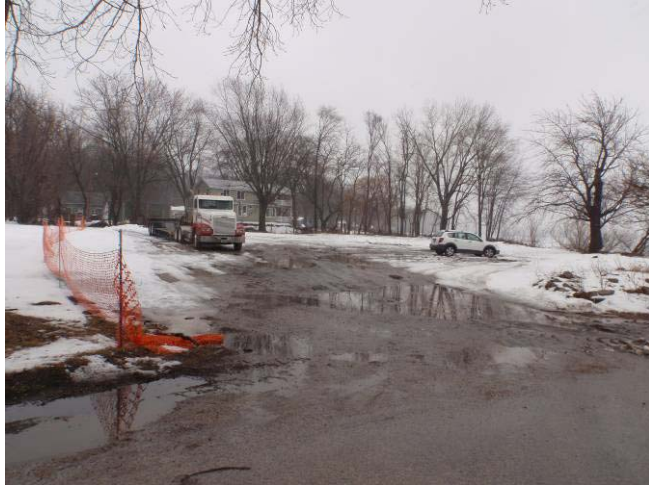
Observation #1: Staging Area

Description of Observation: The construction fencing has been placed and a Road Closed sign is at the entrance. All vehicles and equipment are utilizing the staging area and it appears to be in good condition.

At the entrance of the staging area, looking east.

- Follow-up Required **Action Items: None**

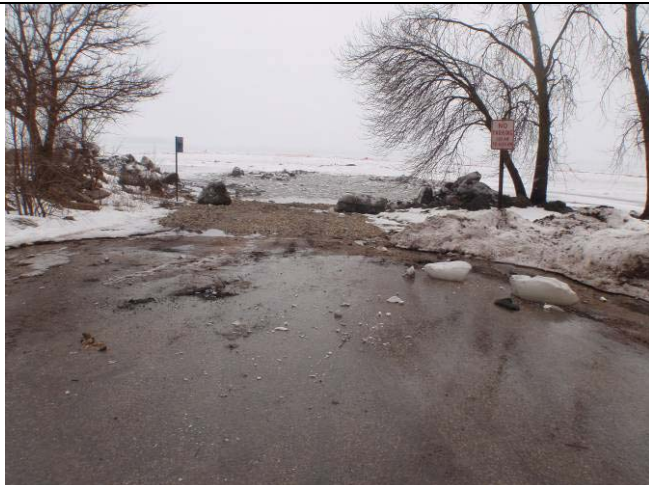
Observation #2: Tracking Pad

Description of Observation: The tracking pad has been placed and appears to be functioning appropriately. Additional rock has been placed at the boat launch and will be graded later that day.

At the tracking pad, looking south.

- Follow-up Required **Action Items: None**

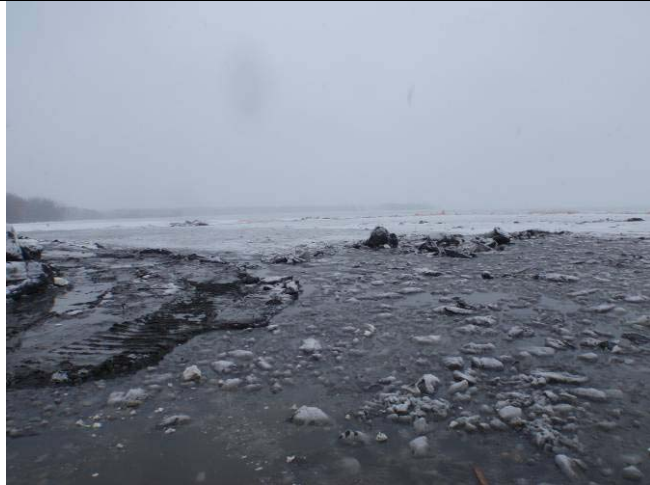
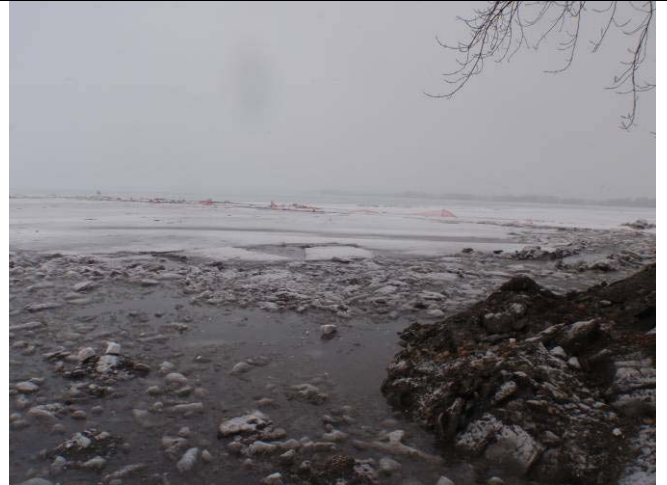
Observation #3: Dredge Area

Description of Observation: The silt curtain has been removed. The traffic control measures are still in placed. Dredging operations are complete.

At the boat launch, looking east onto the eastern side of the dredge area.

At the boat launch, looking west onto the western side of the dredge area.

- Follow-up Required **Action Items: None**

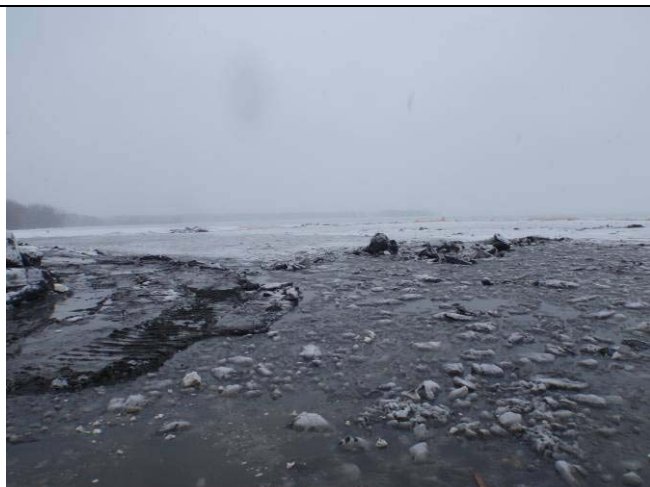
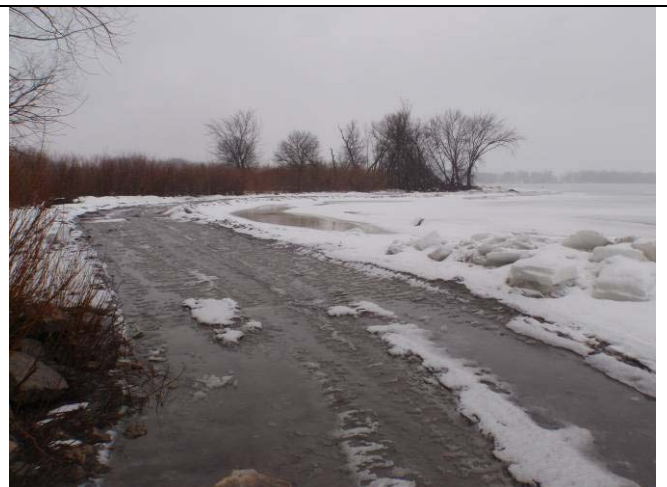
Observation #4: Haul Route

Description of Observation: The ice road is now melting and is no longer in use.

At the boat launch, looking SW.

Looking south toward the north end of the berm.

- Follow-up Required **Action Items: None**

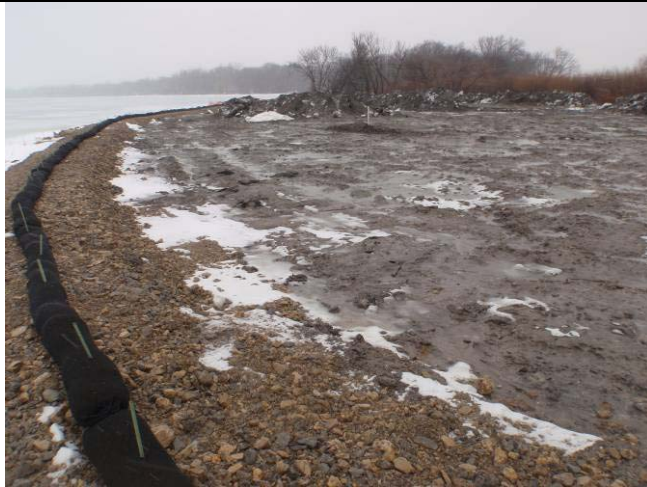
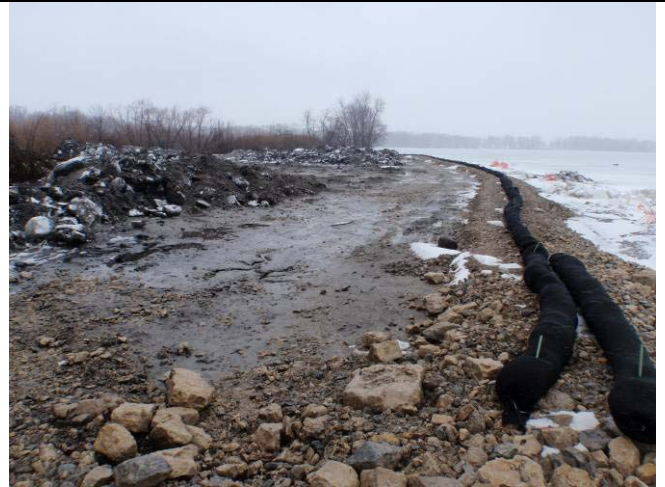
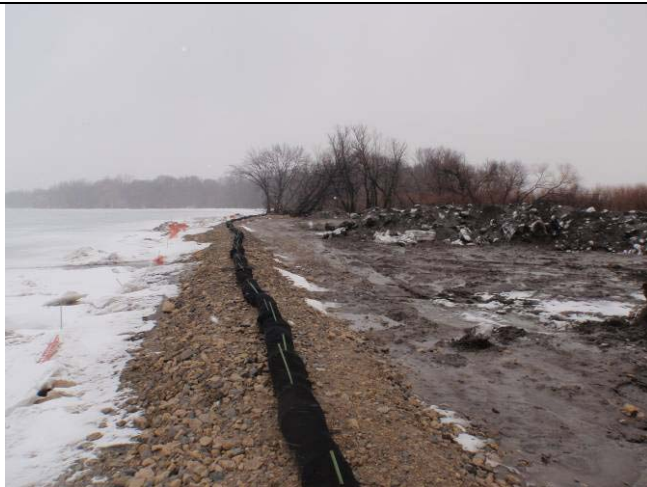
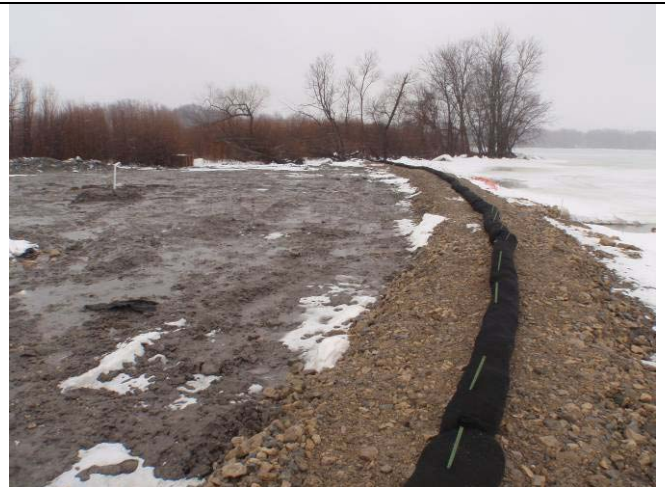
Observation #5: Dredge Placement

Description of Observation: The berm is complete. Dredge material has been placed and ice has been stockpiled. The silt curtain has been removed. The traffic control measures have been placed around the dredge placement area. The silt sock has been placed along the berm for temporary stabilization.

At the south end of the berm looking north onto the dredge placement area.

At the north end of the berm looking south onto the dredge placement area. The two portions of the silt sock has been temporarily moved for vehicle access.

At the center the berm looking north.

At center of the berm looking south.

- Follow-up Required **Action Items: None**

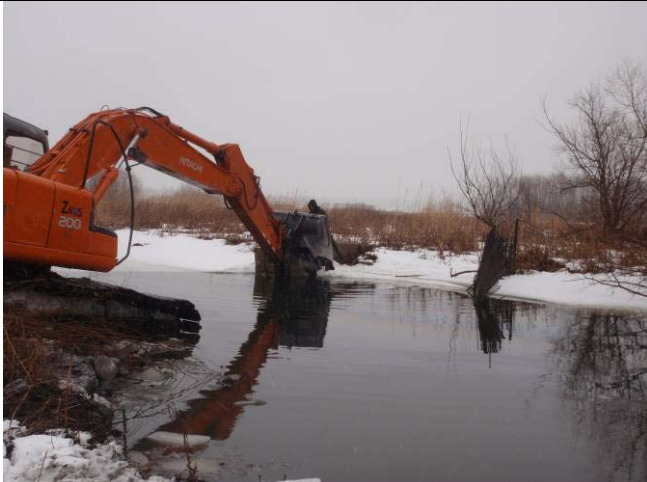
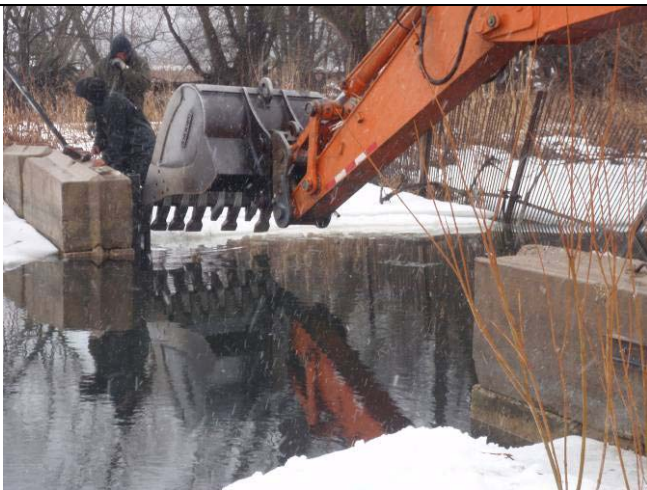
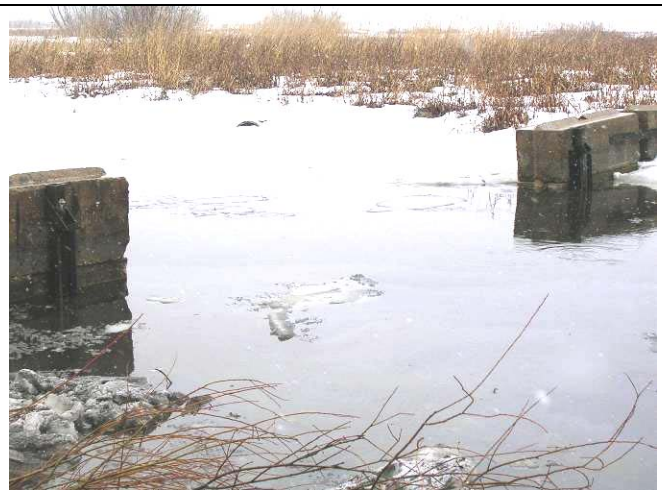
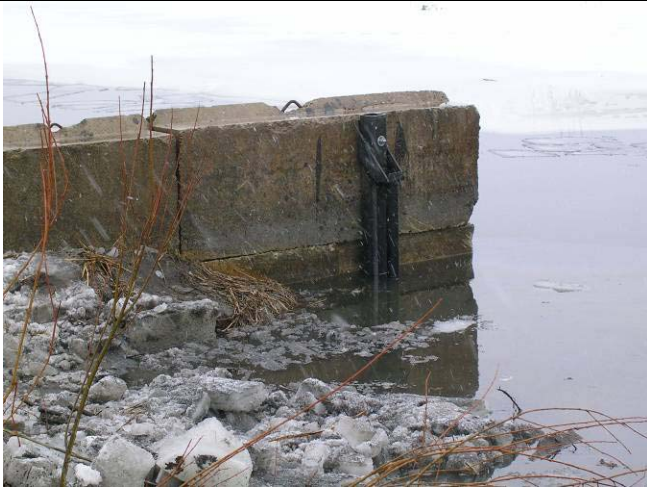
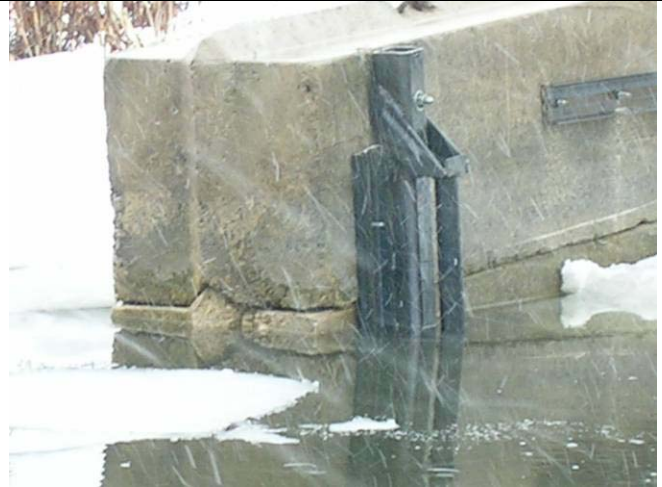
Observation #6: Carp Gate

Description of Observation: The carp gate anchorage work was being completed while on site.

At the carp gate looking north onto the construction.

At the carp gate looking east onto the installation of the anchorage poles.

At the carp gate looking north onto the installed anchorage.

At the carp gate looking east onto the installed west anchorage.

At the carp gate looking east onto the installed east anchorage.

- Follow-up Required Action Items: None

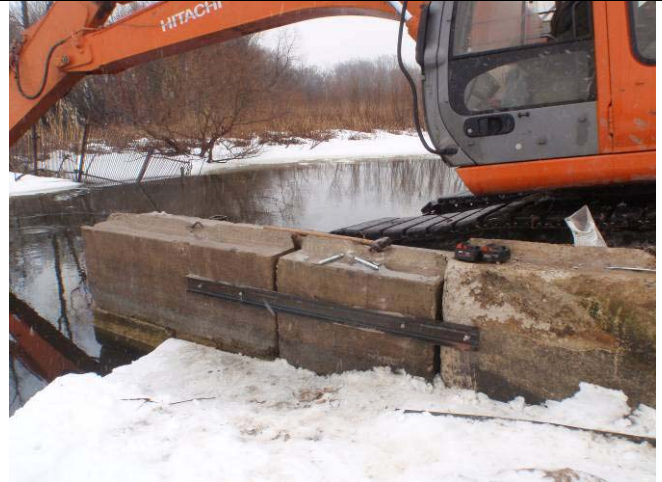
At the carp gate looking south onto the construction. The strapping has been anchored to the concrete blocks.

While on the phone: the strapping on the concrete blocks at the carp gate should be done on each side of the blocks for additional stability.
