## Montgomery Associates, Resource Solutions Construction Site Inspection Report/Erosion Control Checklist

<b>Name of Permittee:</b> Rock-Koshkonong Lake District (RKLD)	
<b>Construction Site (Project) Name:</b> Lake Koshkonong Dredging and Shoreline Restoration Project	<b>Project ID #:</b> 1453-001
<b>Site Location:</b> Boat Launch at end of North Shore Road, Town of Sumner	<b>County:</b> Jefferson
<b>Contractor:</b> Badgerland Excavating	<b>Site Contact Person:</b> Kevin Hahn: 608-333-5607 or Tim Van Bommel: 608-354-5442
<b>Name of Individual Performing Inspection:</b> Danielle Lee (MARS): 608-839-4422	
<b>Date of Inspection (mm/dd/yyyy):</b> 03/04/2013 <b>Start Time:</b> 10:30 am <b>End Time:</b> 11:15 am	<b>Type of Inspection:</b> <input checked="" type="checkbox"/> <b>Weekly</b> <input type="checkbox"/> <b>Precipitation Event</b> <input type="checkbox"/> <b>Other (specify):</b>
<b>Weather Conditions:</b> Clear and cold, 30°F.	<b>Rainfall Since Last Inspection (if applicable):</b> 0.32 inches of precipitation (a portion as snow) since the last inspection on 02/26/2013 (NOWData - NOAA Online Weather Data for Fort Atkinson)

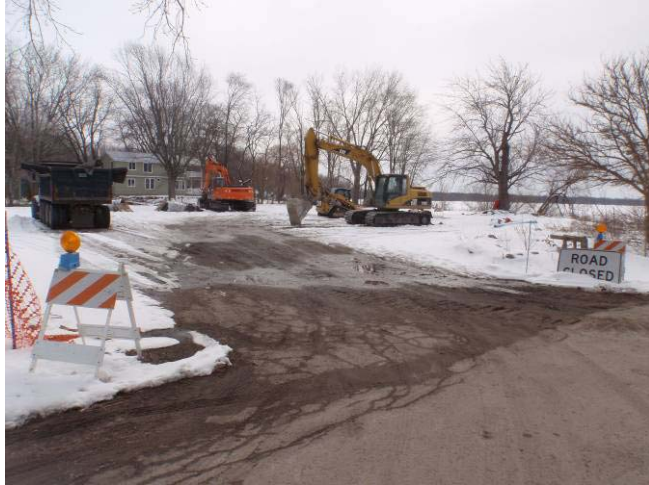
Observation #1: Staging Area

**Description of Observation:** The construction fencing has been placed and a Road Closed sign is at the entrance. All vehicles and equipment are utilizing the staging area and it appears to be in good condition.

At the entrance of the staging area, looking east.

- Follow-up Required    **Action Items: None**

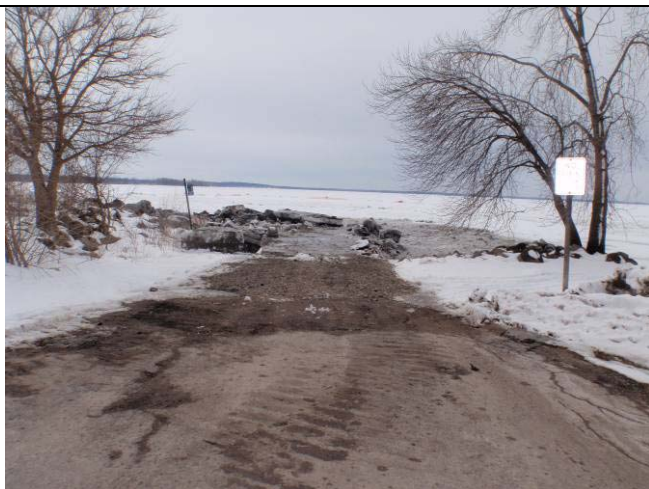
Observation #2: Tracking Pad

**Description of Observation:** The tracking pad has been placed and appears to be functioning appropriately.

At the tracking pad, looking south.

- Follow-up Required    **Action Items: None**

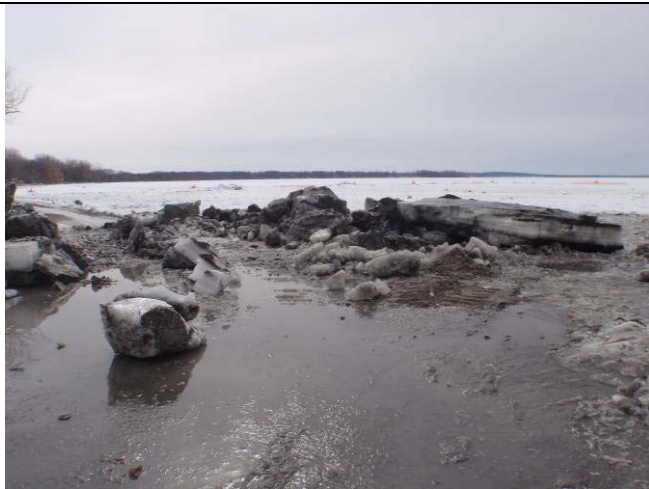
Observation #3: Dredge Area

**Description of Observation:** The silt curtain has been placed but is covered by snow and frozen in place. The traffic control measures have been placed. Dredging operations are nearly complete. The ice roads are also acting as perimeter control as silt socks are no longer practical. There is continuity between the ice road and the silt curtain for a full perimeter.

At the boat launch, looking east onto the eastern side of the dredge area.

- Follow-up Required    **Action Items: None**

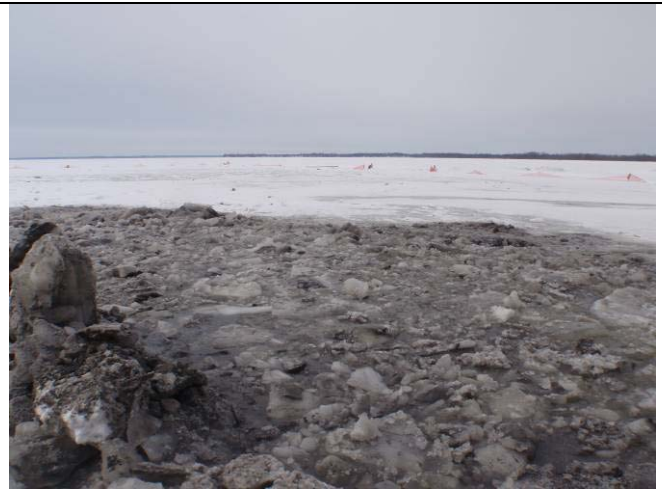
At the boat launch, looking west onto the western side of the dredge area.

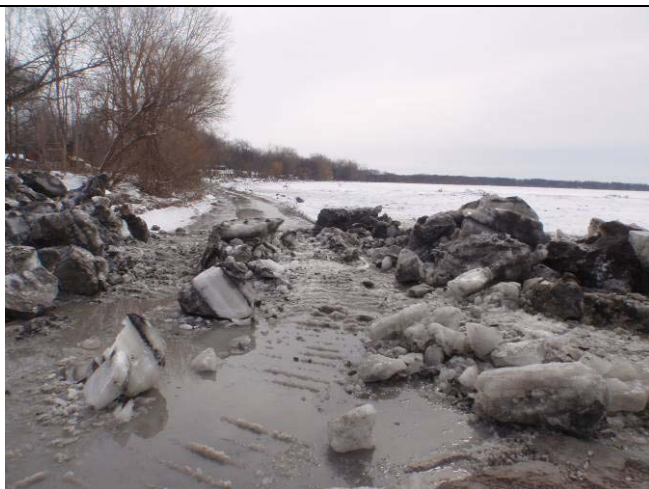
Observation #4: Haul Route

**Description of Observation:** The ice road has been actively used for construction.

At the boat launch, looking SW.

- Follow-up Required    **Action Items: None**

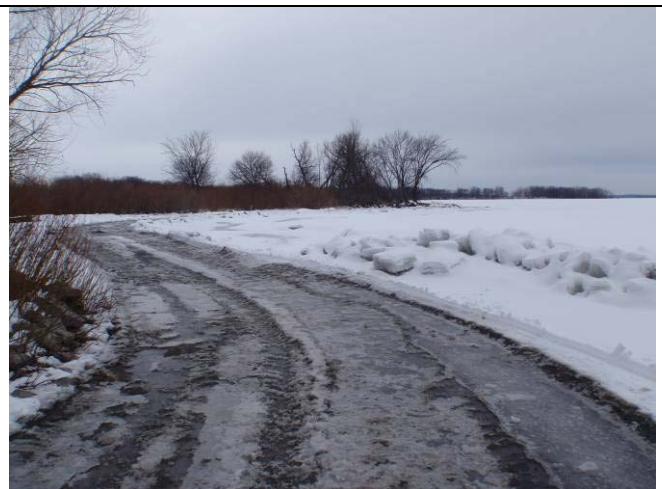
Looking south toward the north end of the berm.

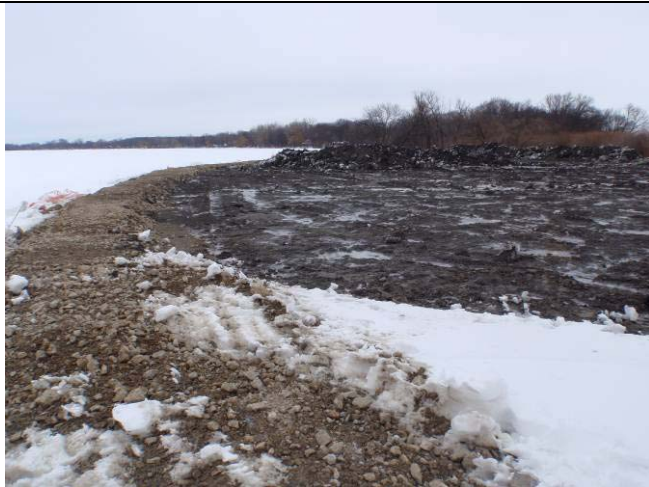
Observation #5: Dredge Placement

**Description of Observation:** The berm is about 95% complete with some basic tie in work remaining. The majority of the dredge material has been placed and grading work remains. The silt curtain has been placed but is covered by snow and frozen in place. The traffic control measures have been placed around the dredge placement area. The berm is constructed over geotextile, and the geotextile is also separating the riprap from the breaker run. There are small stockpiles of stone that will be used to complete the berm construction.

At the south end of the berm looking north onto the dredge placement area.

- Follow-up Required    **Action Items: None**

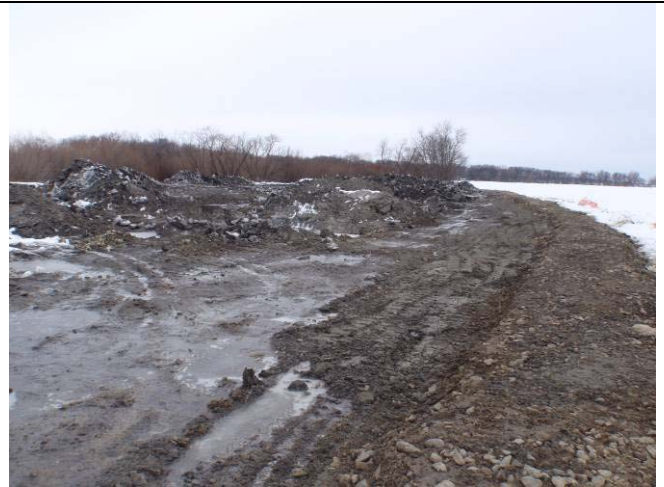
At the north end of the berm looking south onto the dredge placement area.

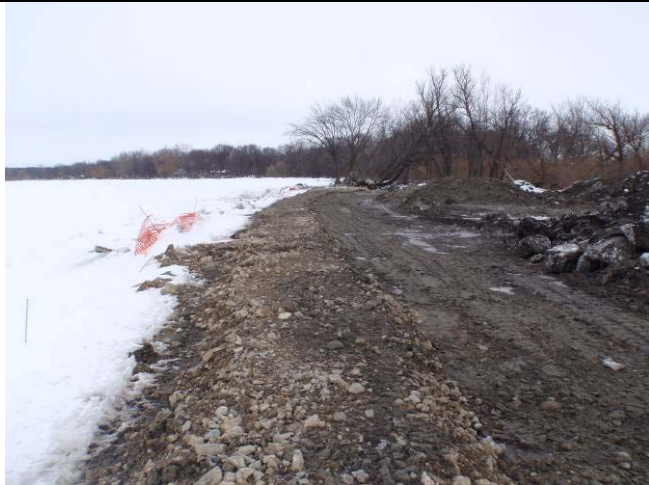
At the center the berm looking north.

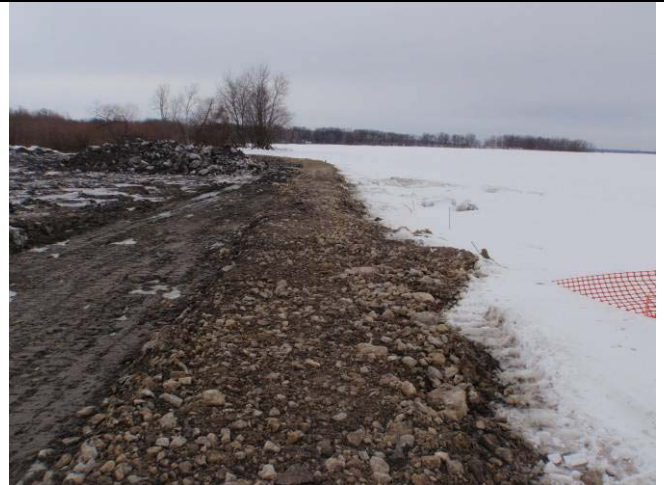
At center of the berm looking south.
