## Montgomery Associates, Resource Solutions Construction Site Inspection Report/Erosion Control Checklist

<b>Name of Permittee:</b> Rock-Koshkonong Lake District (RKLD)	
<b>Construction Site (Project) Name:</b> Lake Koshkonong Dredging and Shoreline Restoration Project	<b>Project ID #:</b> 1453-001
<b>Site Location:</b> Boat Launch at end of North Shore Road, Town of Sumner	<b>County:</b> Jefferson
<b>Contractor:</b> Badgerland Excavating	<b>Site Contact Person:</b> Kevin Hahn: 608-333-5607 or Tim Van Bommel: 608-354-5442
<b>Name of Individual Performing Inspection:</b> Danielle Lee (MARS): 608-839-4422	
<b>Date of Inspection (mm/dd/yyyy):</b> 02/11/2013 <b>Start Time:</b> 3:15 pm <b>End Time:</b> 4:30 pm	<b>Type of Inspection:</b> <input checked="" type="checkbox"/> <b>Weekly</b> <input type="checkbox"/> <b>Precipitation Event</b> <input type="checkbox"/> <b>Other (specify):</b>
<b>Weather Conditions:</b> Cold, overcast, with strong wind, 30°F.	<b>Rainfall Since Last Inspection (if applicable):</b> 0.64 inches of rainfall since pre-construction inspection on 02/06/2013 (Watertown Airport Weather Station KRVY, Weather Underground)

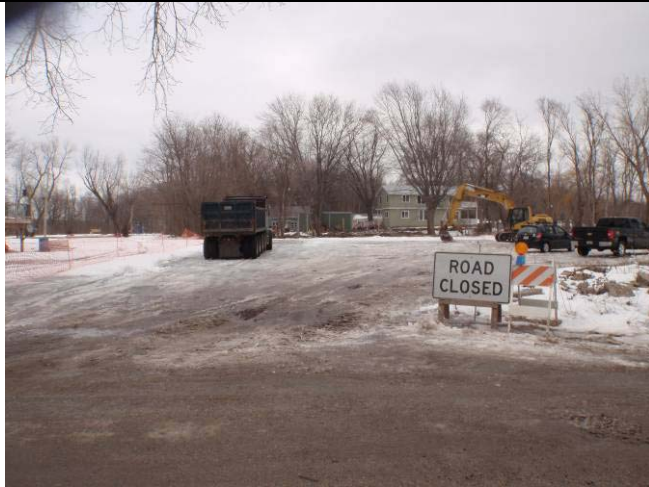
Observation #1: Staging Area

**Description of Observation:** The construction fencing has been placed and a Road Closed sign is at the entrance. All vehicles and equipment are utilizing the staging area and it appears to be in good condition.

At the entrance of the staging area, looking NE.

- Follow-up Required    **Action Items: None**

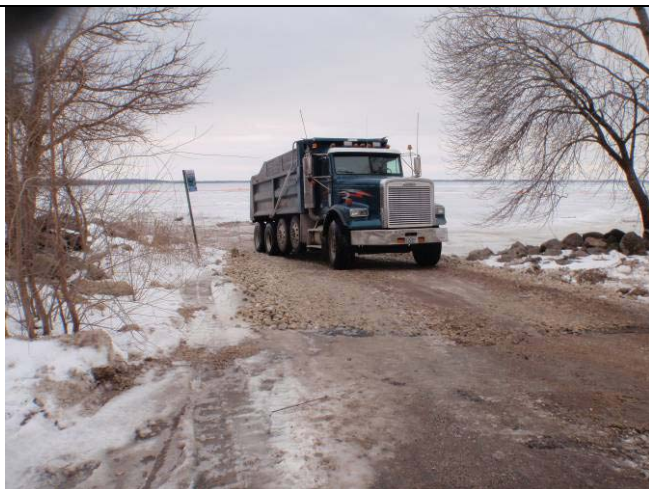
Observation #2: Tracking Pad

**Description of Observation:** The tracking pad has been placed and appears to be functioning appropriately.

At the tracking pad, looking south.

- Follow-up Required    **Action Items: None**

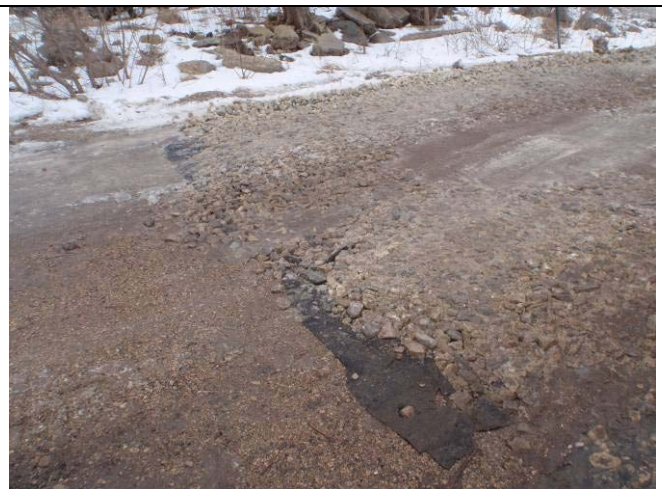
Close up of the geotextile underneath the tracking pad.

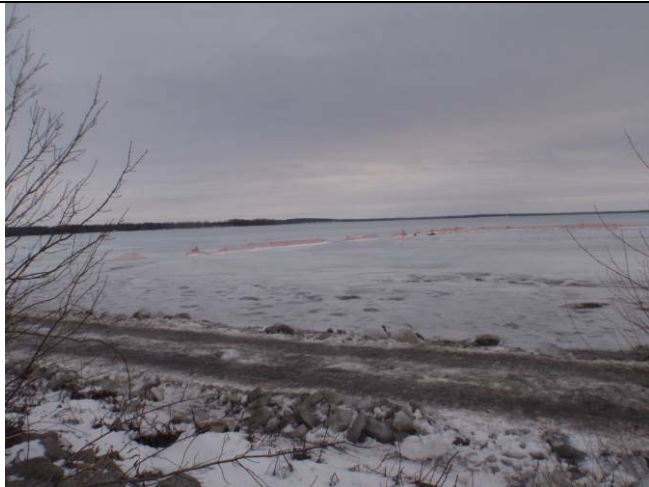
Observation #3: Dredge Area

**Description of Observation:** The silt curtain has been placed but is covered by snow and frozen in place. The traffic control measures have been placed around the dredge area.

At the staging area, looking south onto the eastern side of the dredge area.

- Follow-up Required    **Action Items:** As discussed, the crew will place silt sock when ice is open in appropriate areas.

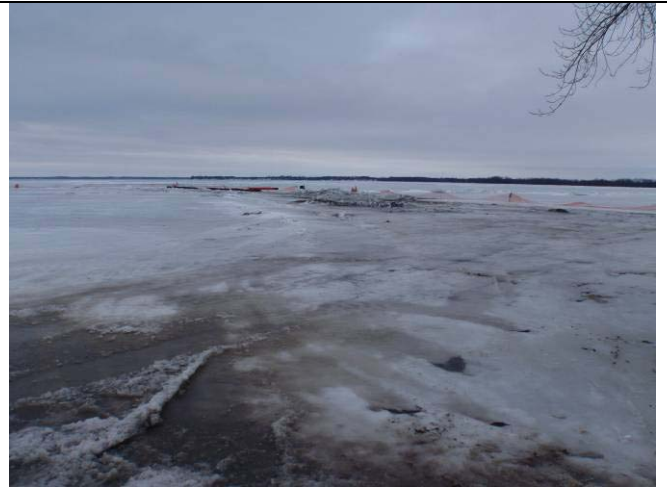
At the boat launch, looking west onto the western side of the dredge area.

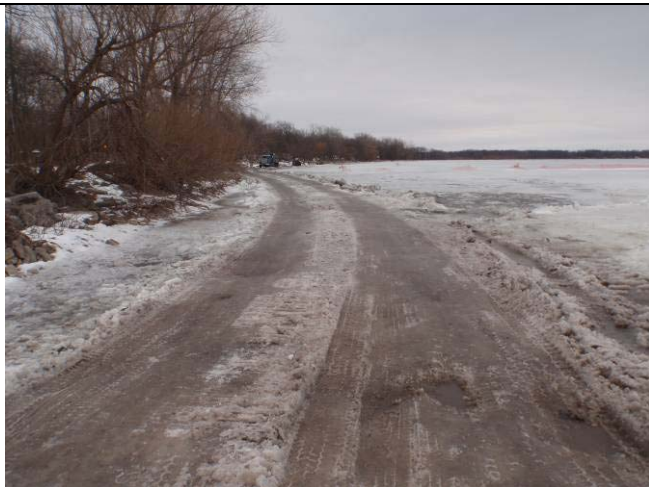
Observation #4: Haul Route

**Description of Observation:** The crew has completed the ice road and are actively using it for construction.

At the boat launch, looking SW.

- Follow-up Required    **Action Items:** None

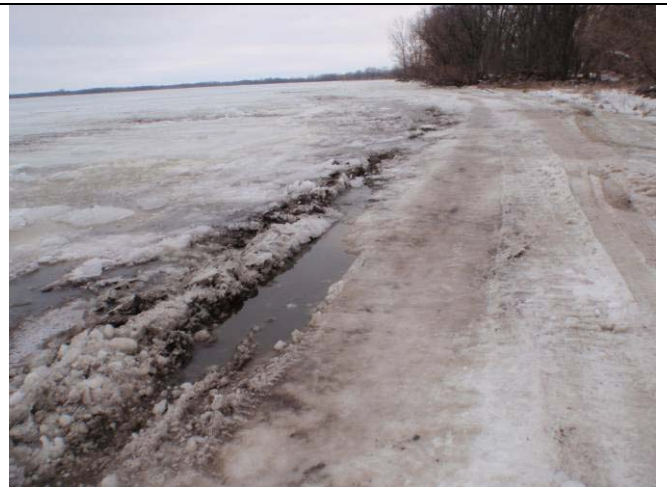
Along the Twin Island Gun Club property, looking NW.

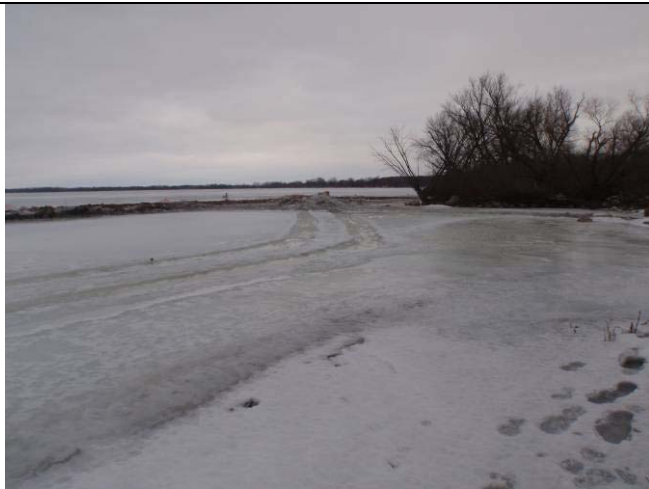
**Observation #5: Dredge Placement**

**Description of Observation:** The silt curtain has been placed but is covered by snow and frozen in place. The traffic control measures have been placed around the dredge placement area. The berm is being constructed over geotextile, and the geotextile is also separating the riprap from the breaker run. The berm is about 25-35% complete.

At the center on the shore of the Dredge Placement area looking NW toward the northern end of the berm.

**Action Items:** As discussed, the crew will place silt sock when ice is open in appropriate areas.

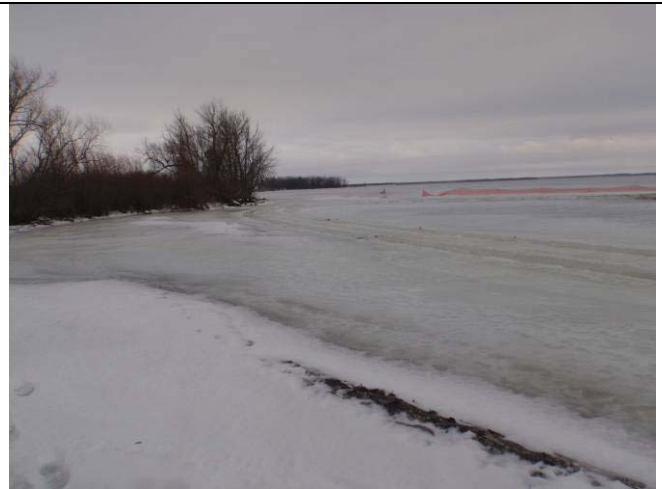
At the center on the shore of the Dredge Placement area looking SW toward the future southern end of the berm.

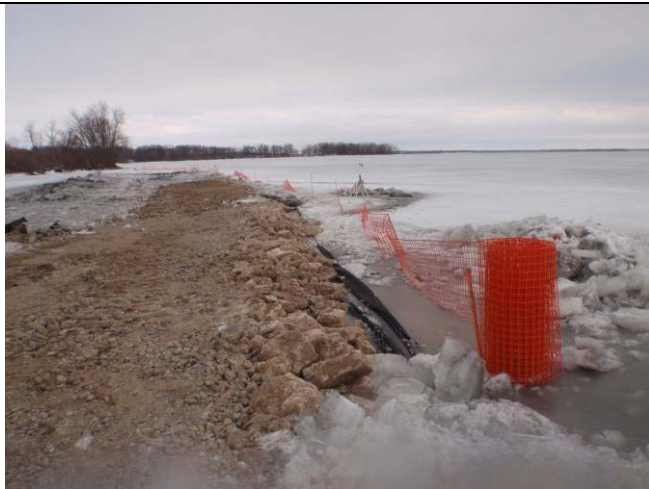
At the north end of the berm looking NW.

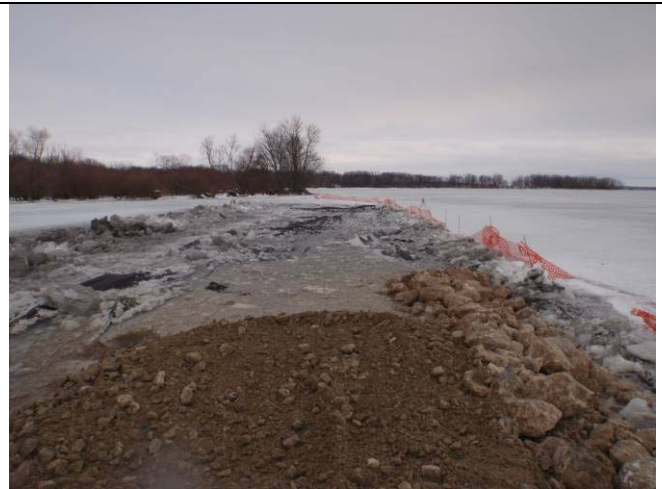
At the southern end of the completed berm looking NW.
