Memorandum

To: Robert Davis, PE – Wisconsin Department of Natural Resources
From: Robert Montgomery, PE
Date: March 21, 2014
cc: Brian Christianson, Rock Koshkonong Lake District
Re: Inspection of Indianford Dam - WDNR Field File 53.04

140325 Indianford Inspection Transmittal Memo

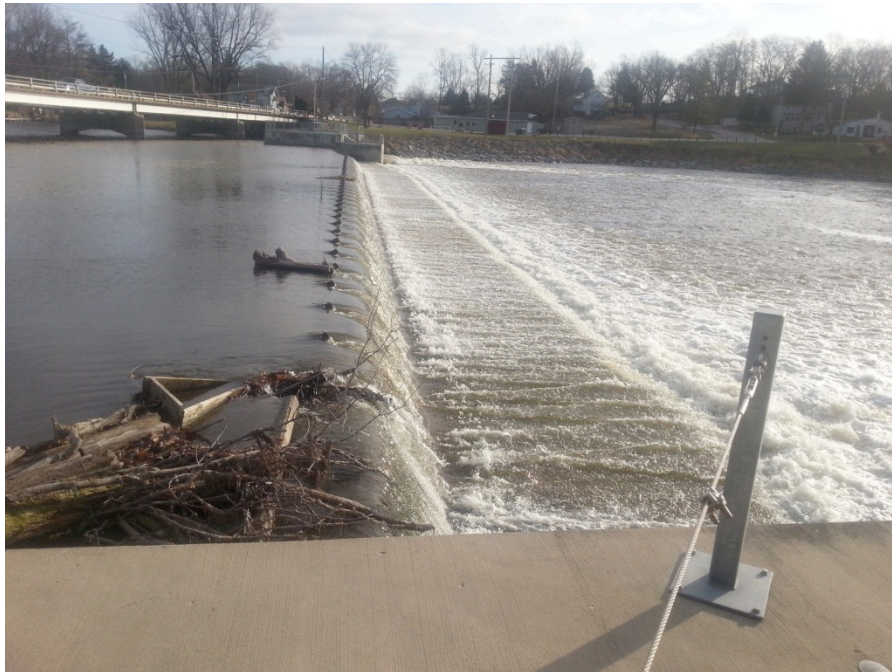
Photo 0060812051301 – View along crest of dam

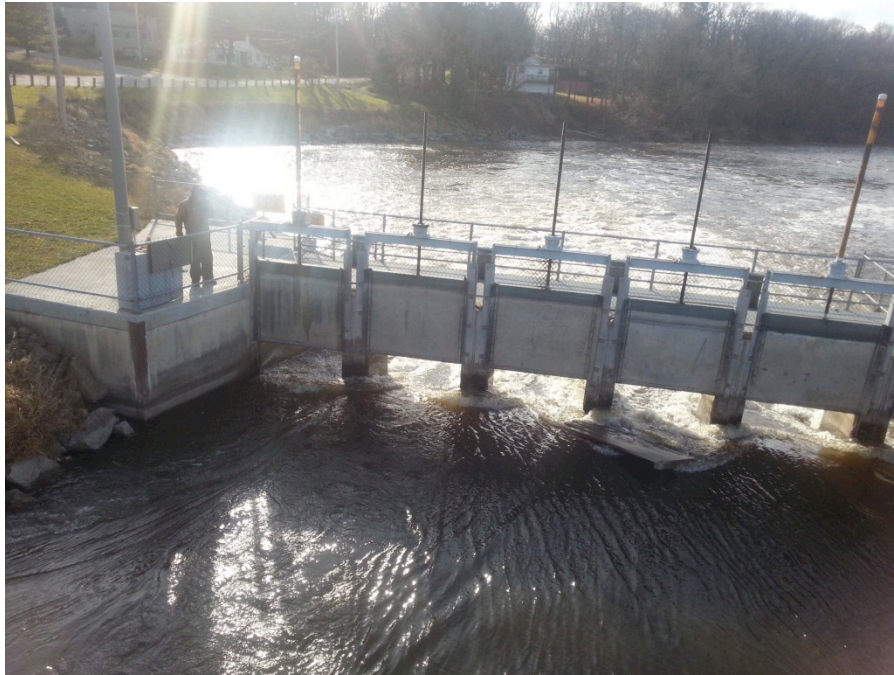
Photo 0060812051302 – Three missing stem covers

1. The Emergency Action Plan and Operation Inspection and Maintenance Plan need to be updated
2. The portable motor driven actuator and stem covers for the six slide gates need maintenance
3. Installation of a motorized system for clearing debris from the powerhouse intake trash racks should be considered together with completion of the sediment accumulation and debris clearing program that was initially proposed for the fall of 2013.

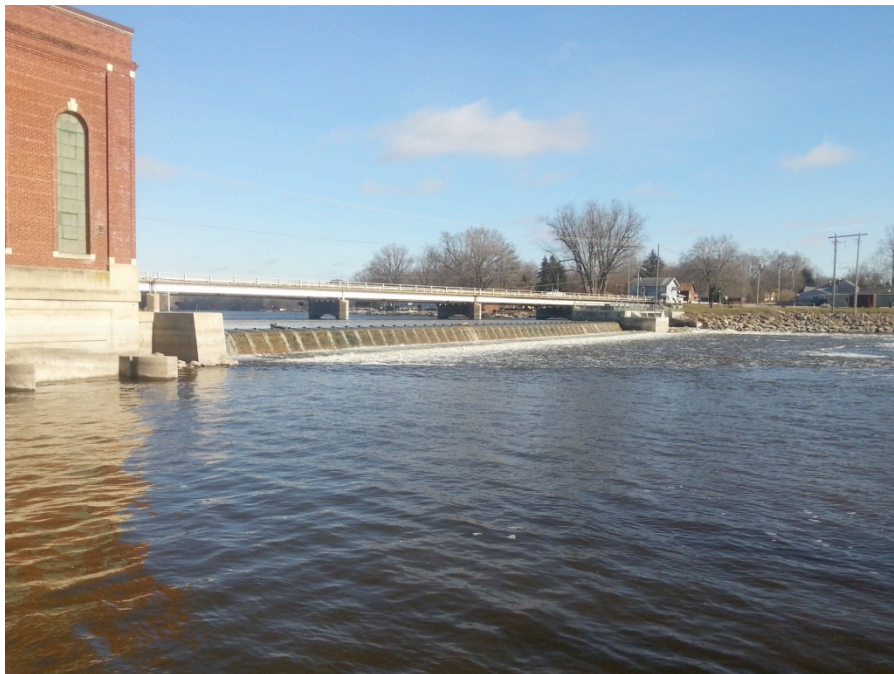
Photo 0060812051303 – Downstream face of dam
