**RE: INDIANFORD DAM INSPECTION, DNR FIELD FILE #53.04 PERFORMED ON  
NOVEMBER 4, 2024**

Attached is a final report for the inspection of the Indianford Dam located on the Rock River just west of Edgerton, Wisconsin, adjacent and down river from the County Road M Bridge. The report contains the following items for your review and comment:

Local Dam Name (PRINT): Indianford

DNR Field File #: 53.04

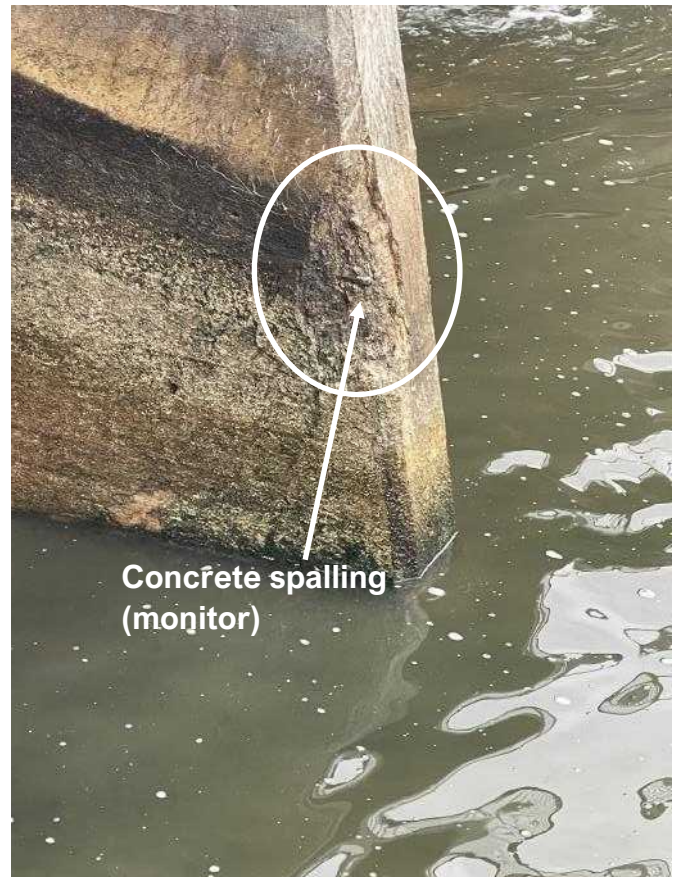
| <b>File Name</b> | <b>Description</b> |
|---|---|
| 0060811042417 | Monitor concrete spalling at third gate abutment (looking east) |

Photo 0060811042417 - Monitor concrete spalling at third

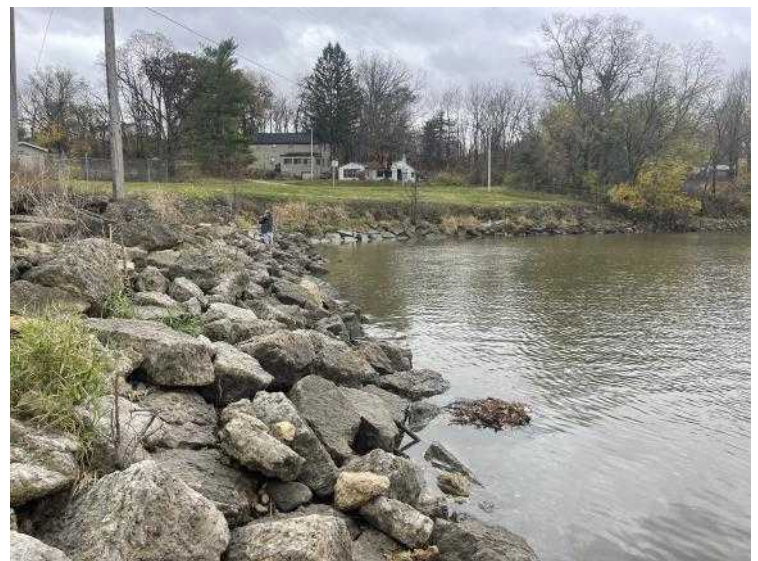
Photo 0060811042421 - Auxiliary gate riprap looking east. No signs of seepage. Above ground scope stable with 2-3 foot wide riprap

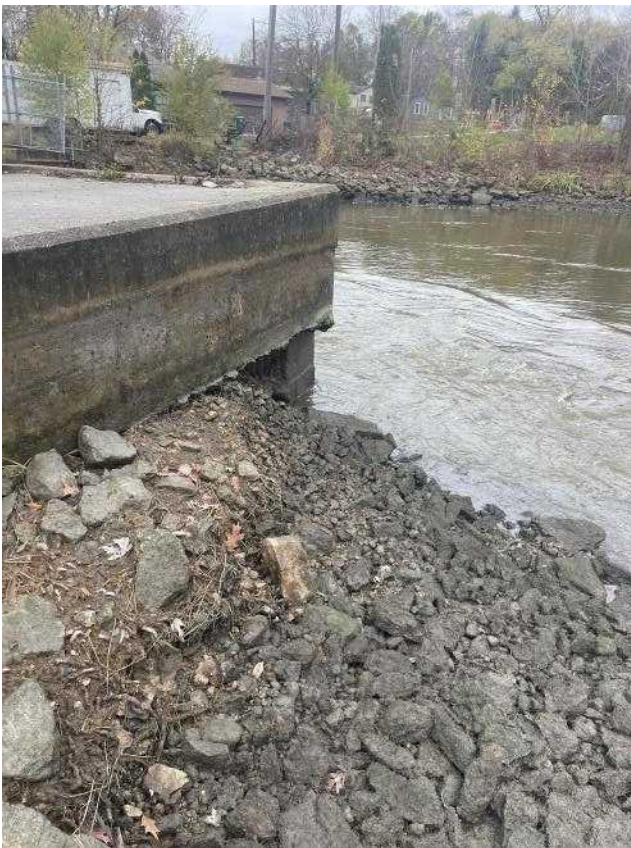
Photo 0060811042431 - Scour at primary slide gate

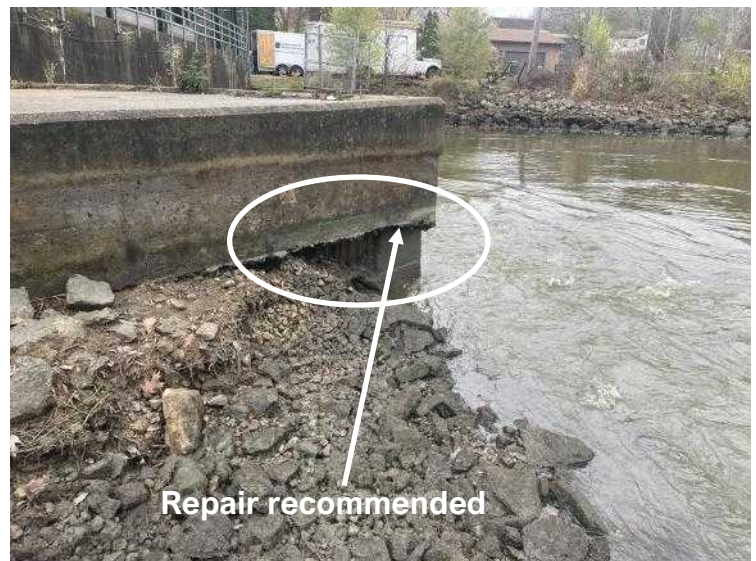
Photo 0060811042432 - Scour at primary slide gate abutment

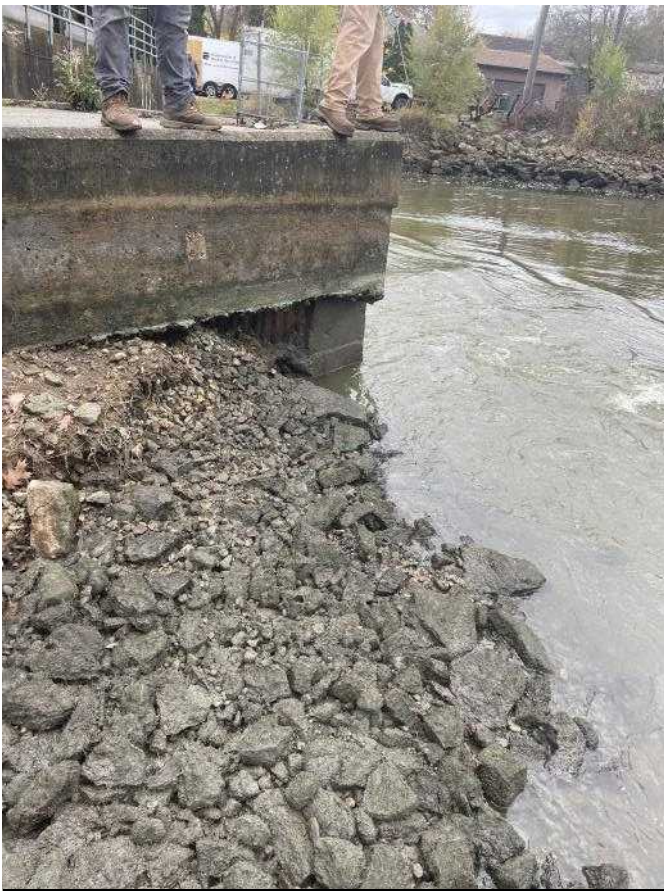
Photo 0060811042433 - Abutment scour at draw down

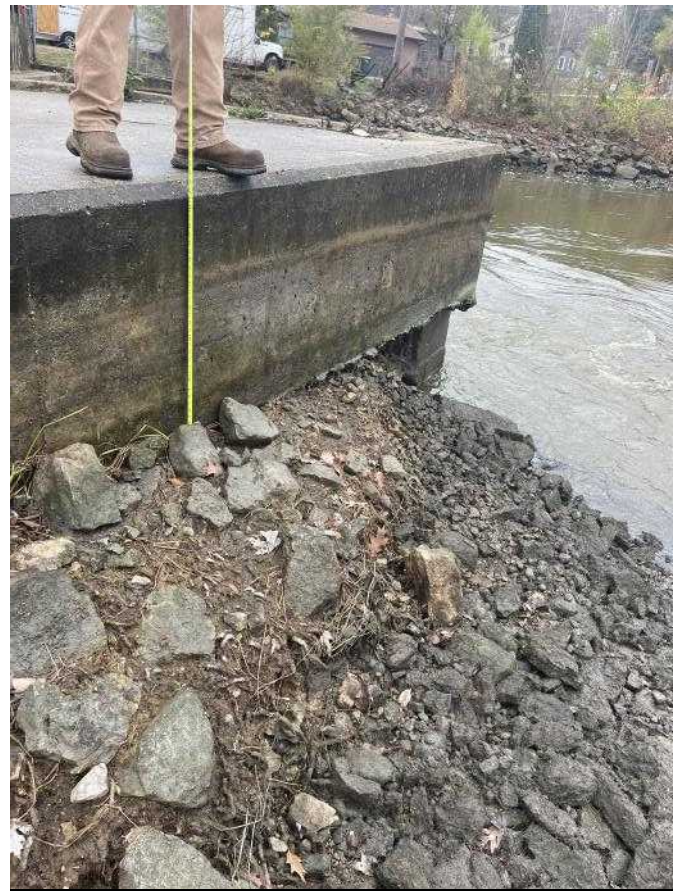
Photo 0060811042434 - Abutment scour at draw down

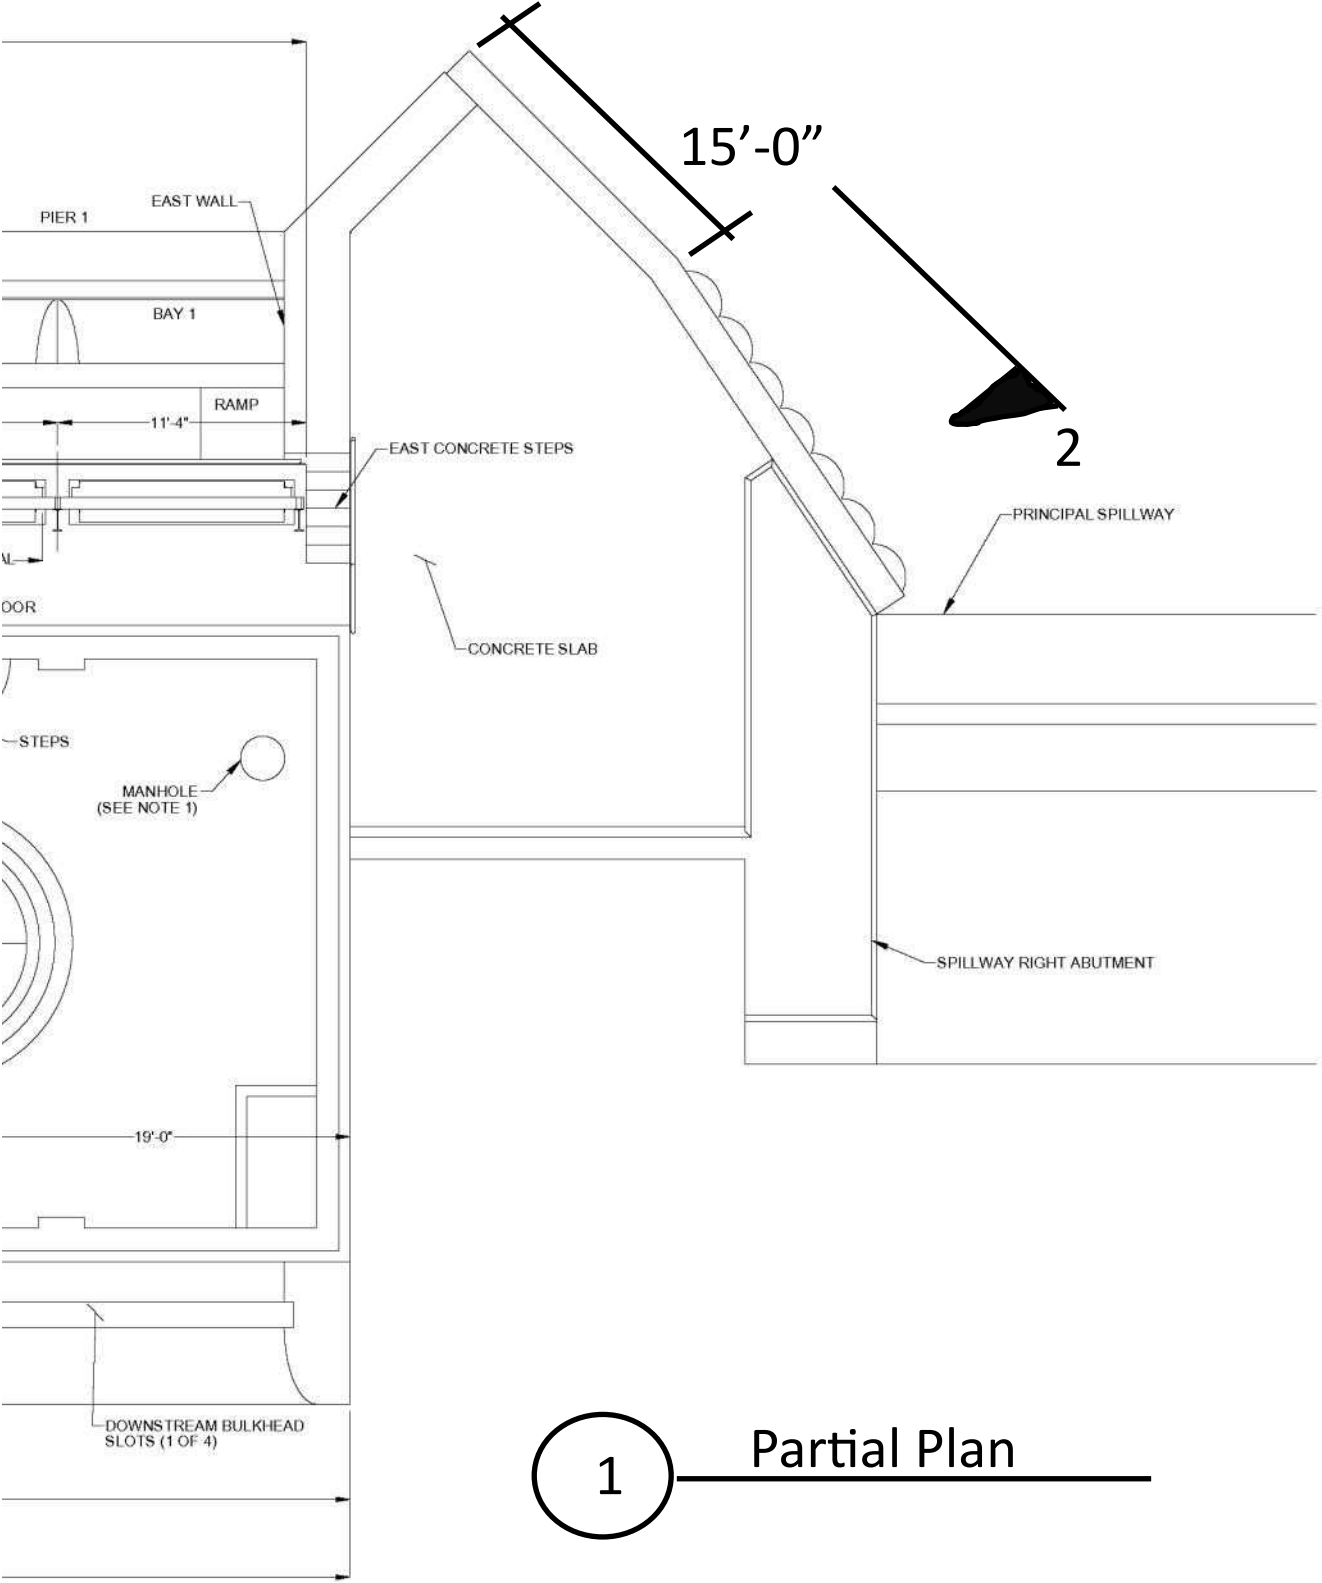
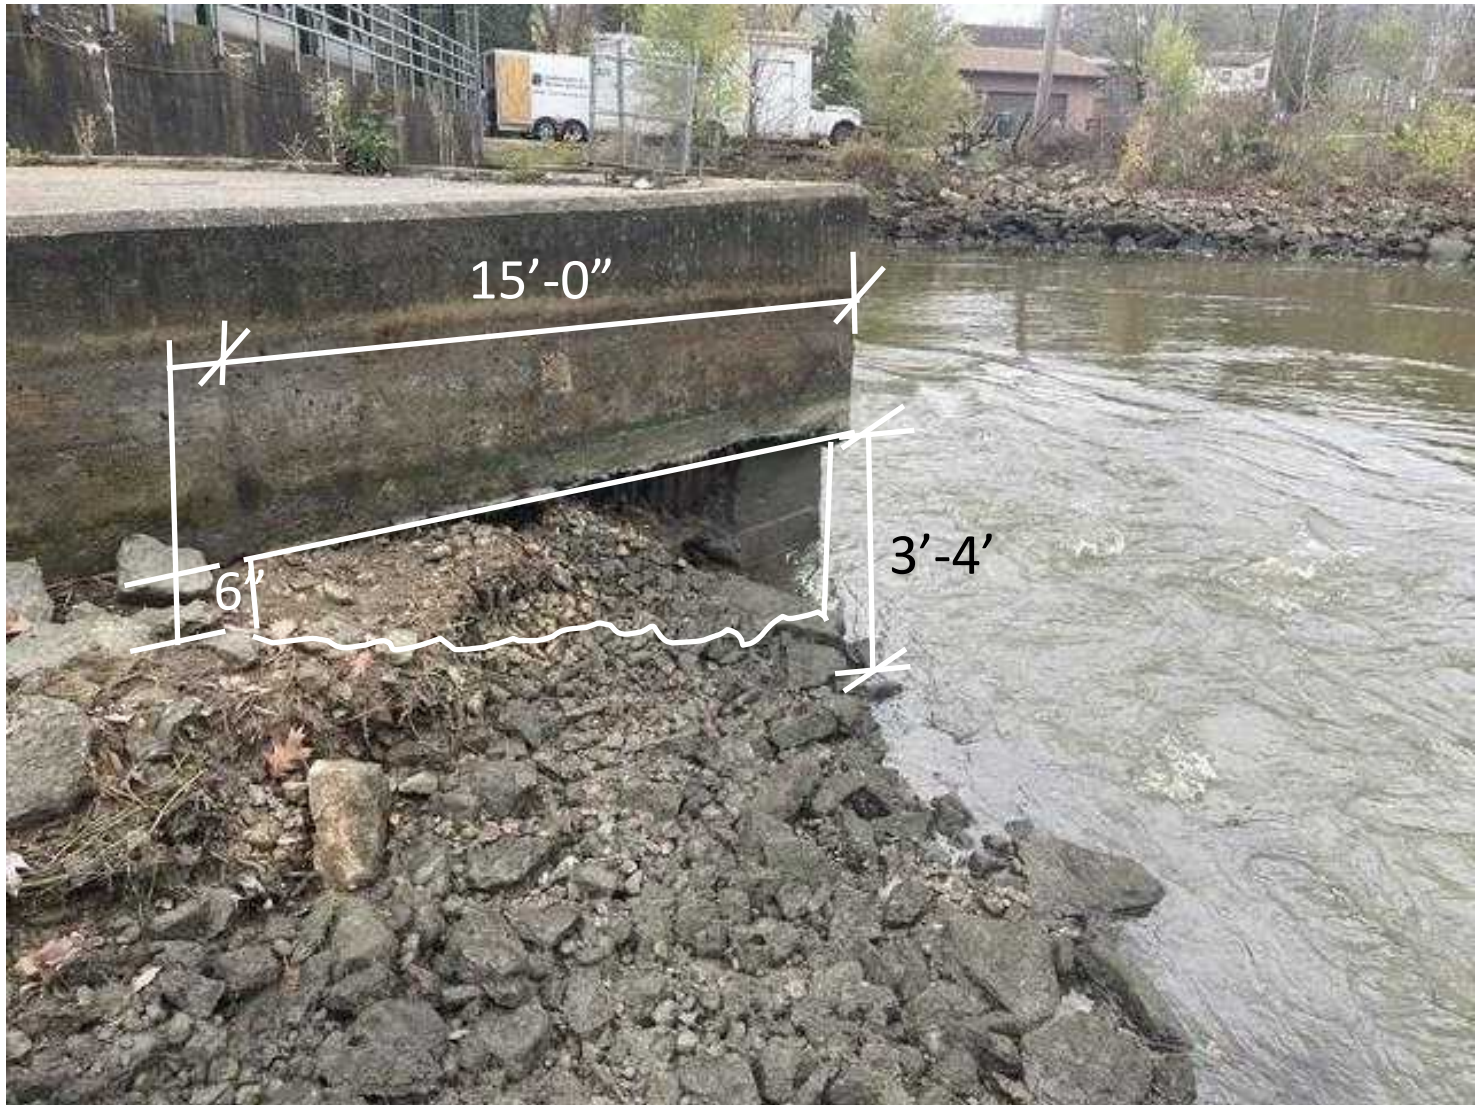
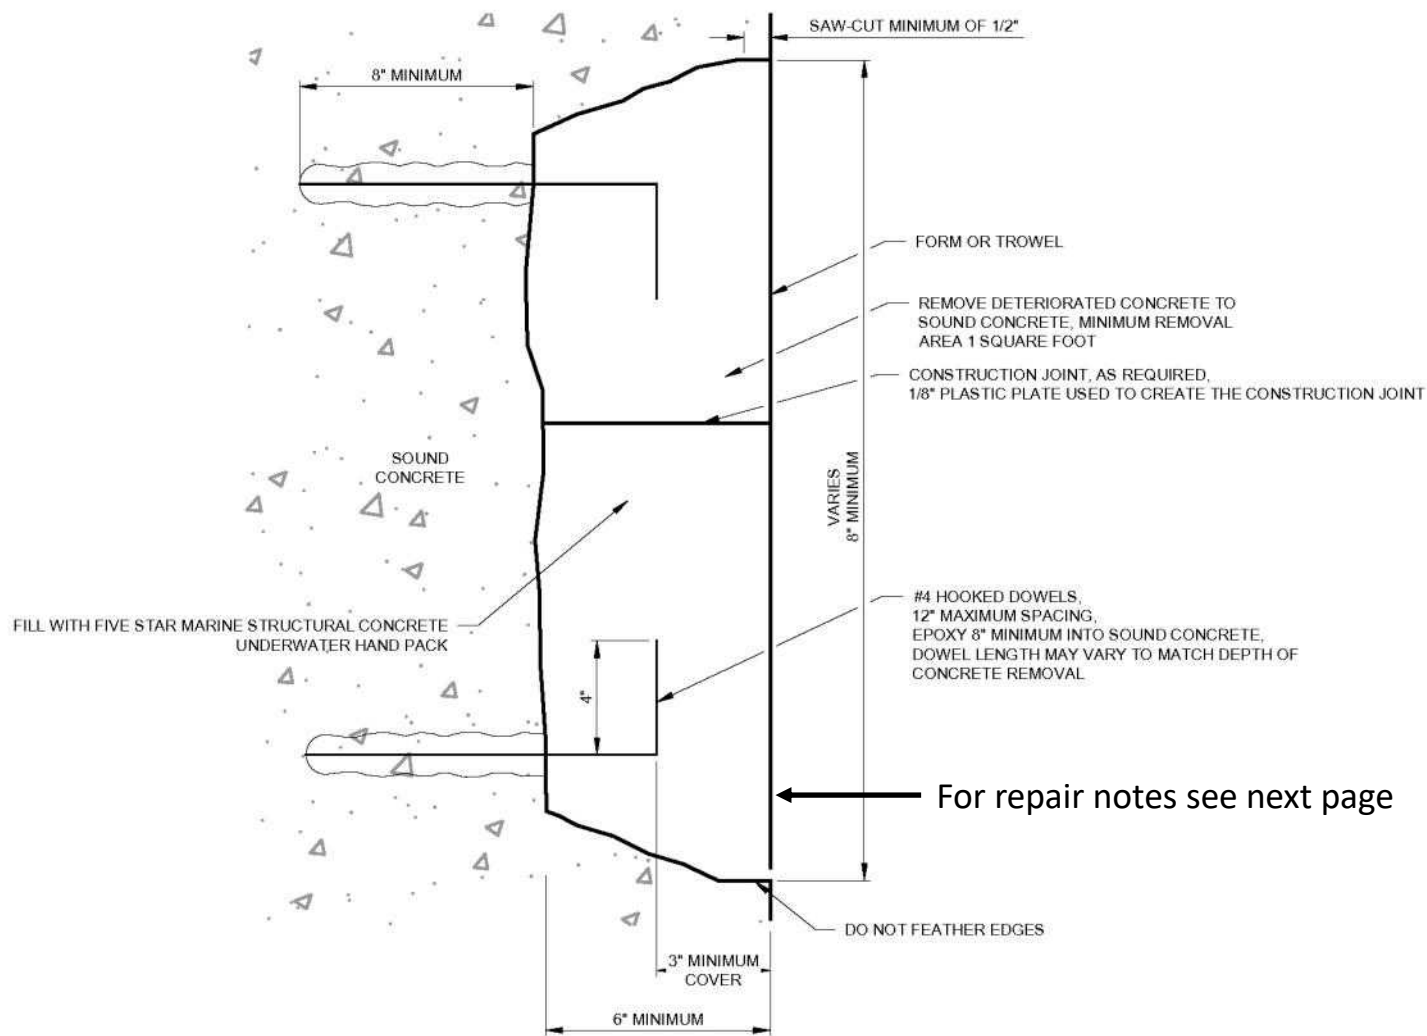
# Power House Abutment Repair

(Item No. 5)

1. THE EXACT LIMITS OF CONCRETE PATCHING TO BE DETERMINED IN THE FIELD BY THE ENGINEER.
2. CONCRETE SURFACE REPAIR SHALL CONSIST OF REMOVAL OF ALL LOOSE SPALLED AND DETERIORATED MATERIALS IN DAMAGED AREAS.

3. ALL LOOSE SCALE, RUST, CORROSION BYPRODUCTS, PREVIOUSLY PLACED PROTECTIVE COATINGS, AND CONCRETE SHALL BE REMOVED FROM EXPOSED REINFORCING STEEL.
4. REINFORCING STEEL EXPOSED FOR MORE THAN ONE THIRD OF ITS PERIMETER CIRCUMFERENCE SHALL BE COMPLETELY EXPOSED TO PROVIDE 1-INCH MINIMUM CLEARANCE.

5. SURFACES OF OLD CONCRETE TO WHICH NEW CONCRETE IS TO BE BONDED MUST BE CLEAN AND ROUGH.
6. PLACE AND CURE PATCHED AREAS IN ACCORDANCE WITH MANUFACTURER'S RECOMMENDATIONS.
