Lake Koshkonong Lake and Wetland Survey

October 17, 2008

Hjort and Nichols observations at the following locations.

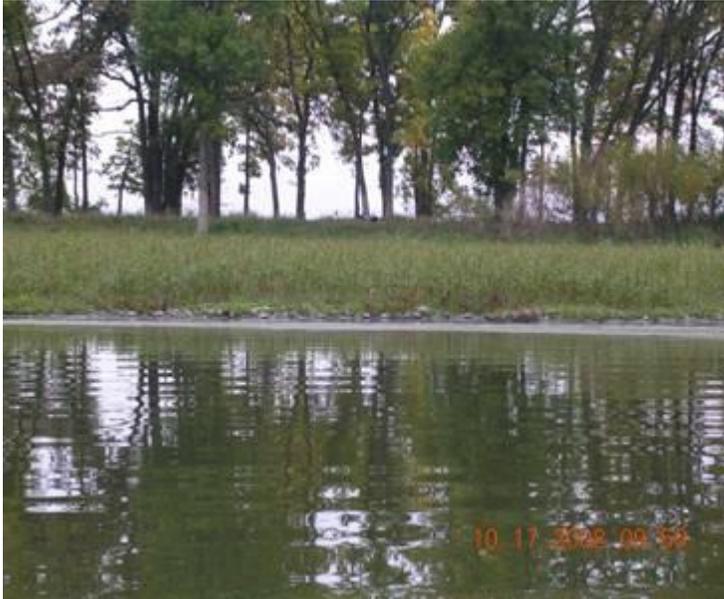
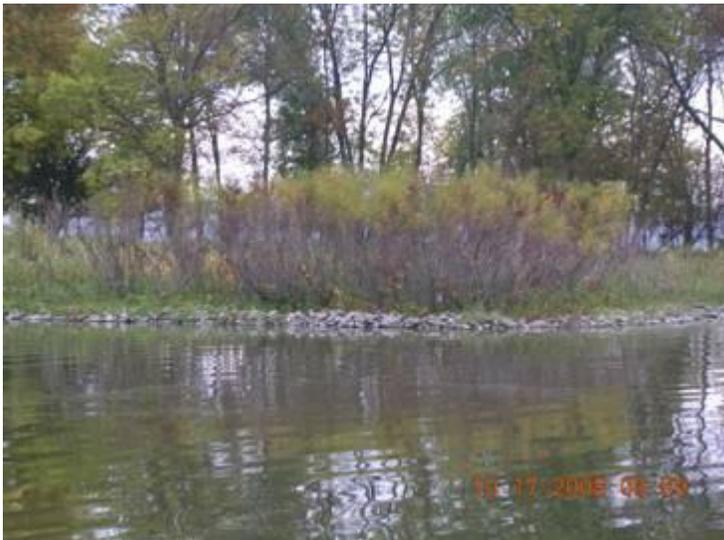
Haight's Bay Shallow Marsh (approximate location of Lake Study Plot)

The top photograph is of the approximate location of the Lake Study Plot and the bottom photograph is of the short point east of the Lake Study plot. The rock armor that was placed during the \$10K grants is still in place and working as a shoreline stabilization structure. Haight's

Bay normally contains a substantial area vegetated by sago pondweed but no submergent or emergent plants were observed outside of the armoring during the survey.

The Lake Study Plot was dominated by river bulrush and is vegetated out to the rock armor. The monotypic river bulrush community contrasts to other years studied and reflects extended flooding conditions that created an inundation amplitude and duration that selected for species that could survive high water conditions. Previous studies typically included numerous obligate and facultative wetland species in this area. The extended flooding essentially ‘drowned out’ the normal assemblage of species.

The absence of leaves on the lower portion of the sandbar willow in the second photograph shows the amplitude of floodwaters along the armored point. The willow survived the flood however the lower portions are likely permanently damaged.

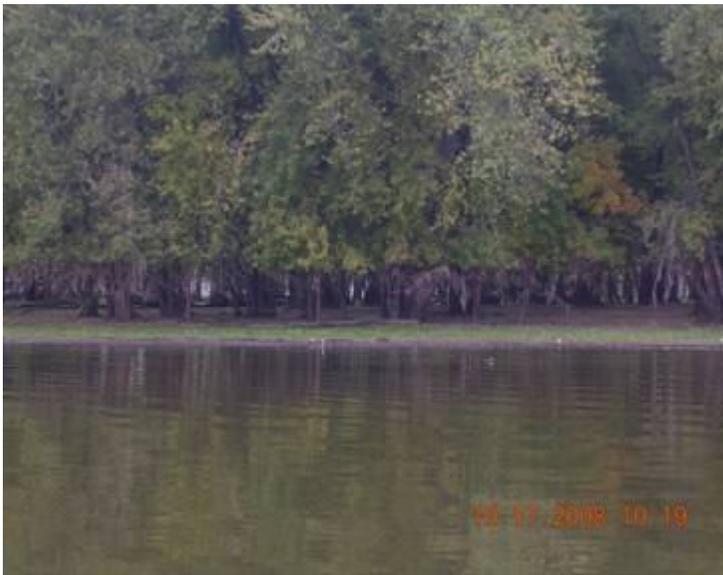
Vinne Ha Ha Floodplain Forest (approximate location of Lake Study Plot)

This Lake Study Plot looks similar to previous studies and the extended high water level is evident by the horizontal line of leaves and watermarks on the trees. It appears that additional sand and gravel was deposited along this shoreline similar to high water years of the recent past. It appeared that there was ponded surface water approximately 100 meters east of the shoreline. This area was previously an ephemeral pond. This lake area normally contains a substantial area vegetated by sago pondweed but no submergent or emergent plants were observed during the survey.

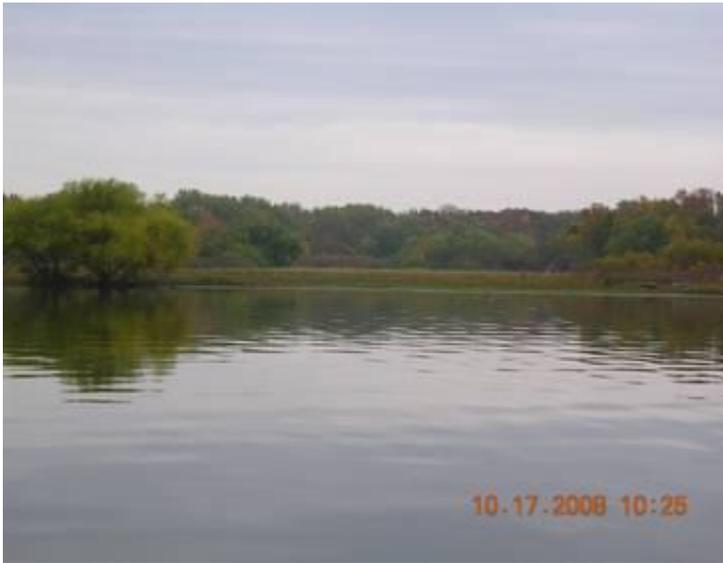
## WDNR Public Land Shoreline

The lakeward or leading edge of the shallow marsh area does not appear to have been eroded by the high water. This lake area normally contains a substantial area vegetated by sago pondweed but no submergent or emergent plants were observed during the survey.

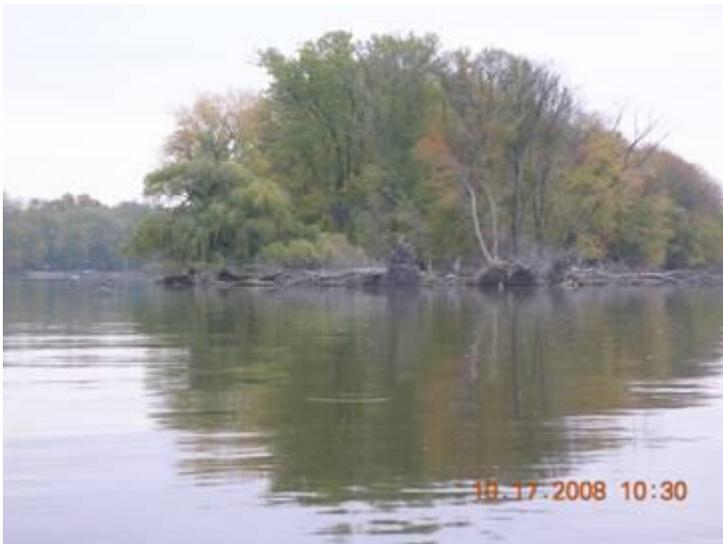
## Blackhawk Island Southern River Mouth Floodplain Forest

Numerous tip-overs were observed and there was loss of some of the former leading edge trees on the point. The amount of acreage lost is uncertain but numerous tree stumps and large branches were noted.

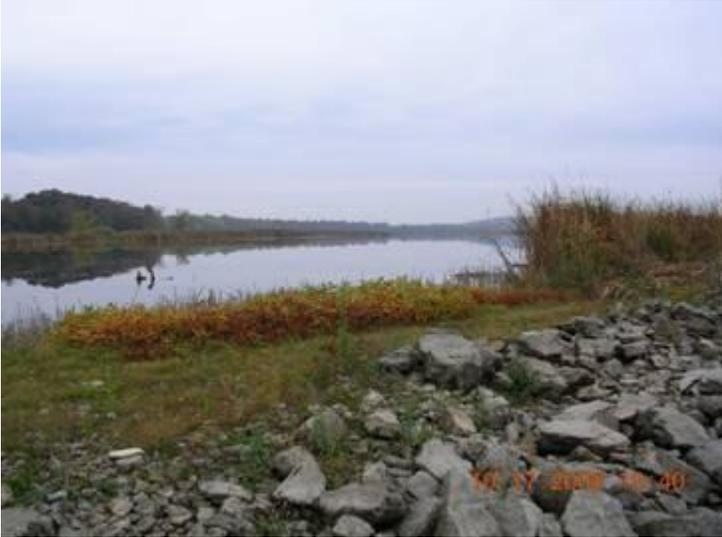
## HAI Wetland

The shallow marsh appears to have lost a large amount of cattail and the open water area has increased significantly. Numerous cattail bogs settled on top of the rock armor after water levels receded.

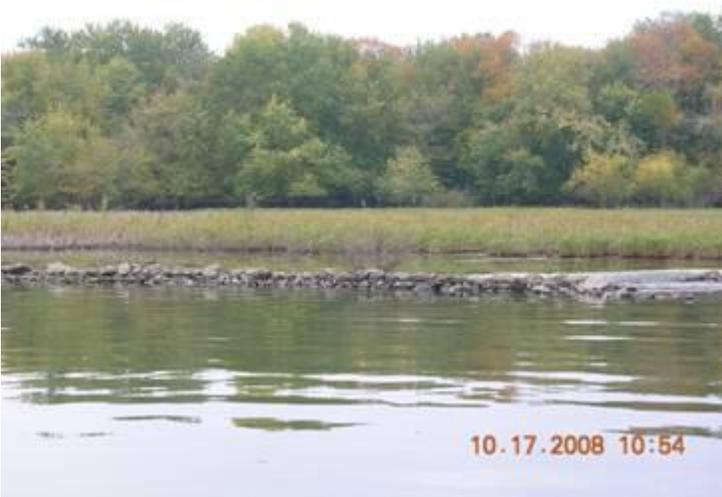
Carcajous Shallow Marsh (approximate location of Lake Study Plot)

The shallow marsh plant community was similar to Haight's Bay in density and limited species diversity. It appears that the lakeward or leading edge of the shallow marsh plant community has extended lakeward towards the rock armor and is comprised of river bulrush and cattail. The rock armor cut has silted in (right central portion of photograph) to the approximate elevation of the rock armor. Sandbar willow colonized portions of the rock armor.

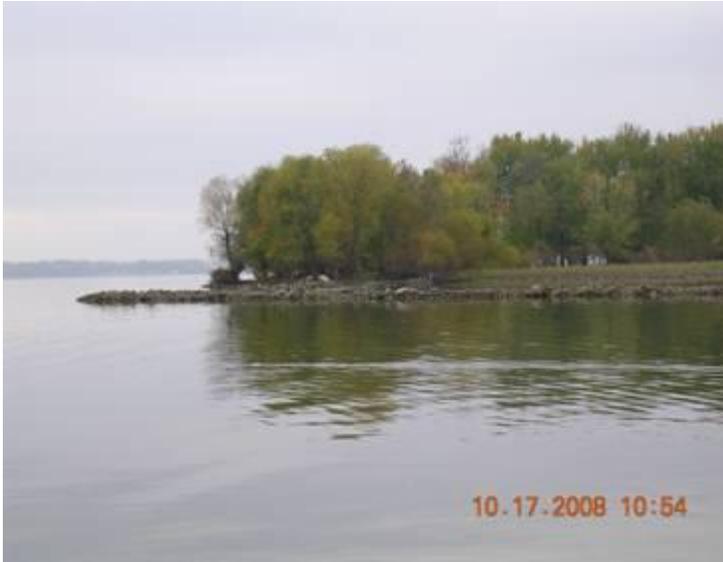
Photograph of rock armor extending west towards Carcajou Point. Rock armor appears to be maintaining position and effectiveness.

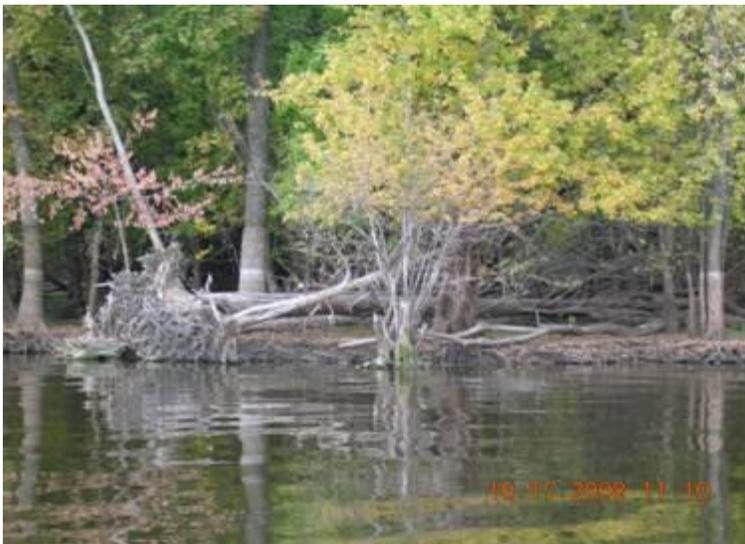
Carcajou Floodplain Forest (approximate location of Lake Study Plot)

The Lake Study Plot was not armored and showed evidence of continued erosional losses. Extreme high water mark (top of gray) and extended high water mark (white line) are easily observed on trees. Scattered sago pondweed was observed in this area of the lake.

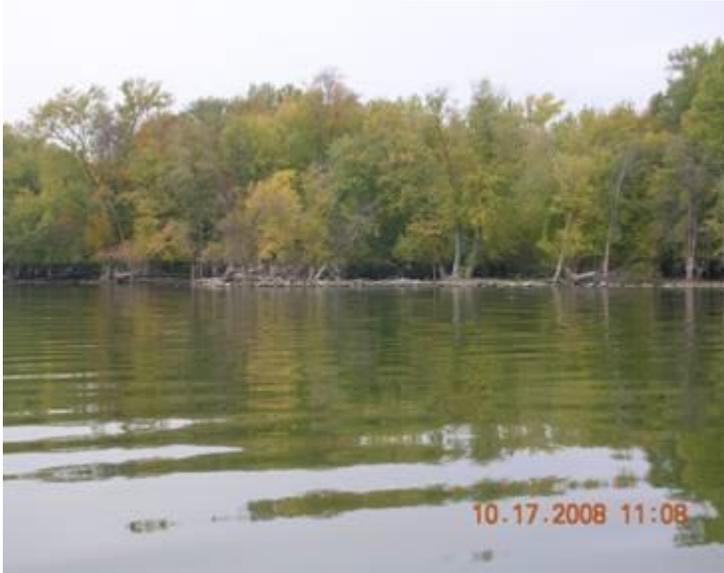
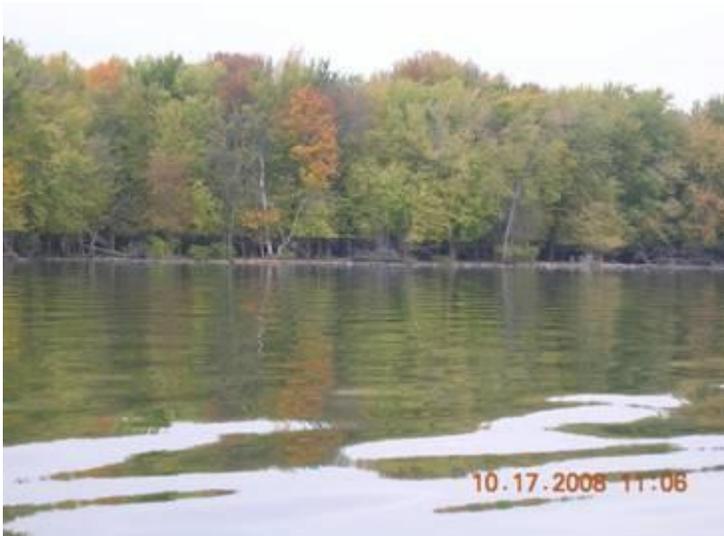
Rock armor along the western Carcajou shoreline appears to be effective for shoreline maintenance and reduction of tip-overs.

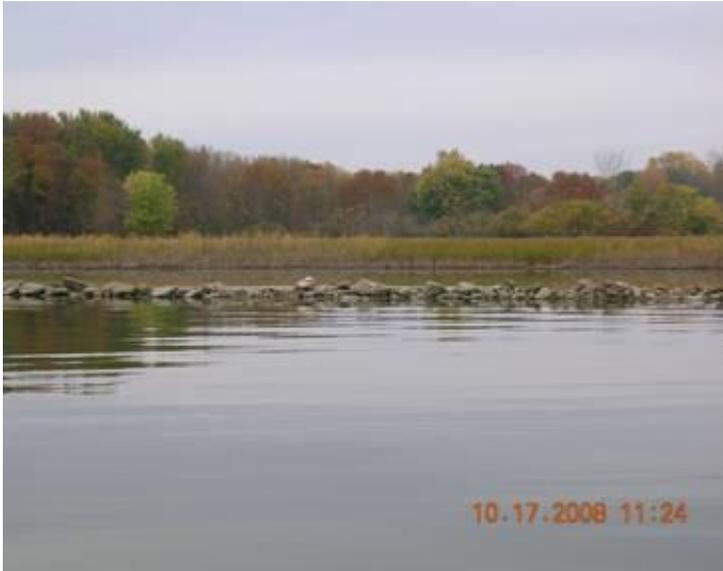
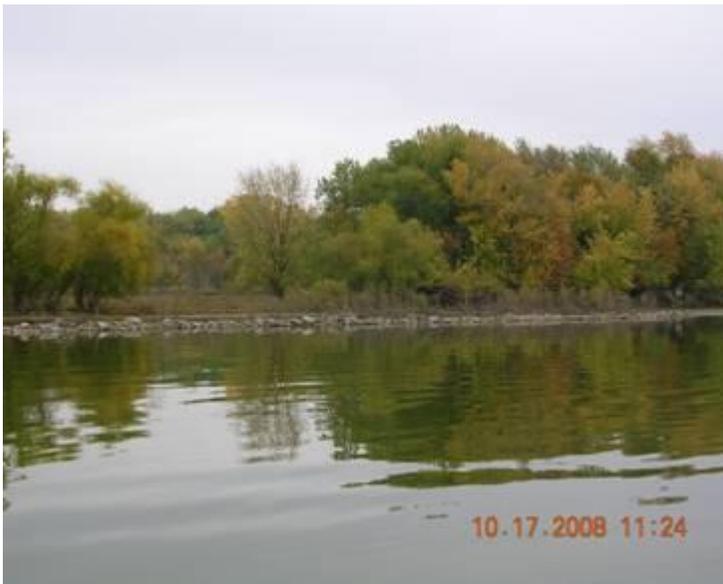
The Gilberts Bay wetland complex appears to be similar in appearance to other shallow marshes with less species diversity at the lake edge than in the past and with the rock armor being colonized by sandbar willow.
