Subject: Water Level Order IP-SC-2019-54-01639 for Lake Koshkonong and the Indianford Dam
Field Investigation of Impacts from Increased Water Levels

SUBJECT: Lake Koshkonong 2019 Wetland Quality Monitoring Results

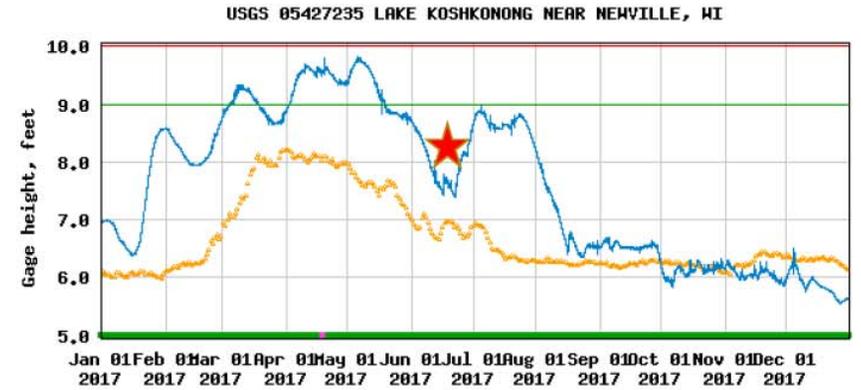
Hydrographs from 2016, 2017, and 2019 based on USGS data from the Newville Station

Red star indicates approximate timing of vegetative sampling completed during that year.

Note that y-axis is not the same across years.

The wetland survey efforts were led by four field botanist leads and all botanist leads attended a “calibration day” training event where they collectively surveyed a local wetland not included in the 2019 resurvey to ensure relative consistency in survey methods. Surveys were completed between September 9th and 20th. According to the USGS gauge station at Newville, WI, the lake was roughly one to two feet higher than the 30-year average for much of the spring and summer and peaked at around 3.5 feet above the average in the early spring. This extremely high water-level at the beginning of the growing season would likely have impacted wetland community species composition. At the time of the sampling, the water levels were a few inches above the 30-year average. The hydrographs from Lake Koshkonong for 2016, 2017, and 2019 are attached to this memo.

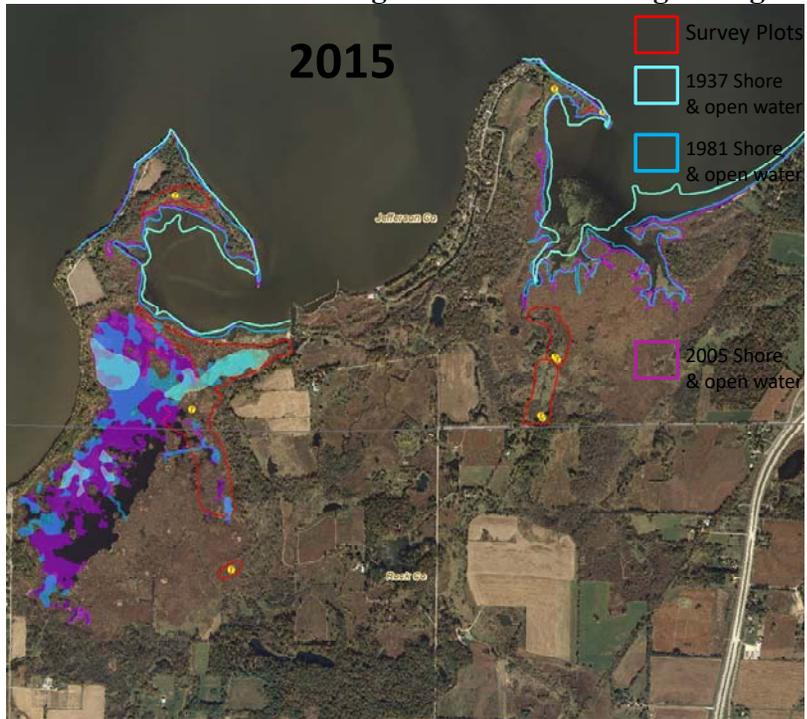
Historic time series showing conversion of emergent vegetation to shallow emergent marsh and aquatic bed

Site 4-7 represents a floating sedge meadow and marsh. Unlike a floodplain marsh, these wetlands have a tendency to grow on a floating mat of organic soils, peat, and plant roots. This floating character is not a natural condition, but the result of the Indianford Dam. Prior to dam construction, this wetland likely had a gently sloping character that allowed groundwater to percolate through the sedge tussocks and soil until it reached the former marsh bottom. After Lake Koshkonong was created through impoundment, the outer edges of this mat would have floated up to the new water level. Over time, the combined physical and biological stress of floating, altered hydrology, flooding, and invasive species invasion has apparently caused many acres of floating mat to break up and dissolve, yielding shallow open water marsh in its place. From an ecological perspective, this shift from emergent floating mat to shallow open water marsh represents a significant degradation of the wetland community, however this shift has been occurring for many years and was not captured in our two vegetation surveys but is easily seen with aerial photography (see attachment #4). It is also impossible to say from the survey data whether any degradation was the

result of higher baseline water levels or severe flood events. Regardless, we expect this trend of wetland shoreline erosion to continue in this marsh and likely in similar situations around Lake Koshkonong.

This activity has also called out holes in our methodology such as identifying likely degradations such as those occurring at site 4-7, where the boundary of persistent emergent wetland vegetation is retreating and leaving open water in its wake. In subsequent samplings, we propose looking into the ability to utilize some aerial photography analysis or on-the-ground methods to measure the loss of vegetated area of this site (and other similar sites) into open water.
