Memorandum

To: Brian Christianson
From: Rob Montgomery
Date: Jan 20, 2015
cc: Steve Hjort, Rick Gerke
Re: Description of stone berm repair at Experimental project completed in February 2014

This documentation has been provided to supplement the 2014 monitoring report for the experimental project on Lake Koshkonong.

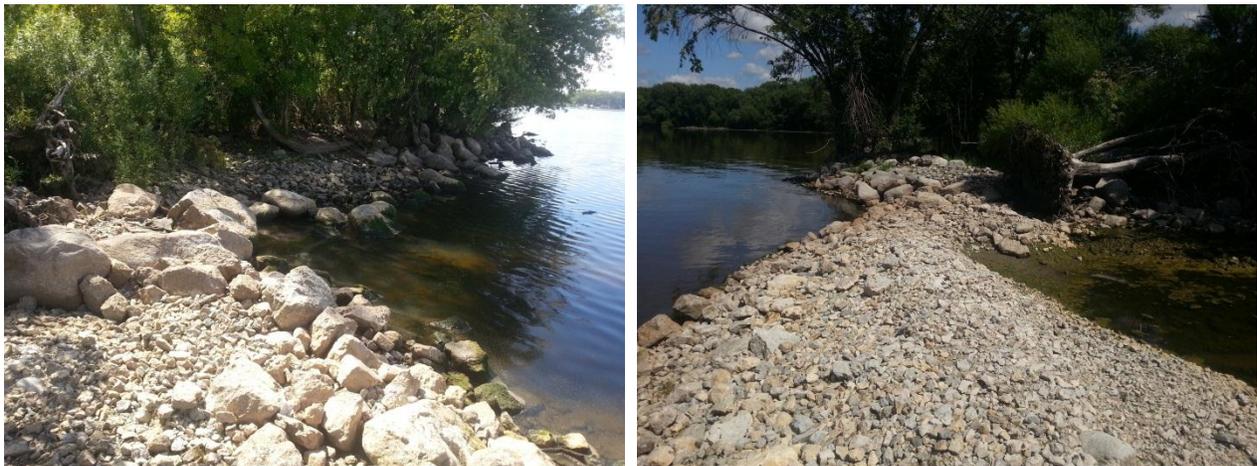
As you know, the Experimental Project was constructed in the winter of 2012 – 2013. The dredge spoil for the wetland restoration area was contained by a stone berm that was placed in late 2012. After the project completed, it was underwater for much of the spring of 2013. When the water levels receded, it was apparent that two low spots had developed in the berm were tied into the existing shoreline at the North and South ends. These low spots had apparently developed due to settlement and/or erosion. The photographs below, taken in August 2013, show the south and north ends of the stone berm.

South end (left) and north end (right) of stone berm at original existing shoreline in August 2013

Tallgrass Restoration was retained and directed by us to repair these locations. Stone was placed in February 2014 (see photo below). The stone was transported to the site across the frozen lake bed/ice of the shoreline and placed above the degraded portion of the stone berm using light construction equipment.

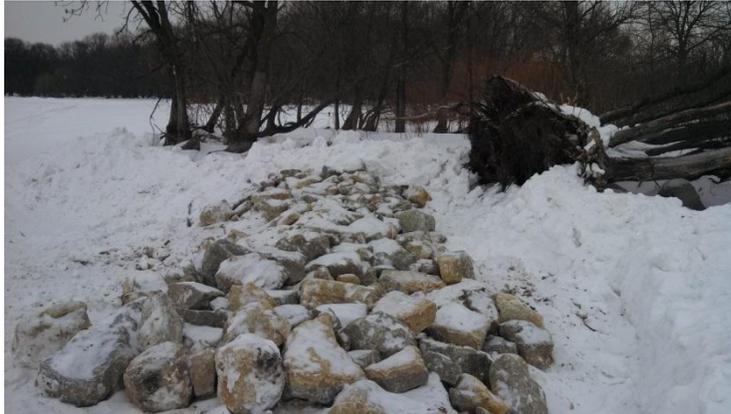
February 2014: newly-placed stone at the north end of the stone berm

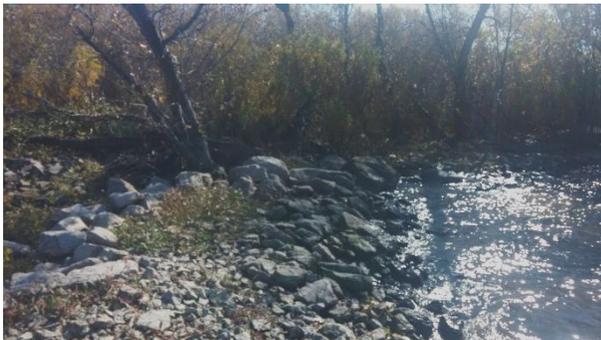
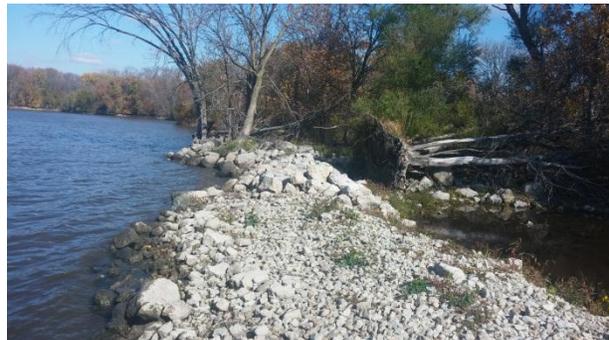
The repair to the North and South ends of the stone berm was successful in restoring the cross-section and providing sufficient armor, as shown in the photographs below.

October 2014: repair to the south end (left) and north end (right) of the stone berm
