Water Resources Operations Report RKLD Annual Meeting 2011

July 30, 2011

Montgomery Associates
Resource Solutions, Inc.

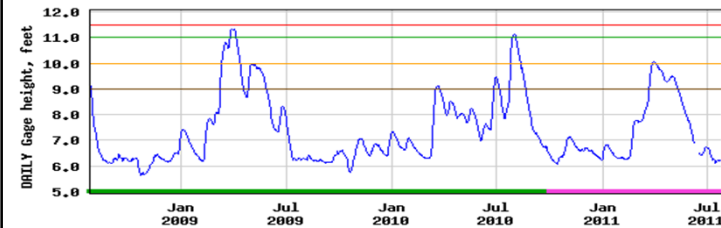
USGS 05427235 LAKE KOSHKONONG NEAR NEWVILLE, WI

Water Level Criteria for Slow No Wake

- Rock County
- Current situation: request-driven
- Flood typically rise faster than they fall
- Need for objective criteria

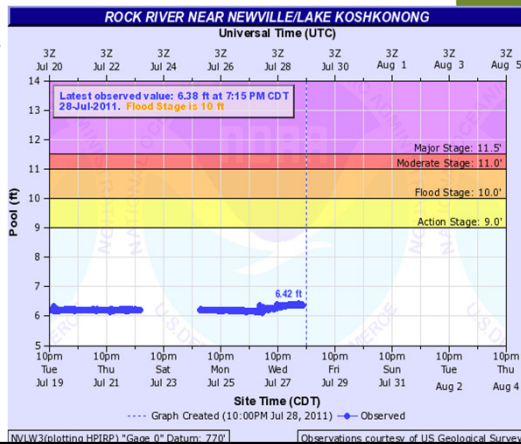
NVLW3(plotting HP1RP) *Gage 0" Datum: 779'

Weather Bureau Flood Prediction

- Web based
- Includes predictions
- Flood levels based on when "things start to flood"
- Defines an "Action Stage"
- Action Stage for Lake Koshkonong is 779.0
- <http://water.weather.gov/ahps2/hydrograph.php?wfo=mkx&gage=nvlw3&view=1,1,1,1,1,1%22>

Observations courtesy of US Geological Survey

- Action Stage at Lake Koshkonong gage
- Use same Action Stage for SNW on and SNW off
- Action stage at Lake Koshkonong correlates well with Action Stage at Indianford Dam

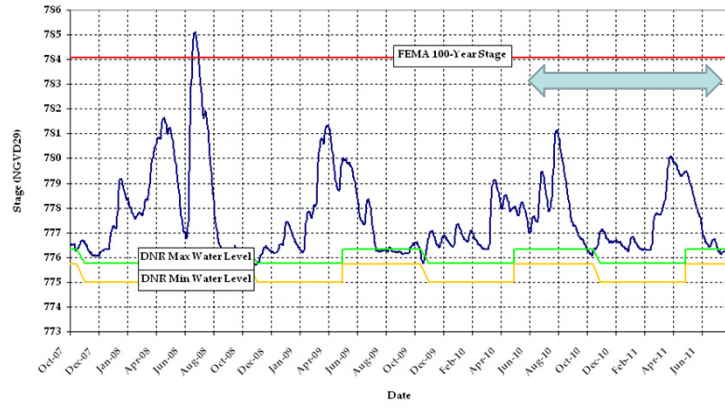
The last year on Lake Koshkonong

- 2011 Flood peak about average in height for record since 1987.
- Flows have generally been higher than average for the last five years – low stages have not been as low as they were previously.
- Winter and summer stages typically above operating order targets.
- Aquatic vegetation on Lake Koshkonong

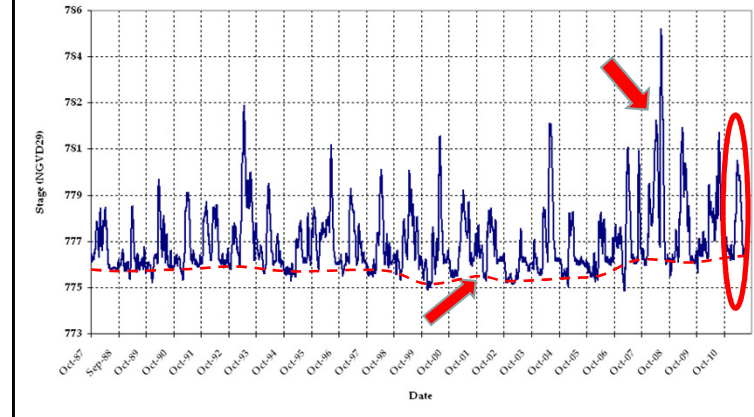
Water Levels, 1987 - Present

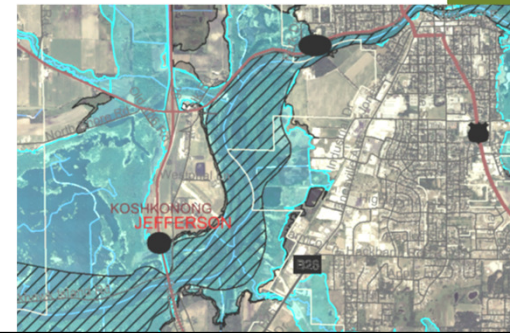
Floodplain Revision for the Rock River

- Restudy initiated by DNR, partly in response to 2008 flood
- 100 Year flood stage change
- Floodplain zoning: floodway, floodfringe

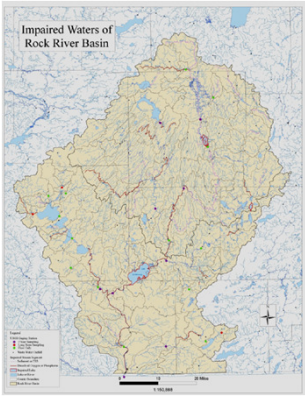
Rock River TMDL

- A draft of the TMDL for the Upper and Lower Rock River Basins is finished and available online.
- There are approximately 40 waters in the Rock River Basin that are impaired by excess phosphorus (TP) and total suspended solids (TSS).
- All of the Rock River & Lake Koshkonong are designated "impaired"
- The DNR is responding to public comments and a final draft will be available soon.

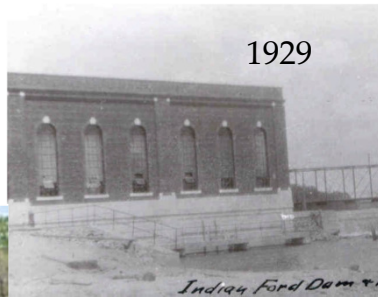
1929

Restoring hydropower at Indianford Dam

- Recognize value of renewable energy
- Recognize value of income stream
