COOPERATIVE LAKE STUDY FIELD MONITORING SHEET

Location: Carcajou Floodplain Forest (N42°52'53.8", W88°58'50.7") Date: 10-31-03
 Observers: Mike Halsted & Steve Hjort Water Level: 775.96 msl
 Conditions: Overcast, 50°F, SW winds from 5-15mph increasing.

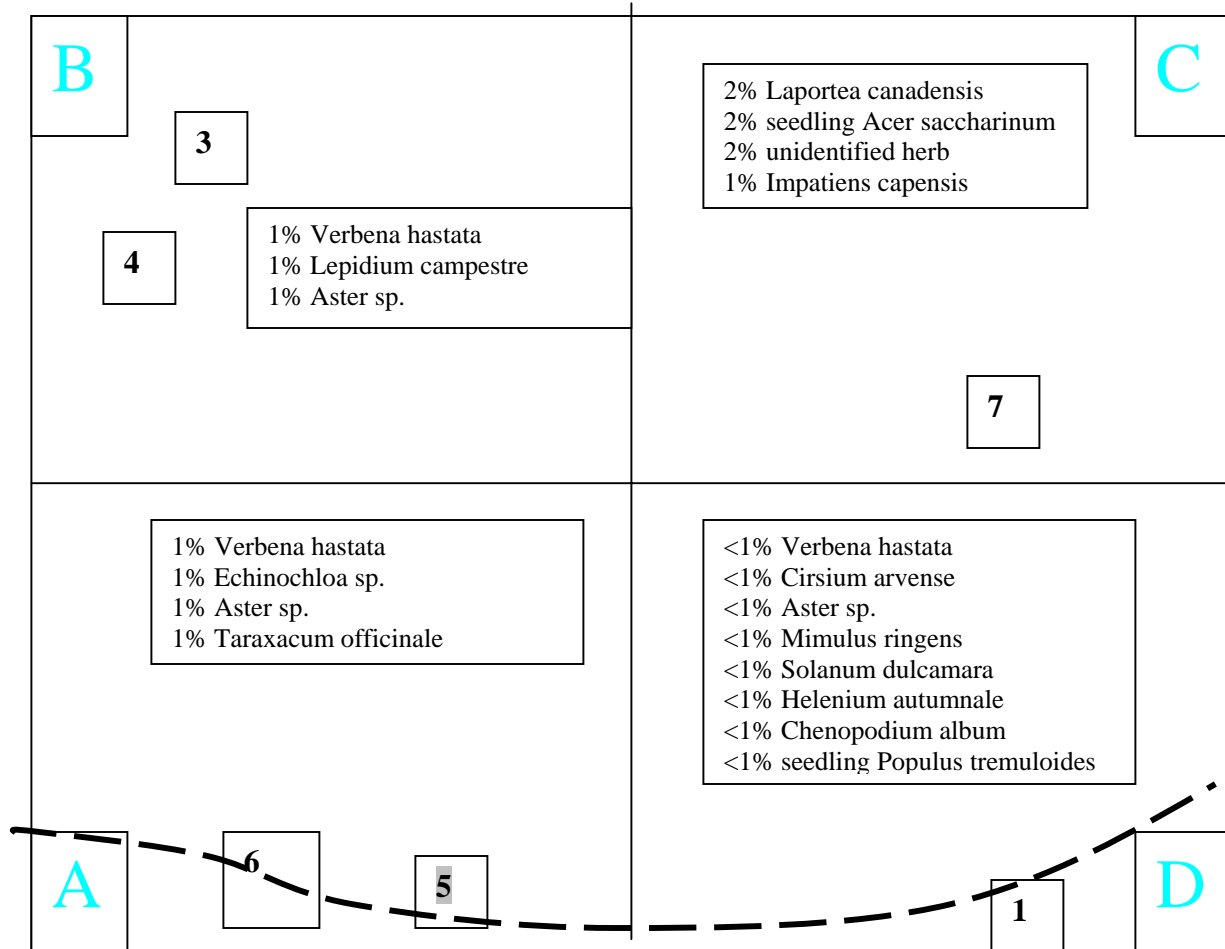
Quad A: **5** = Ulmus americana cut by landowner, **6** = 7" (stump) and 18" dbh trunk Acer saccharinum with 1", 1", 1.5" and .75" suckers. Herb layer vegetation present. Evidence of continued erosion.

Quad B: **3** = 18" dbh Fraxinus pennsylvanica. **4** = Fraxinus pennsylvanica. Herb layer vegetation present. Trees healthy.

Quad C: **7** = 22" dbh Acer saccharinum with 0.75", 2.5", 2.5", 2.5", 3", 3.5" suckers. Herb layer vegetation present. Trees healthy.

Quad D: **1** = Acer saccharinum stumps 12", 9", 7", and 6" cut off by landowner. Herb layer vegetation present. Trees healthy. Evidence of continued erosion.

Notes: Water depth 13 inches at 15' mark. Evidence of continued erosion undermining the tree roots along shore.
