**RE: INDIANFORD DAM INSPECTION, DNR FIELD FILE #53.04 PERFORMED ON  
NOVEMBER 4, 2024**

Attached is a final report for the inspection of the Indianford Dam located on the Rock River just west of Edgerton, Wisconsin, adjacent and down river from the County Road M Bridge. The report contains the following items for your review and comment:

Local Dam Name (PRINT): Indianford

DNR Field File #: 53.04

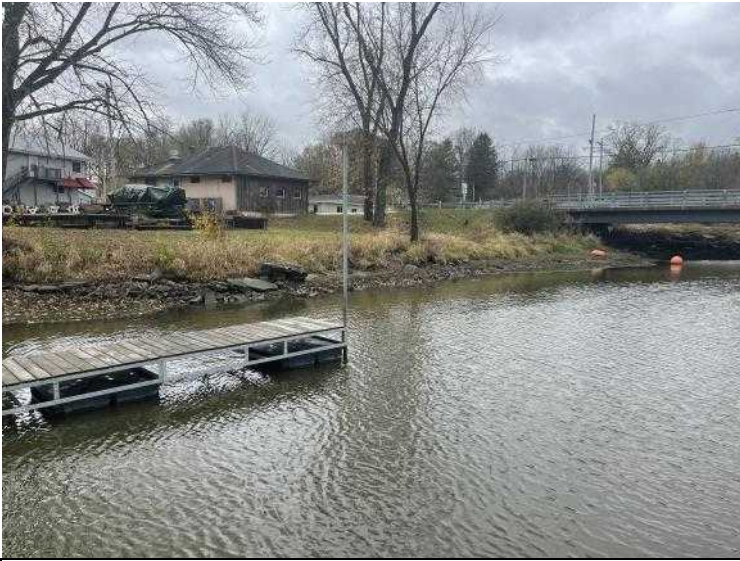
Photo 0060811042402 - East shore line (looking south)

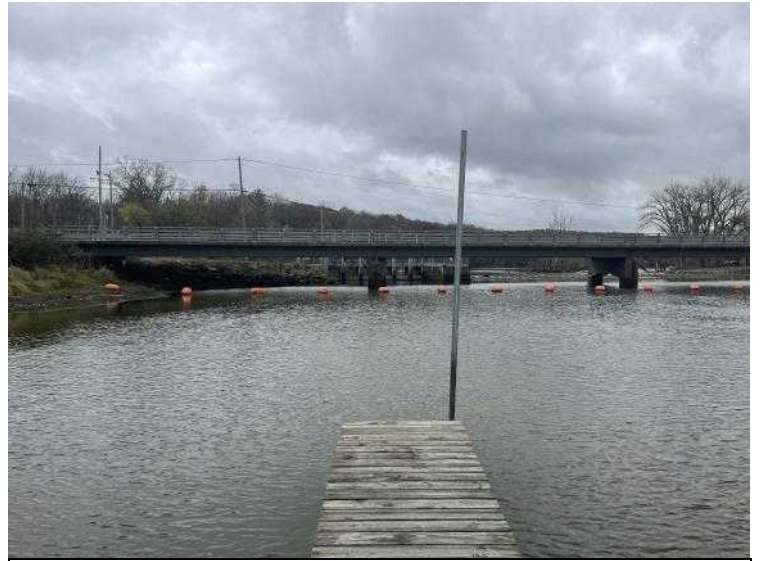
Photo 0060811042403 - Auxiliary slide gate area (looking south)

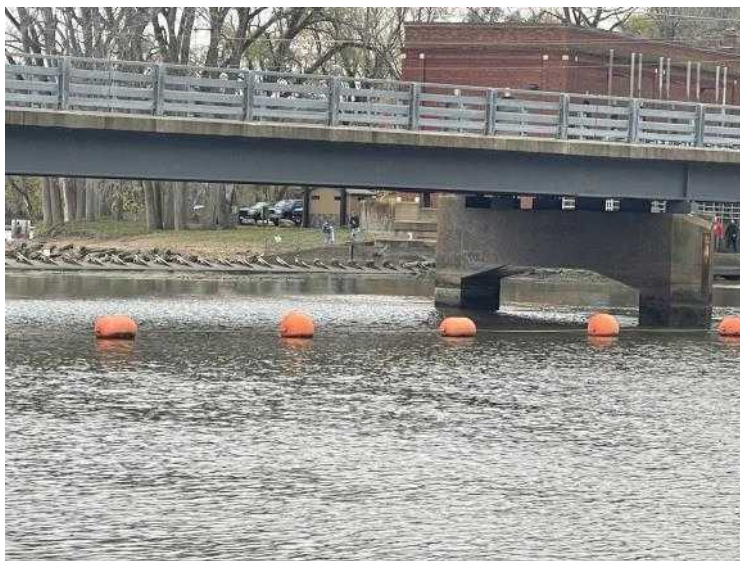
Photo 0060811042404 - Spillway (looking south)

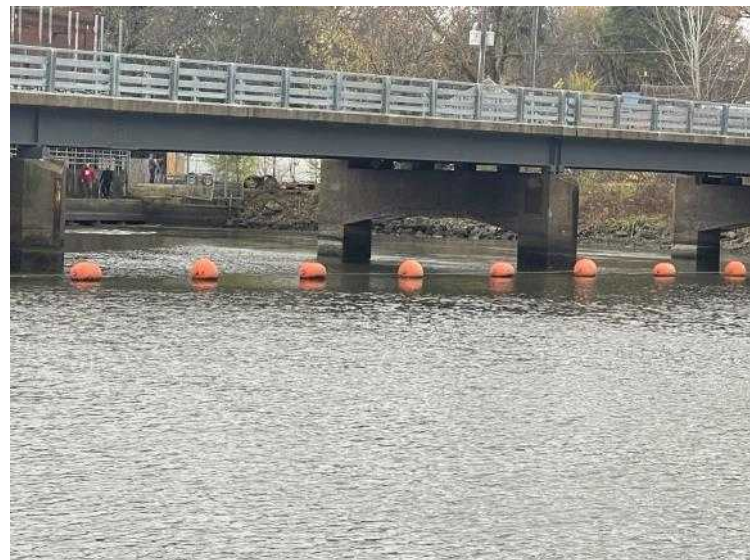
Photo 0060811042405 - Power house building slide gates

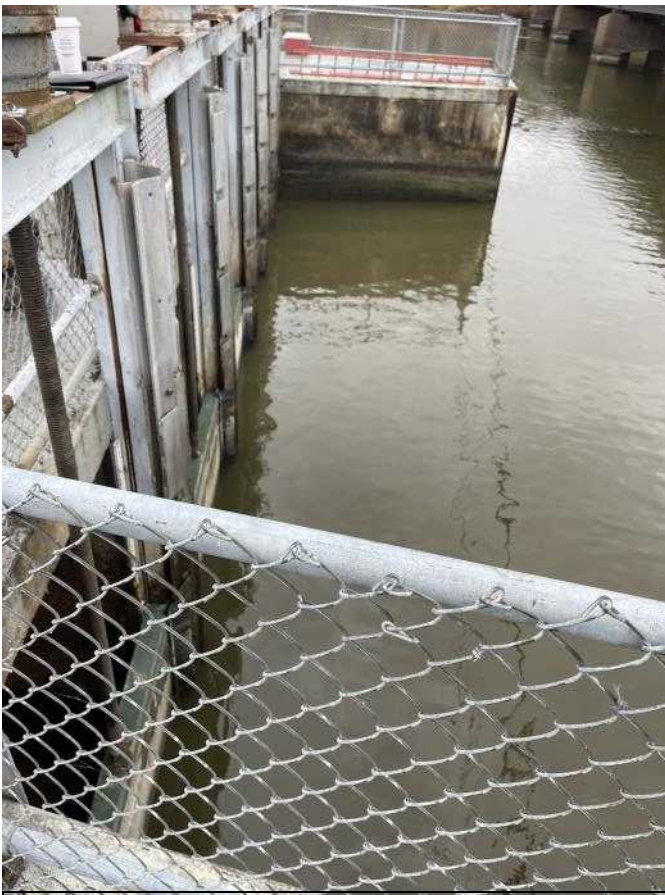
Photo 0060811042406 - Auxiliary slide gates (up river)

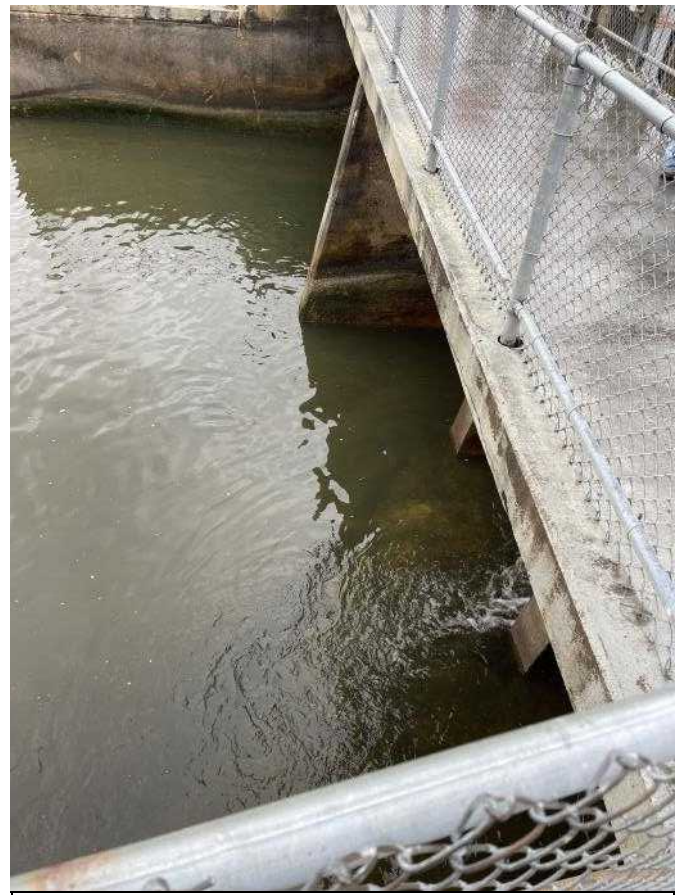
Photo 0060811042407 - Auxiliary slide gates (down river)

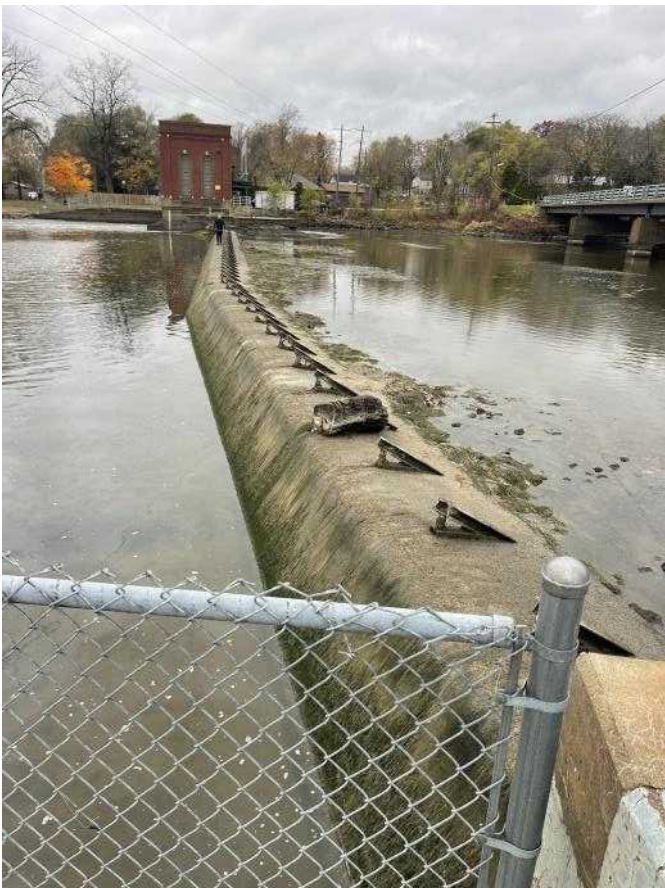
Photo 0060811042408 - Center spillway looking east

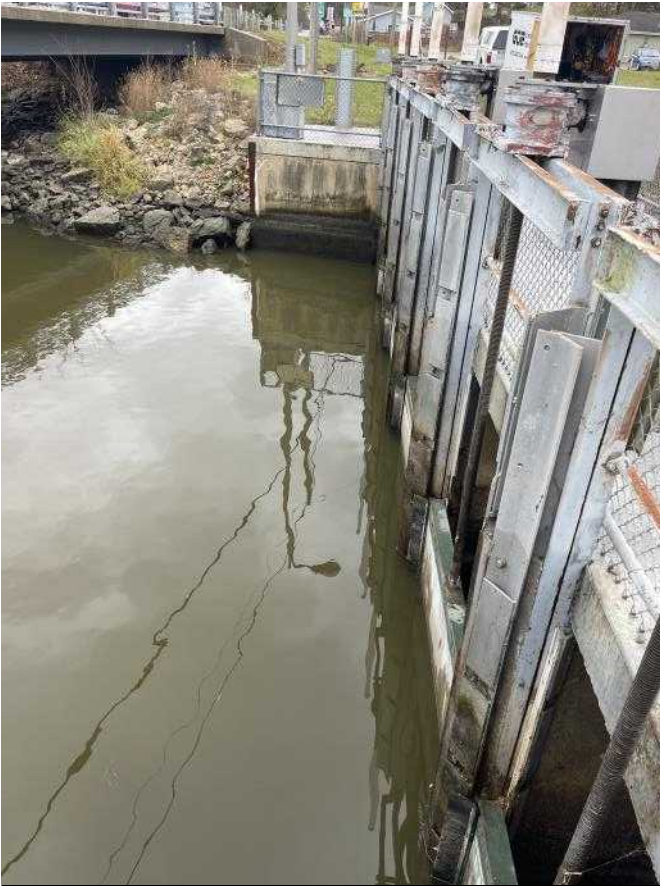
Photo 00608110424010 - Auxiliary side gate up river

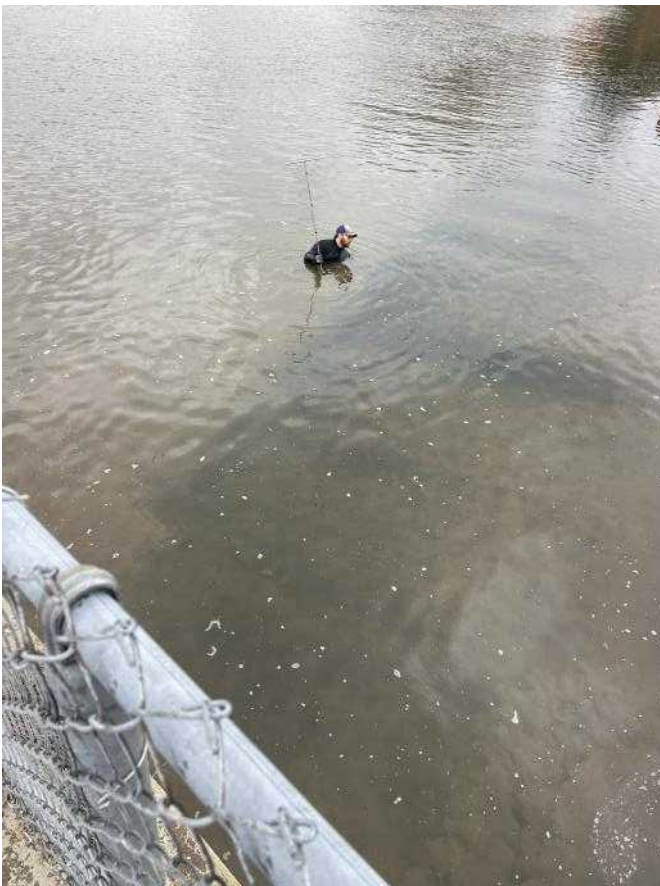
Photo 0060811042412 - Diver inspection of spillway apron

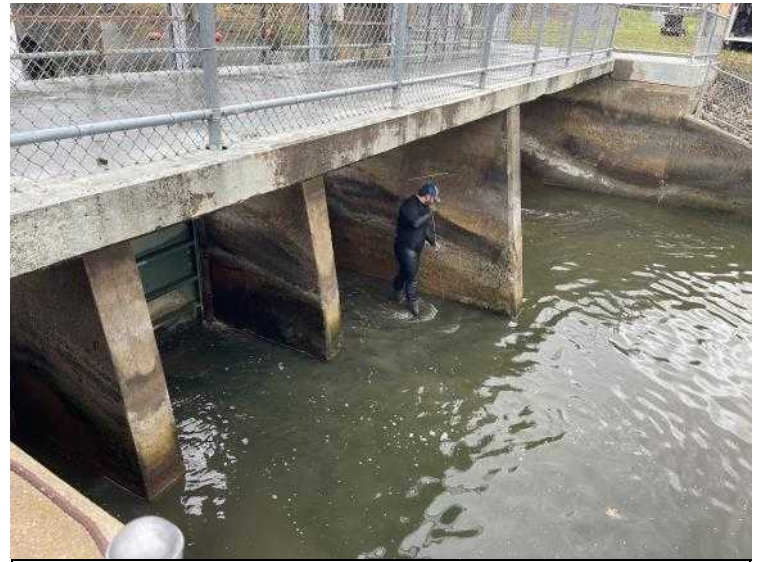
Photo 0060811042415 - Diver inspection of auxiliary gate abutments

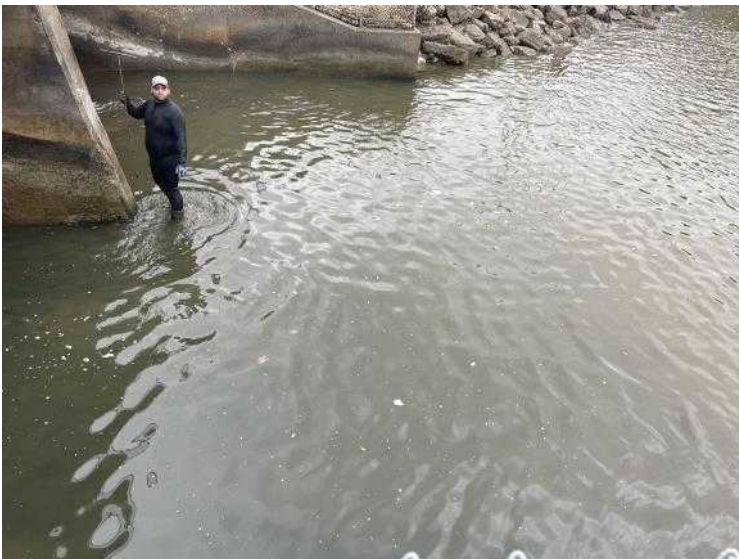
Photo 0060811042416 - Diver inspection of auxiliary gate abutments

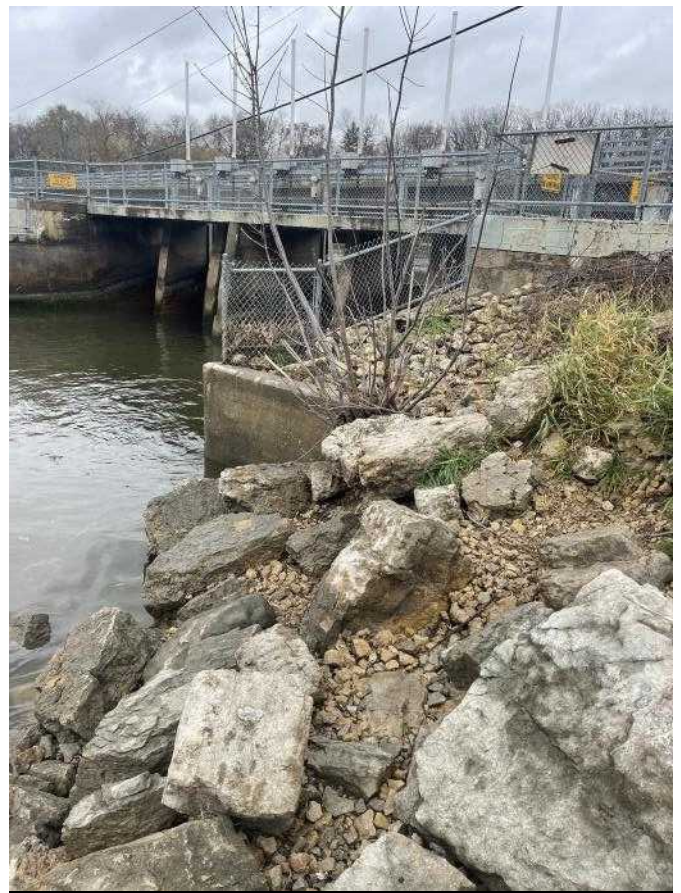
Photo 0060811042419 - Auxiliary gate and adjacent riprap

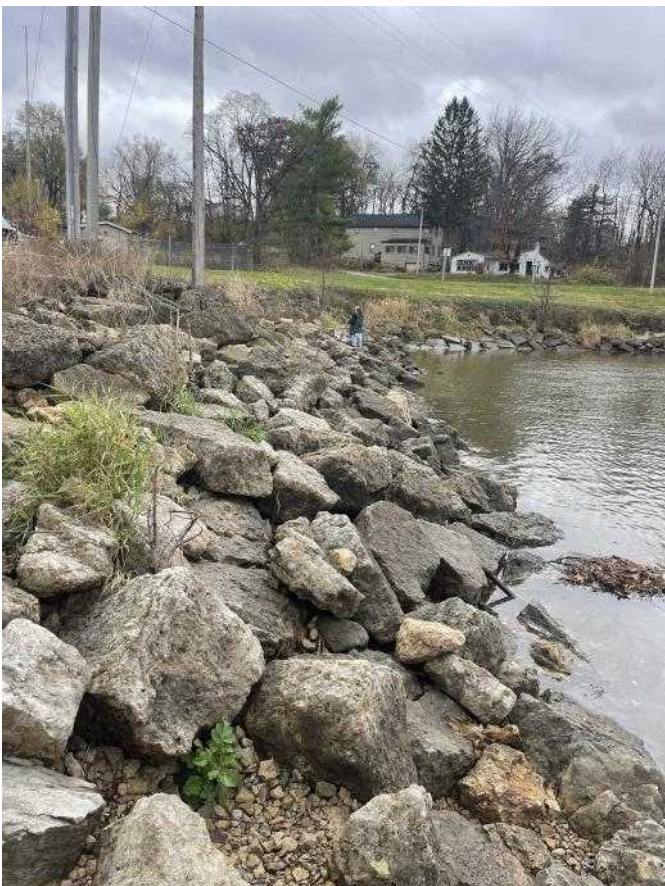
Photo 0060811042420 - Auxiliary gate riprap (looking east)

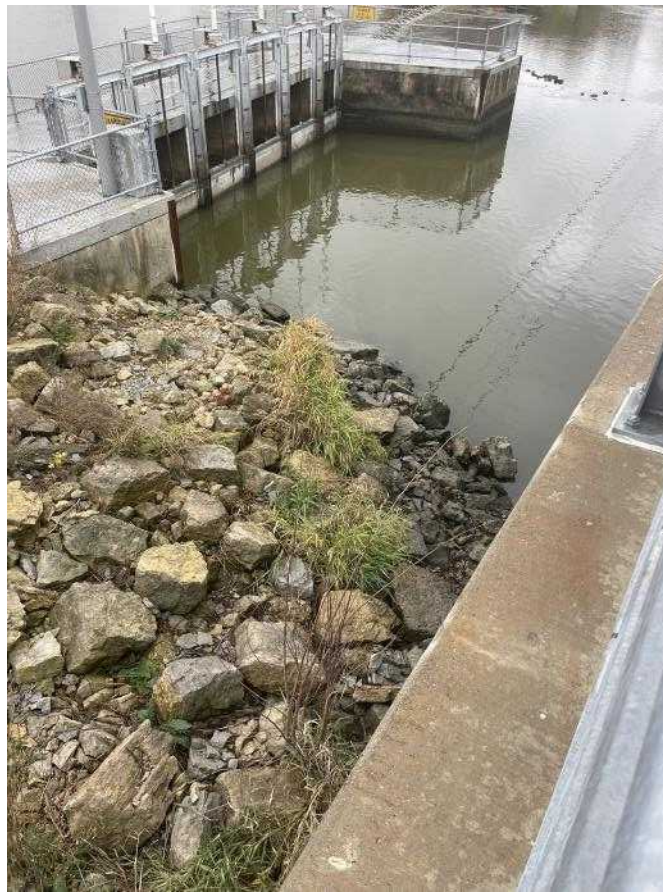
Photo 0060811042422 - Riprap of auxiliary gate between

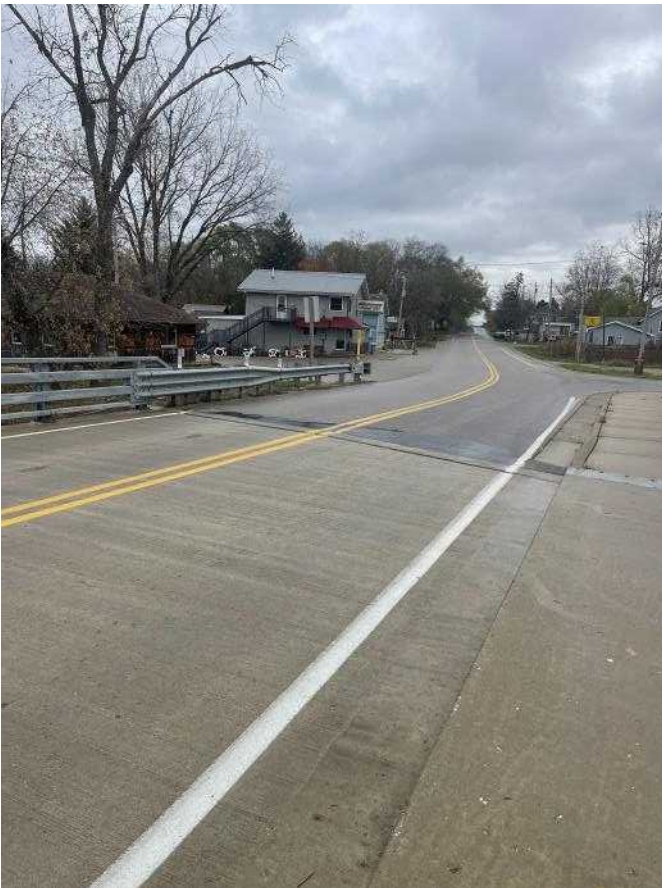
Photo 0060811042423 - County Road M looking east at

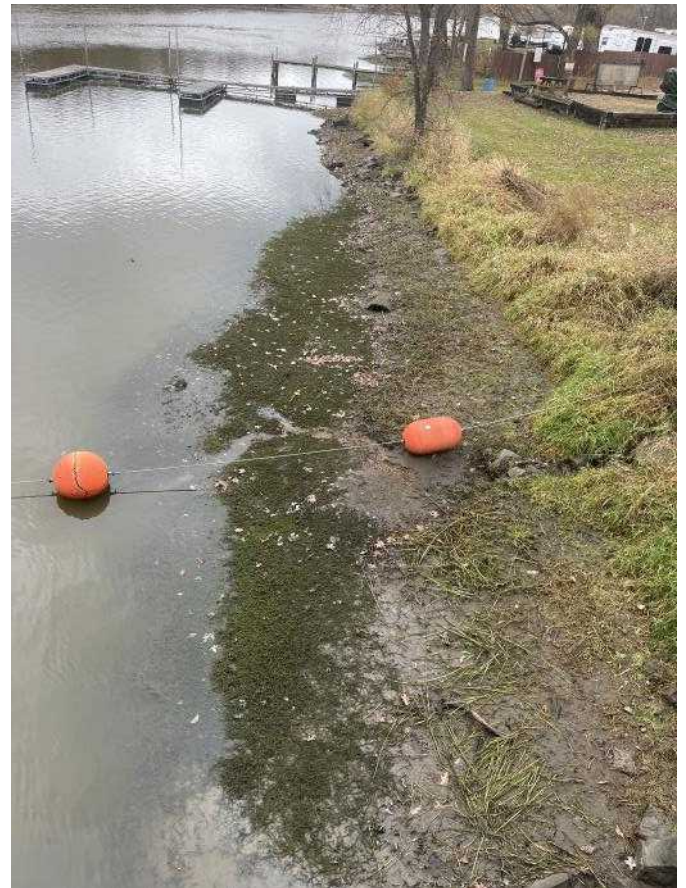
Photo 0060811042424 - Up river from auxiliary slide gates

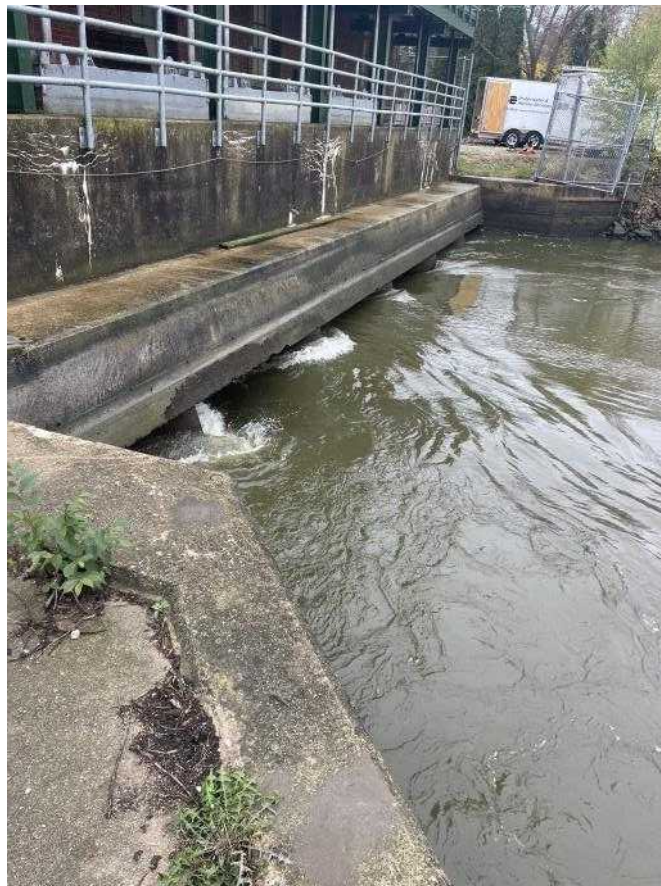
Photo 0060811042435 - Primary building slide gate intake

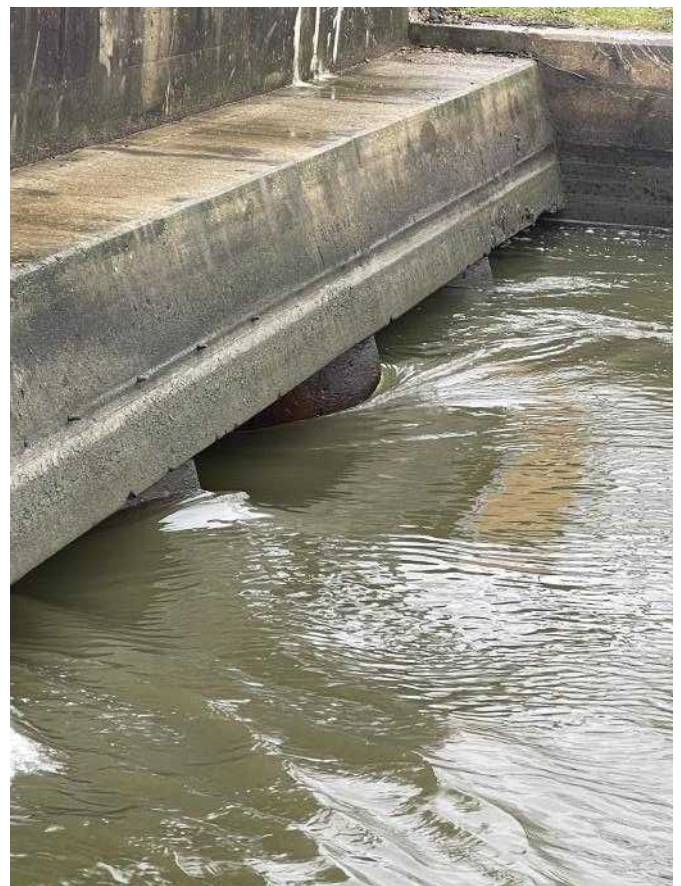
Photo 0060811042437 - Power house up stream wall

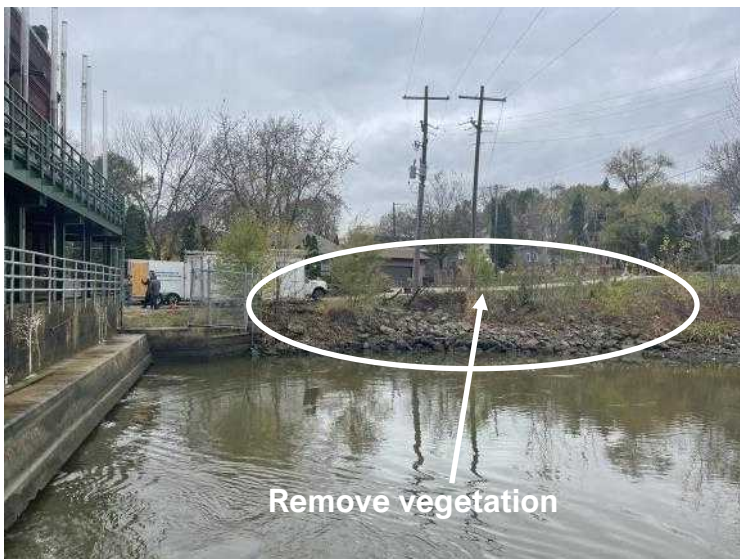
Photo 0060811042438 - West bank up stream of power house

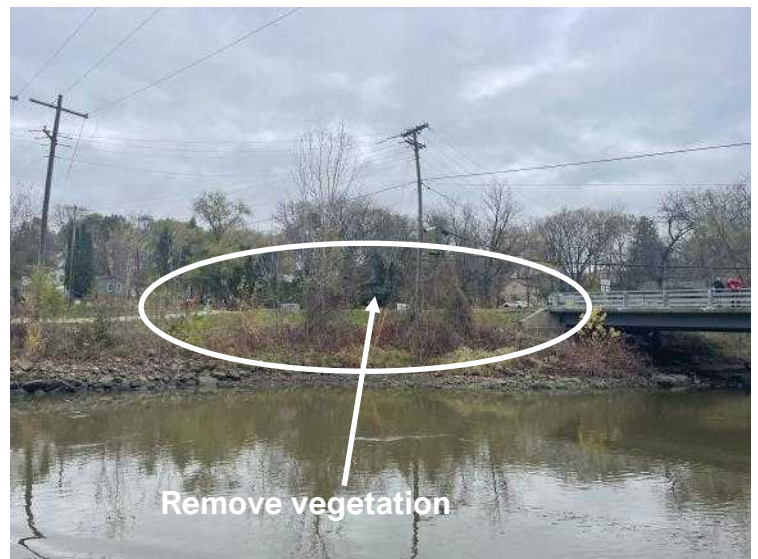
Photo 0060811042439 - West bank upstream of power house

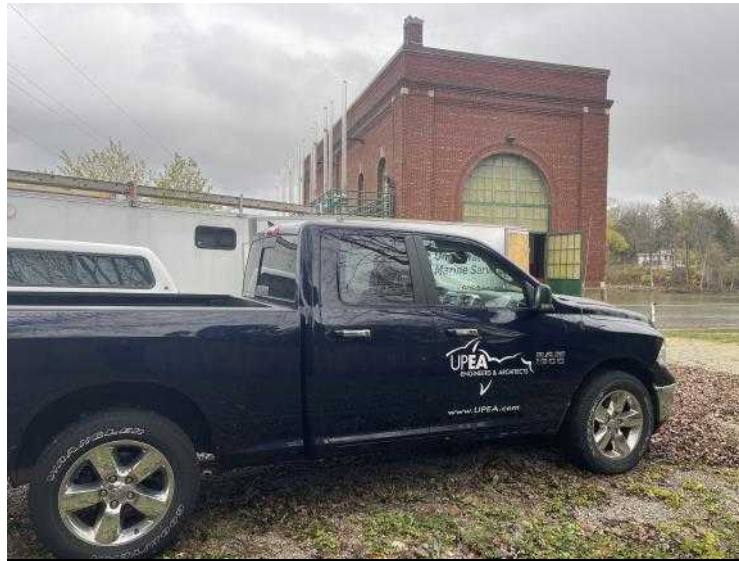
Photo 0060811042442 - Power house (looking east)

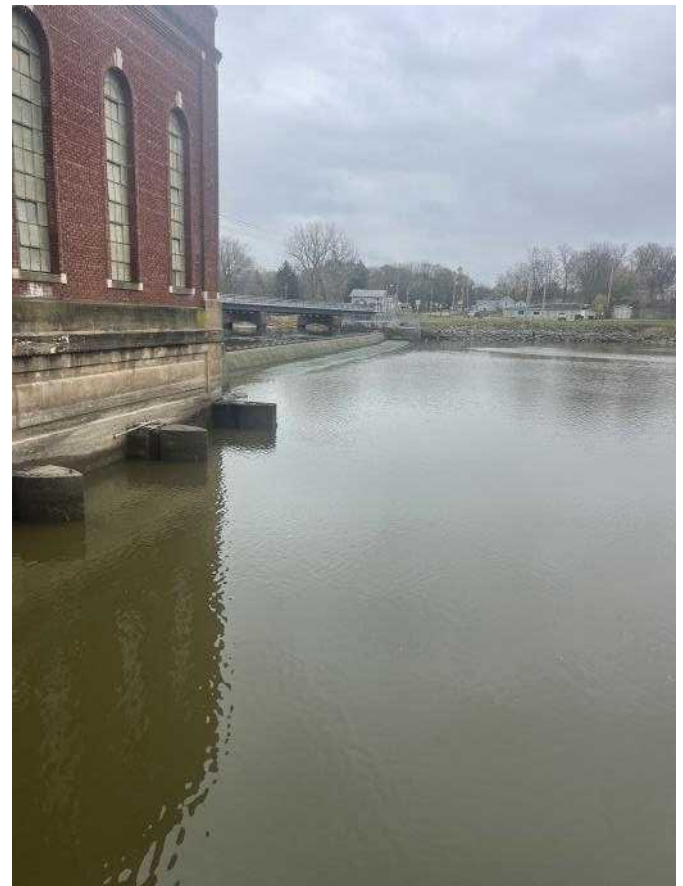
Photo 0060811042447 - Area where sink hold is filled

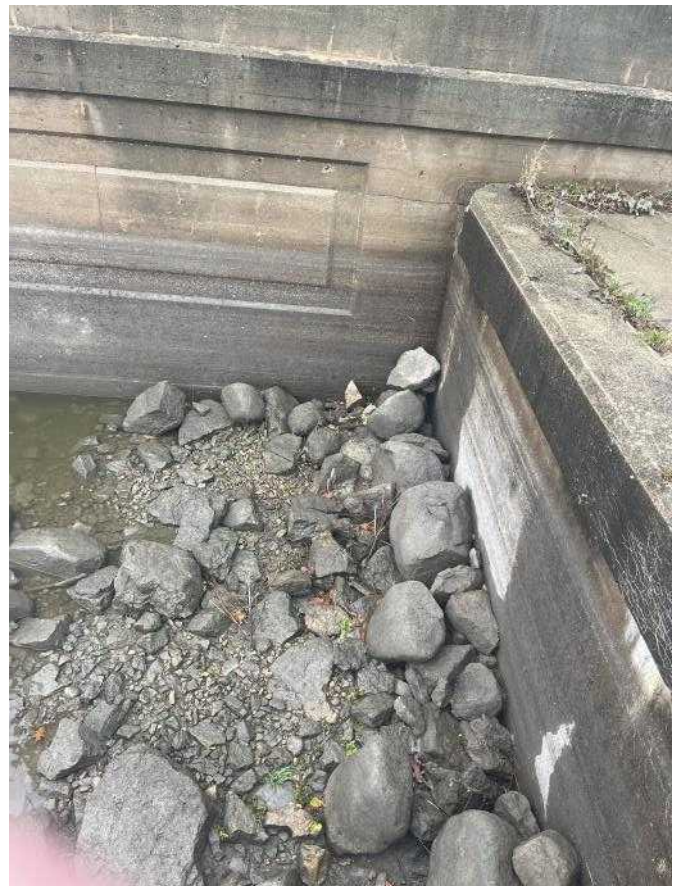
Photo 0060811042449 - Down stream gage

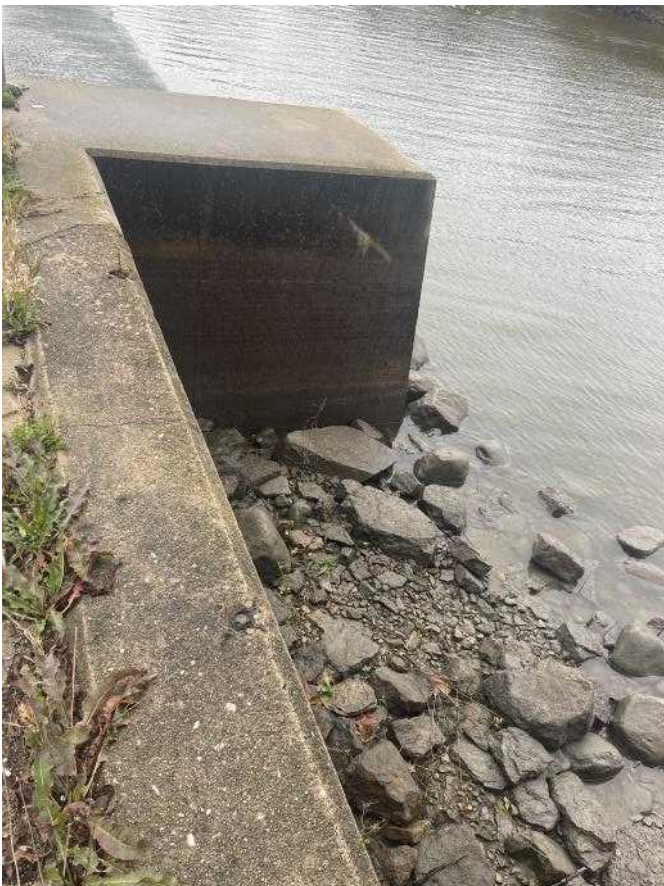
Photo 0060811042450 - Down stream riprap east of power

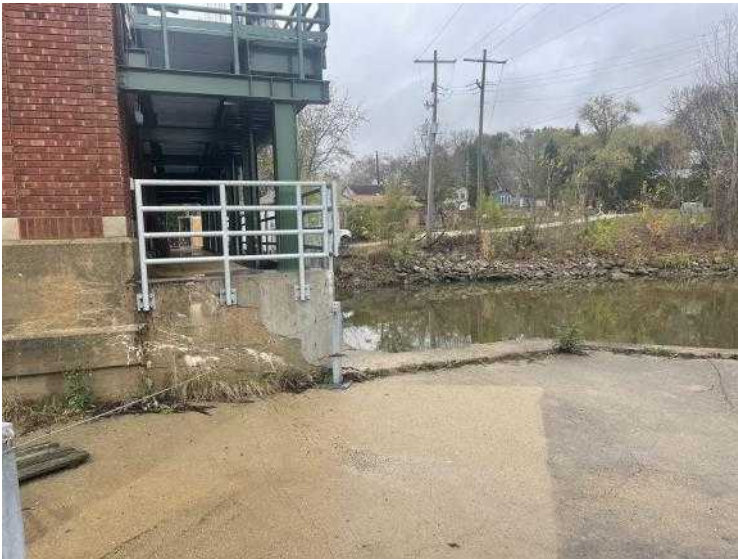
Photo 0060811042456 - Power house east concrete slab

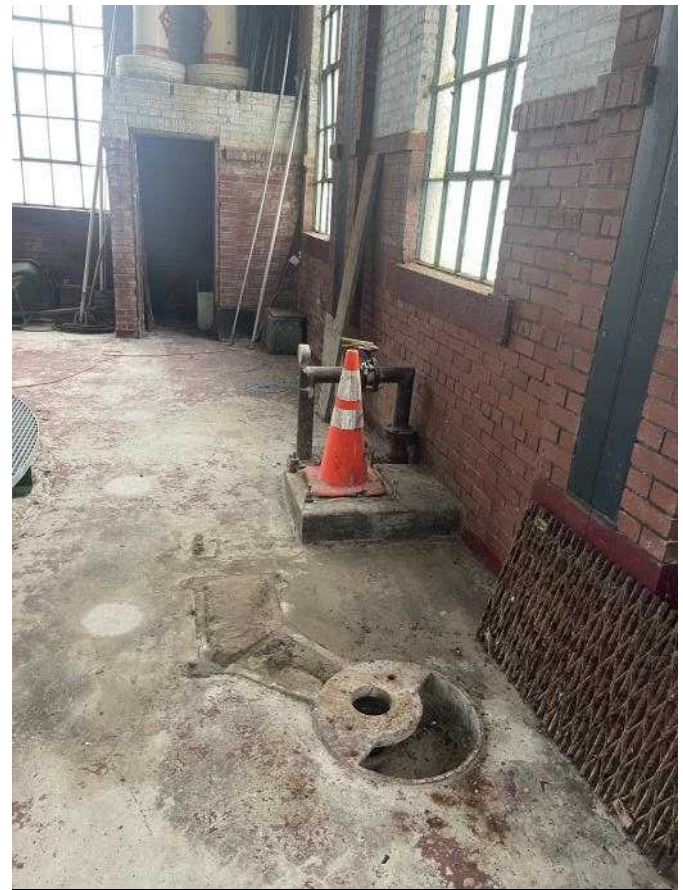
Photo 0060811042459 - Power house north wall (looking east)

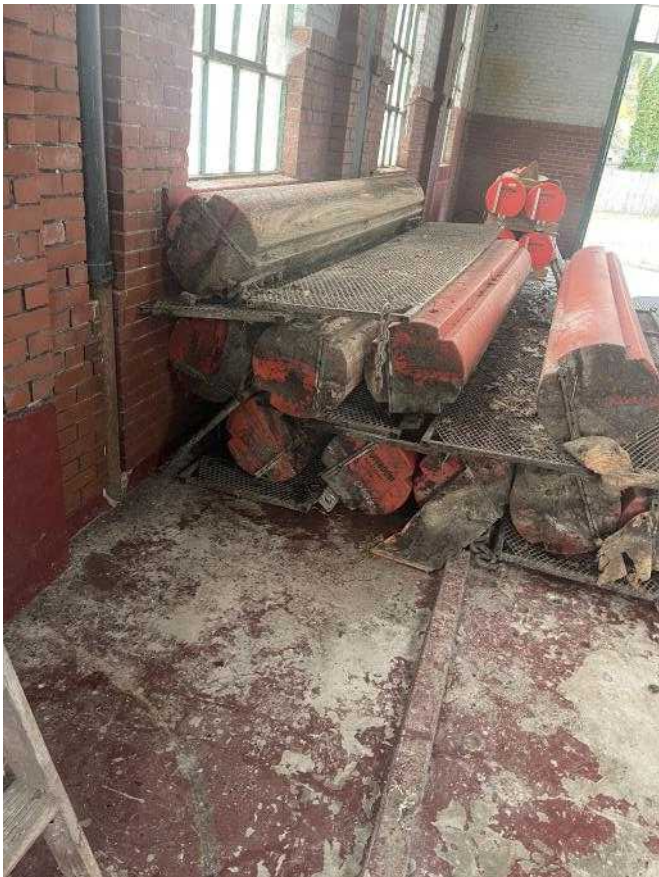
Photo 0060811042460 - Power house south wall

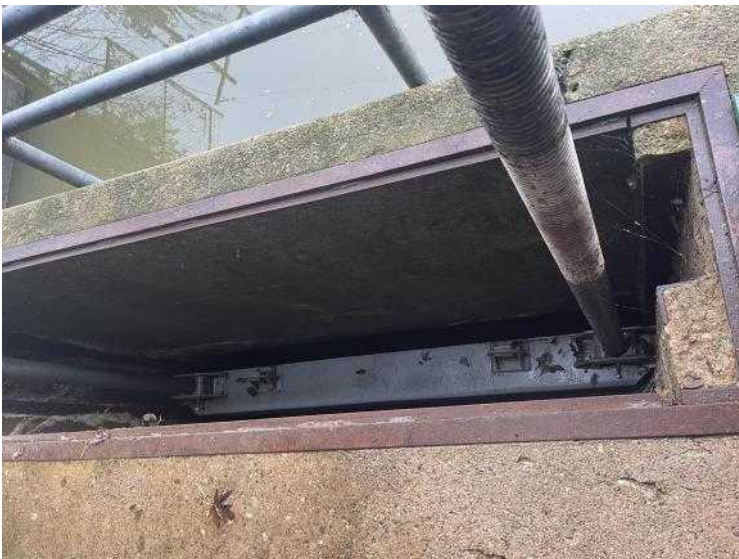
Photo 0060811042462 - Slide gate bay number 6

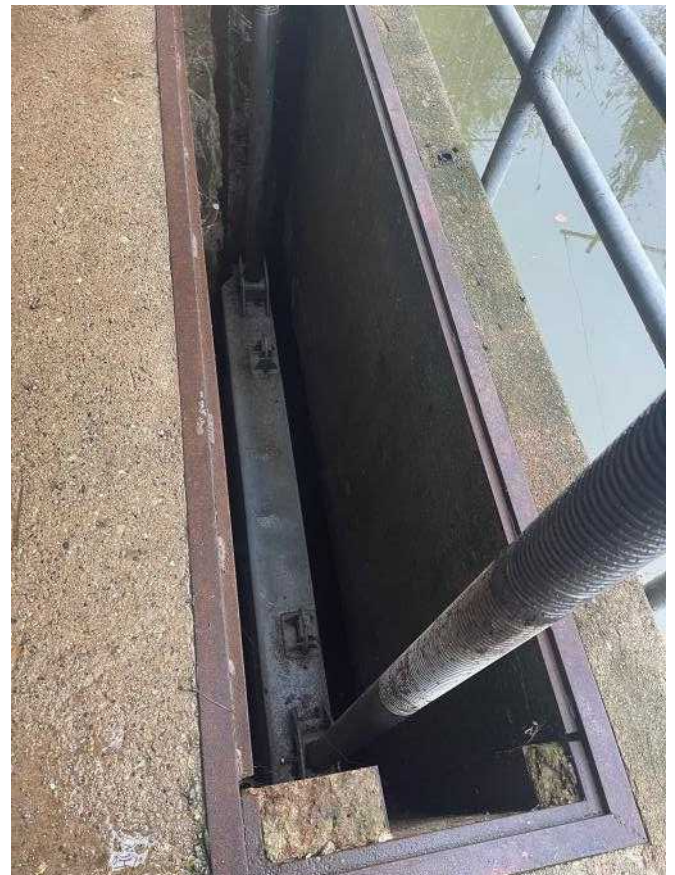
Photo 0060811042463 - Slide gate bay number 5

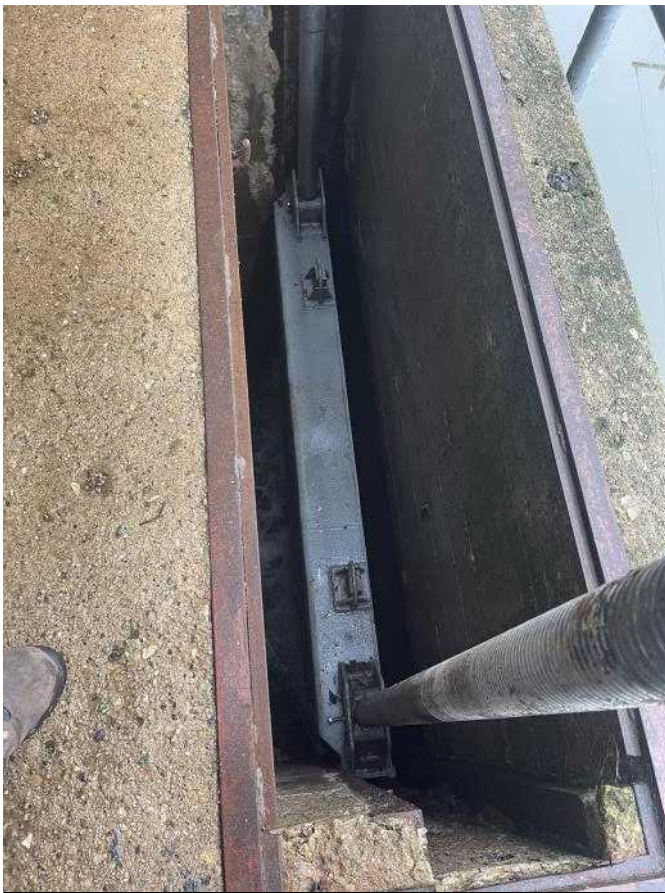
Photo 0060811042464 - Slide gate bay number 4

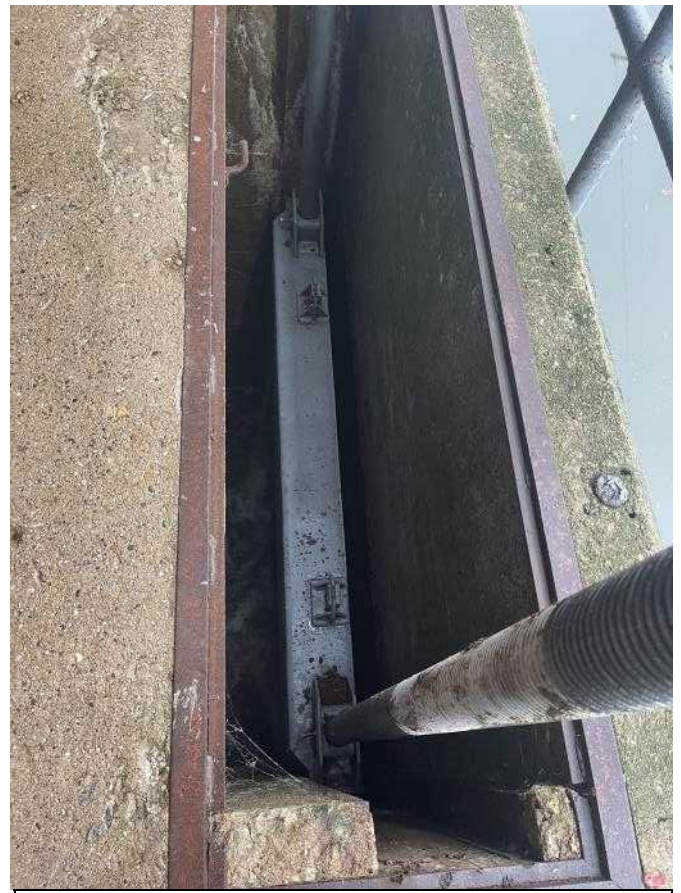
Photo 0060811042465 - Slide gate bay number 3

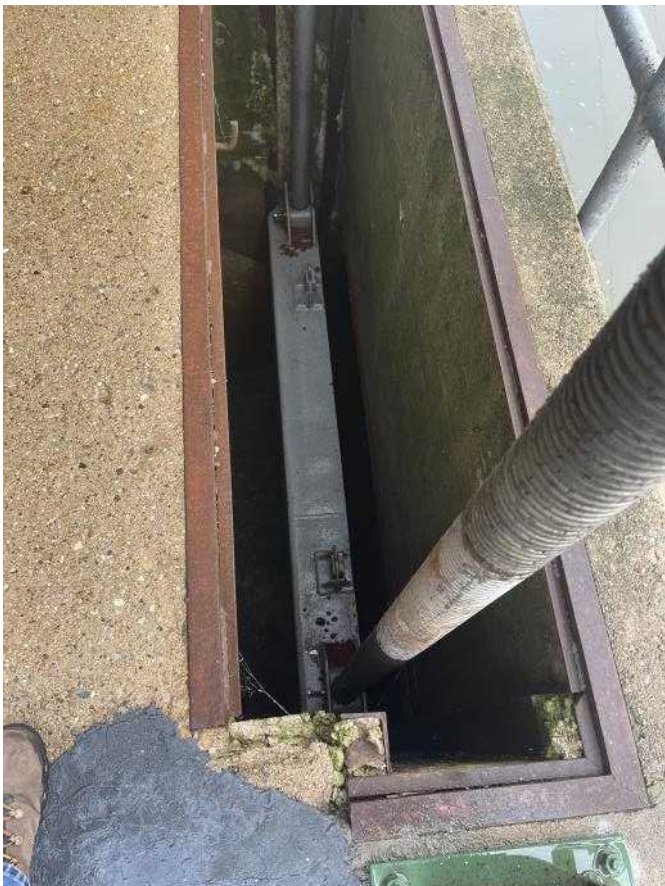
Photo 0060811042466 - Slide gate bay number 2

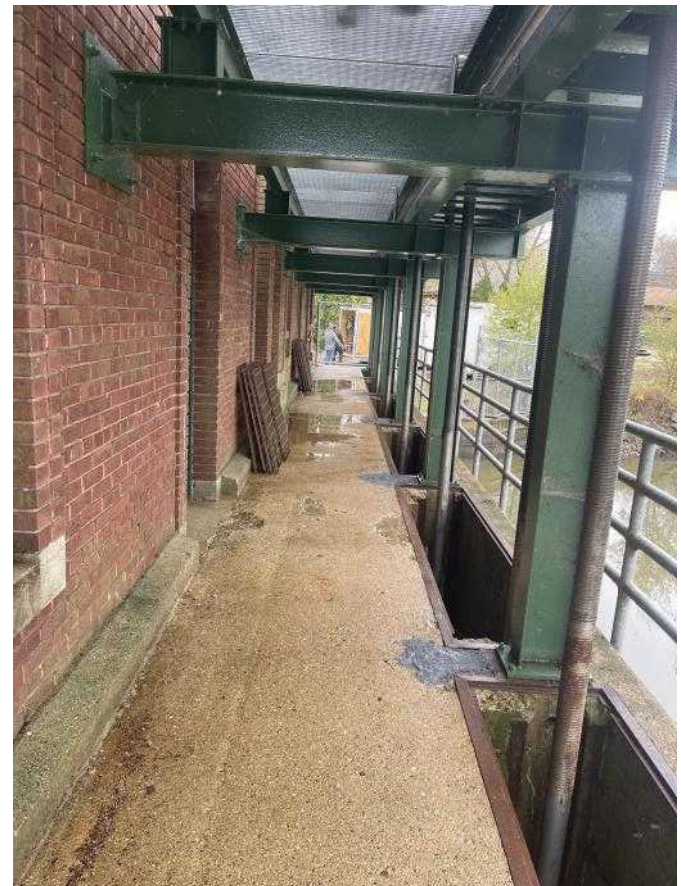
Photo 0060811042467 - Slide gate bay number 1

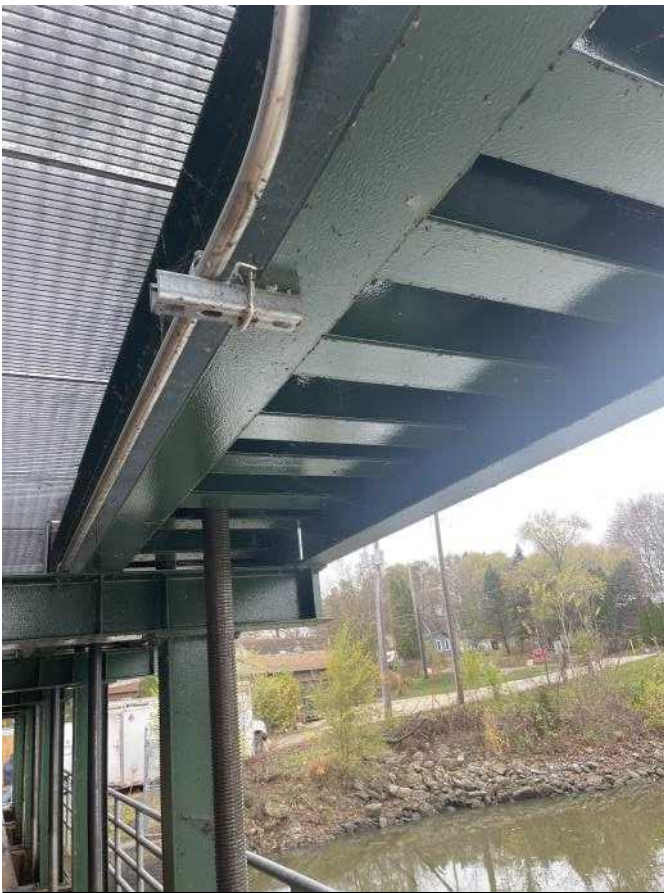
Photo 0060811042468 - Slide gate platform (looking west)

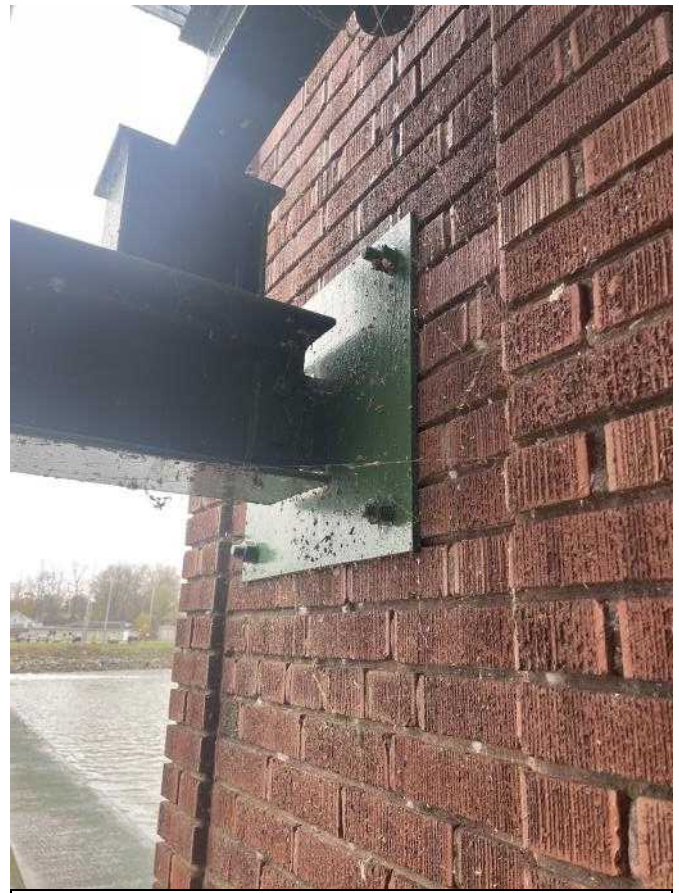
Photo 0060811042469 - Slide gate platform beams
