**RE: INDIANFORD DAM INSPECTION, DNR FIELD FILE #53.04 PERFORMED ON  
NOVEMBER 4, 2024**

Attached is a final report for the inspection of the Indianford Dam located on the Rock River just west of Edgerton, Wisconsin, adjacent and down river from the County Road M Bridge. The report contains the following items for your review and comment:

Local Dam Name (PRINT): Indianford

DNR Field File #: 53.04

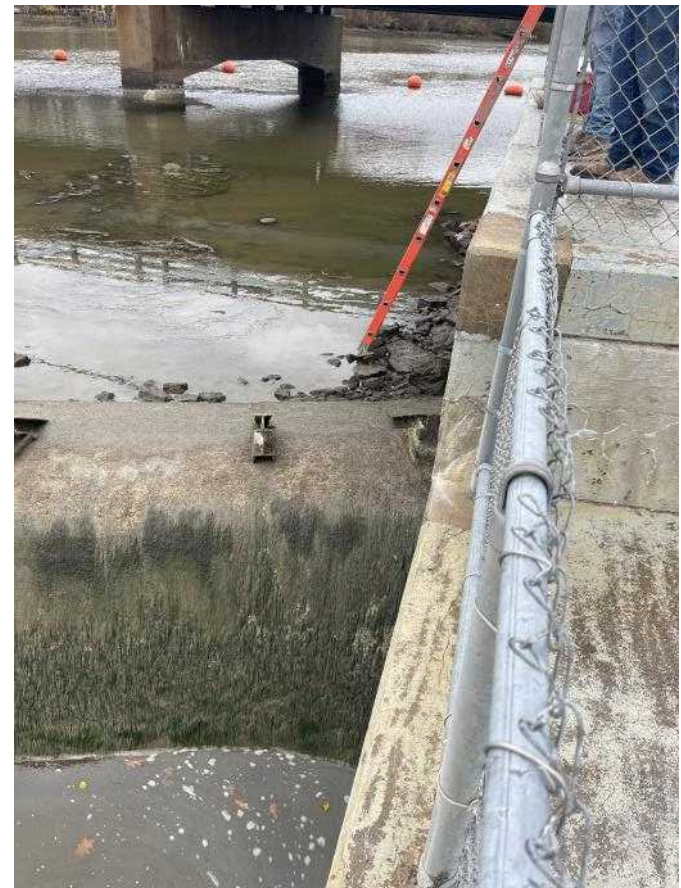
Photo 0060811042409 - Spillway auxiliary slide gate west

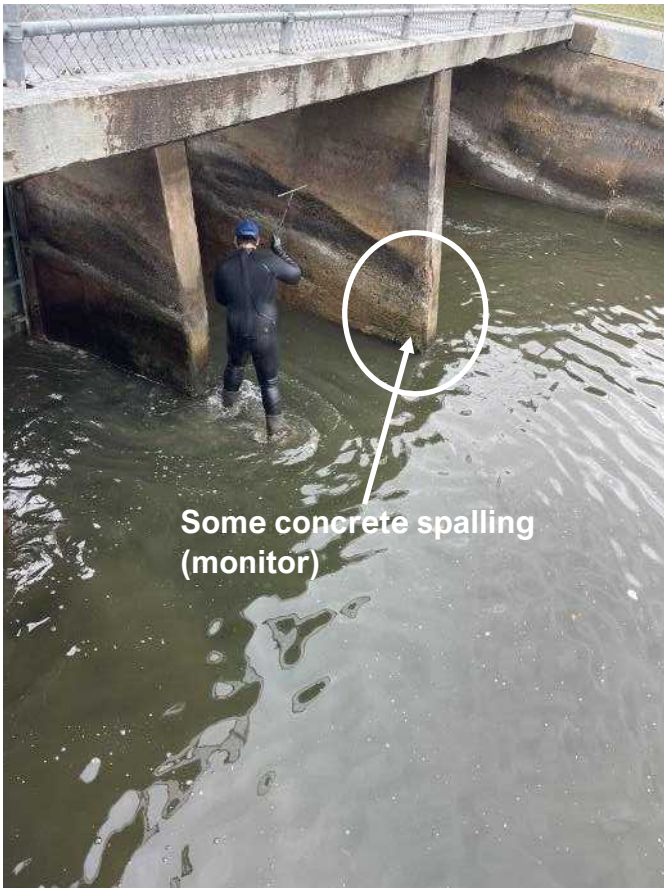
Photo 0060811042414 - Diver inspection of auxiliary gate

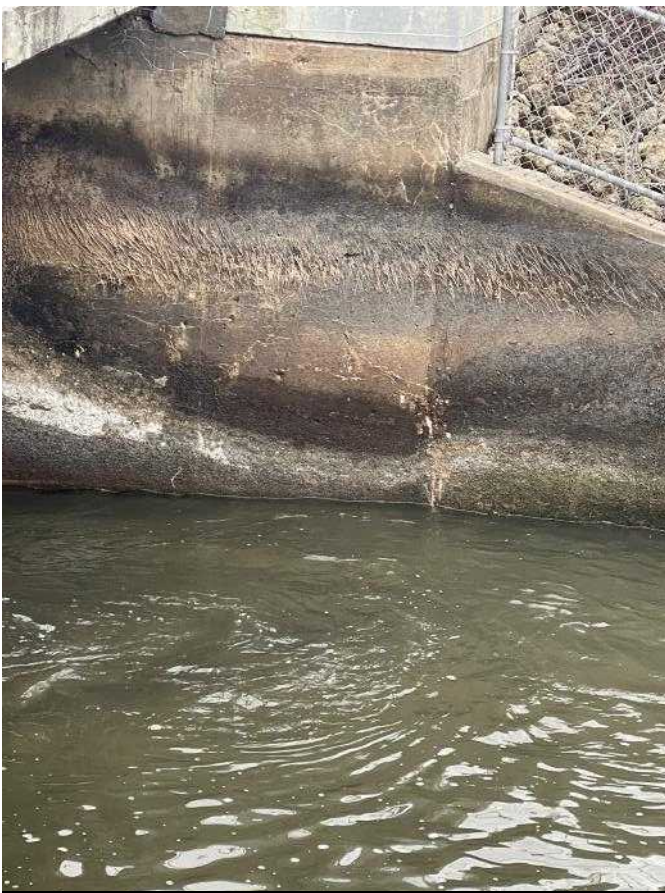
Photo 0060811042418 - Auxiliary abutment

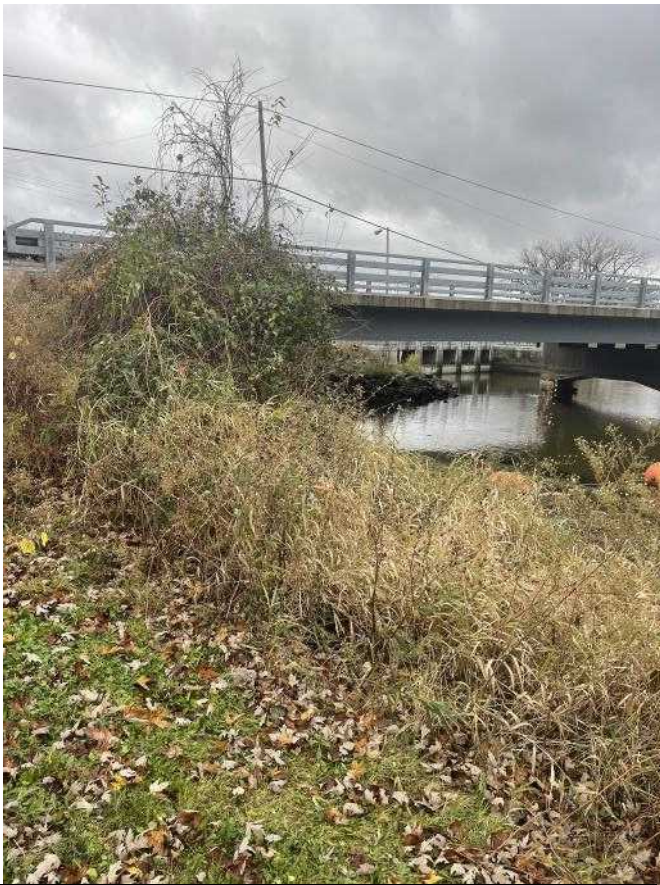
Photo 0060811042425 - Boat barrier anchor behind brush on

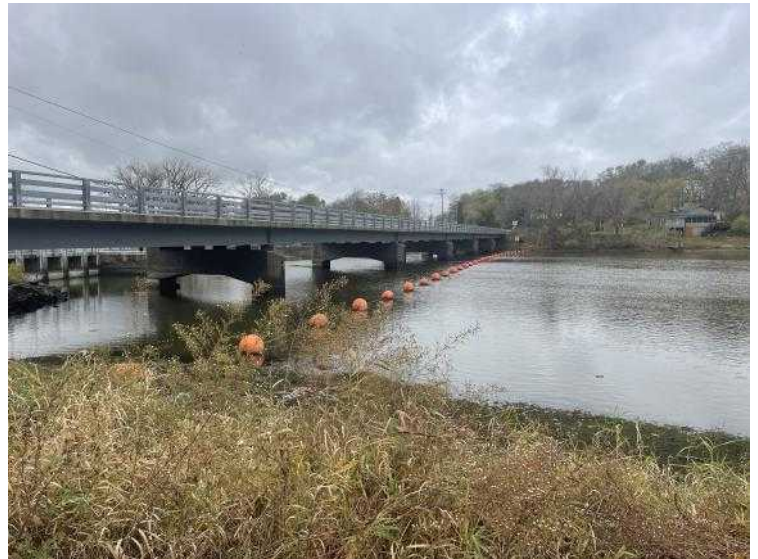
Photo 0060811042426 - Boat barrier and County Road M bridge

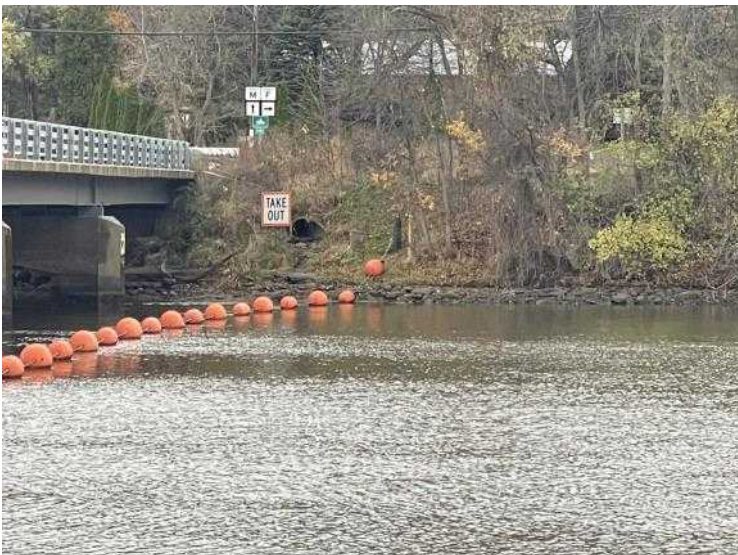
Photo 0060811042427 - West shore above dam (stable)

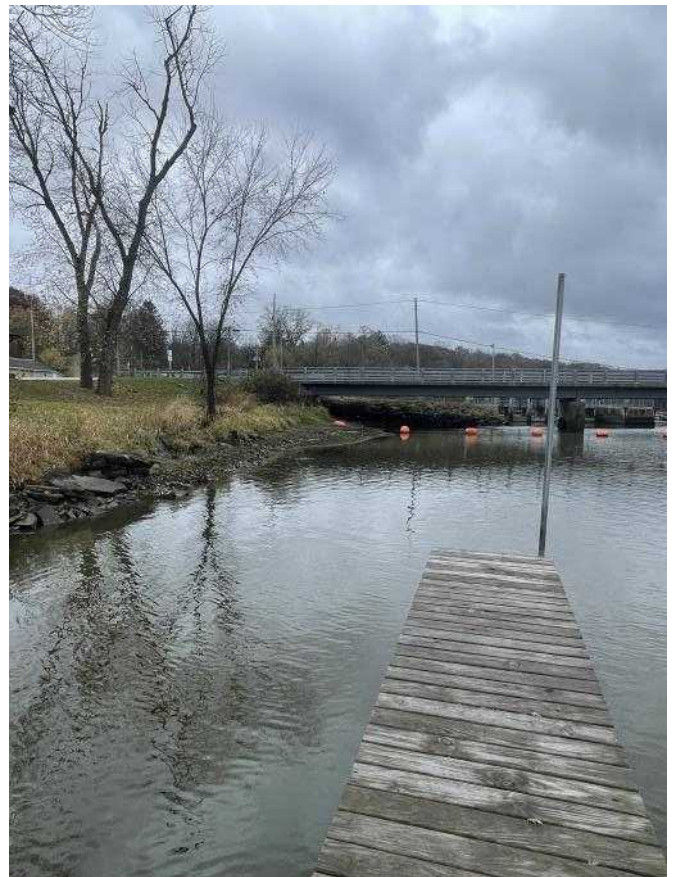
Photo 0060811042428 - East shore above dam (looking

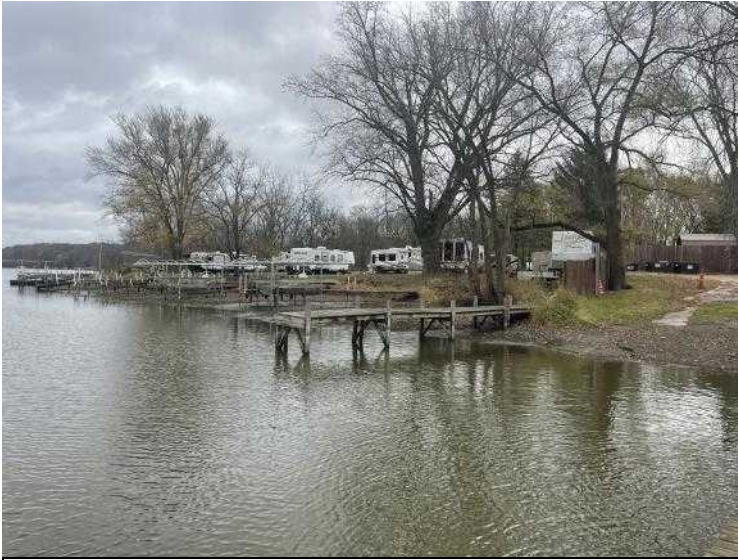
Photo 0060811042429 - East shore up river reservoir (river drain

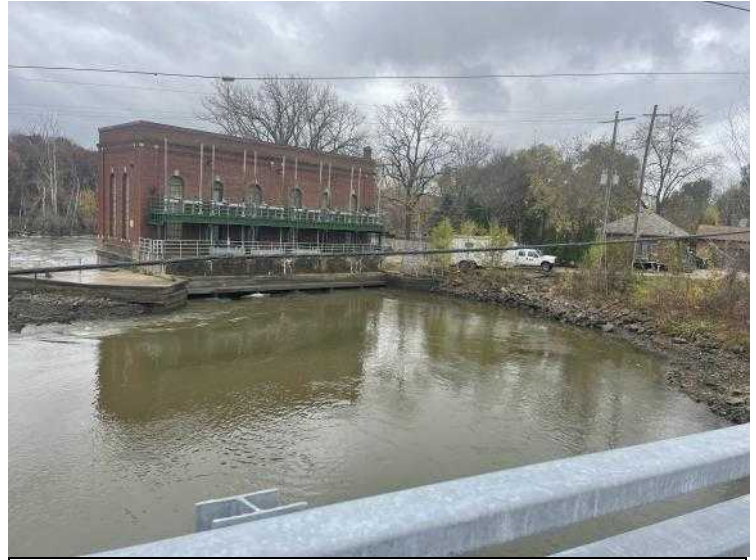
Photo 0060811042430 - West shore, up river reservoir

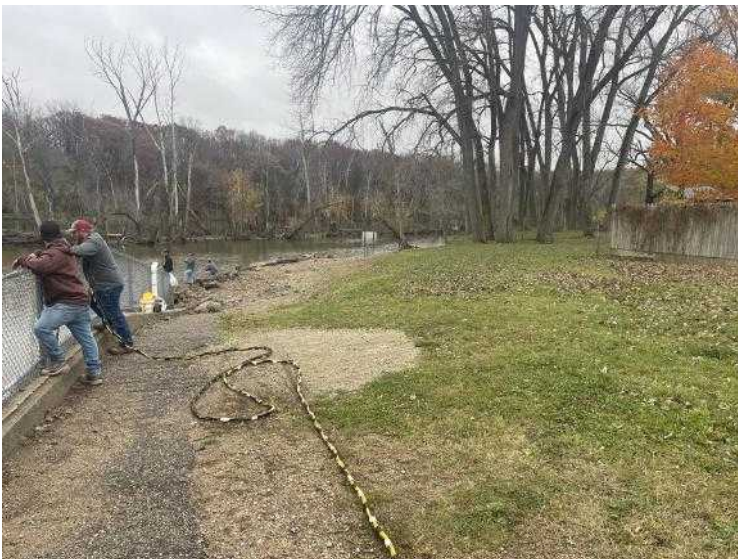
Photo 0060811042447 - Area where sink hold is filled

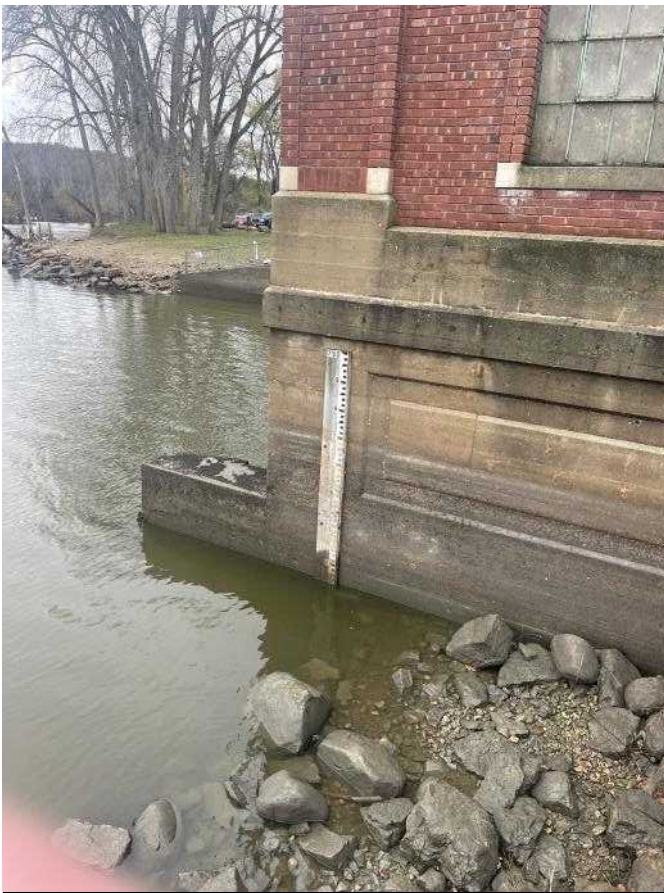
Photo 0060811042448 - Inspection of east gates bays 1 and 2

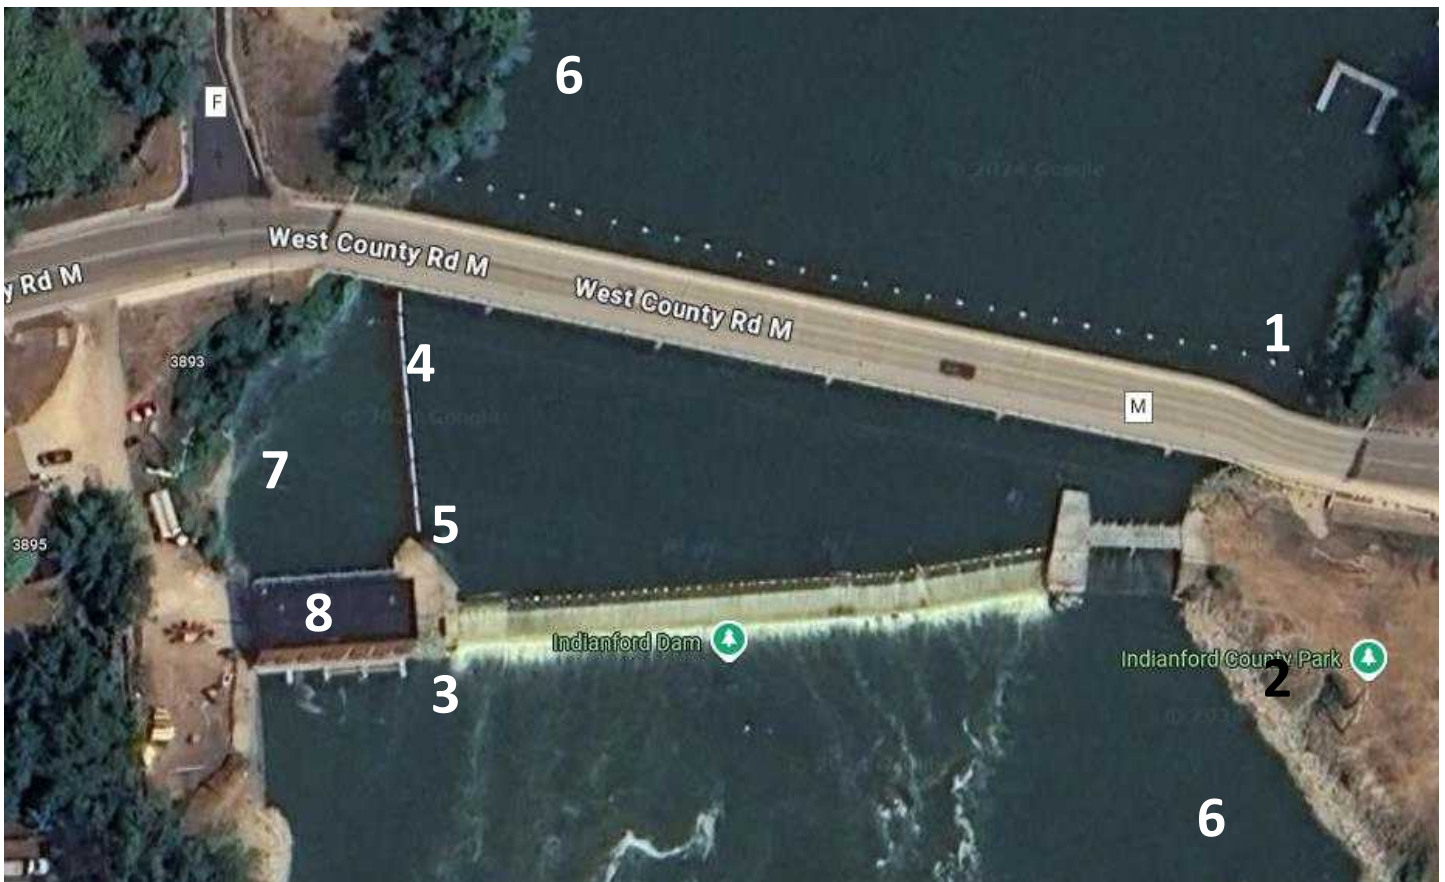
# Power House Abutment Repair

(Item No. 5)

1. THE EXACT LIMITS OF CONCRETE PATCHING TO BE DETERMINED IN THE FIELD BY THE ENGINEER.
2. CONCRETE SURFACE REPAIR SHALL CONSIST OF REMOVAL OF ALL LOOSE SPALLED AND DETERIORATED MATERIALS IN DAMAGED AREAS.

3. ALL LOOSE SCALE, RUST, CORROSION BYPRODUCTS, PREVIOUSLY PLACED PROTECTIVE COATINGS, AND CONCRETE SHALL BE REMOVED FROM EXPOSED REINFORCING STEEL.
4. REINFORCING STEEL EXPOSED FOR MORE THAN ONE THIRD OF ITS PERIMETER CIRCUMFERENCE SHALL BE COMPLETELY EXPOSED TO PROVIDE 1-INCH MINIMUM CLEARANCE.

5. SURFACES OF OLD CONCRETE TO WHICH NEW CONCRETE IS TO BE BONDED MUST BE CLEAN AND ROUGH.
6. PLACE AND CURE PATCHED AREAS IN ACCORDANCE WITH MANUFACTURER'S RECOMMENDATIONS.
